A failure incident occurred on perforated casing tubing for geothermal wells. The damage happened during the drilling process by an air drilling technique after eleven days from the installation. Even though air drilling is a common method for geothermal drilling, this incident showed a lesson to learn to prevent a similar accident in the future. Failure analysis based on the laboratory and field observation was done to get the failure incident's root cause. The visual identification result showed a severe depletion and cracks in the tubing at a depth of 1,450–1,500 m. Optical emission spectroscopy and the tensile test showed materials appropriateness to the specifications. The corrosion attacked from the outer side of the tube. This tubing was exposed to an environment with significant H₂S, CO₂, water steam, and oxygen from the air drilling process. The results of X-ray diffraction analysis (XRD) showed FeS and Fe₃O₄ in the corrosion product. Both of the scale formed as a different layer, where the FeS is formed below the Fe₃O₄ layer. The energy dispersive spectroscopy (EDS) results revealed that each tubing's sulfur content gets an increase in the deeper location. The gas samplin

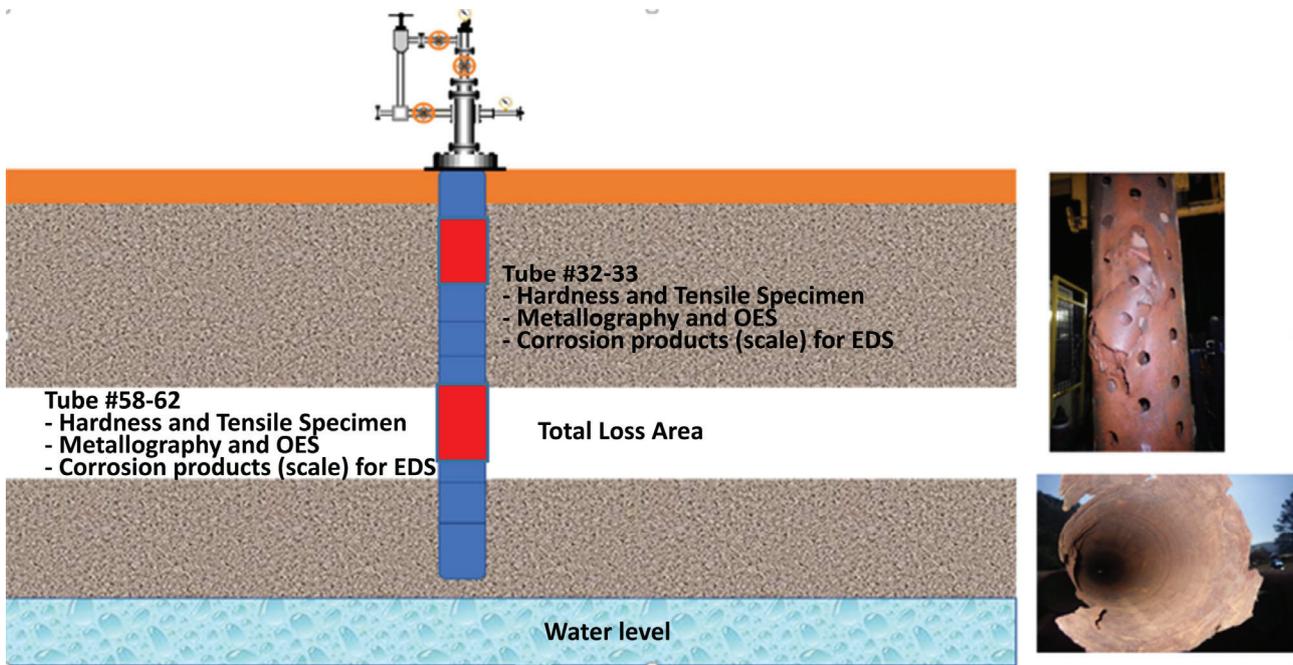
The tubing fracture was found at casing #57–62 with the vertical depth of 1,450–1,500 m below the sea level. This area is the total loss area, where the steam is found. The tubing was severely corroded with the remaining thickness around 1–3 mm, only several days. The tubing was covered by a yellowish scale, especially at casing #60–62.

The perforated hole morphology widened parallel to the flow direction. Based on the gas analysis, the well has 0.2 % wt non-compressed gas (NCG), which consists of 53 % mole CO_2 and 9 % mole H_2S . The schematic position of the failed tube is shown in Fig. 1.

Fig. 1. Position of perforated tubings leak

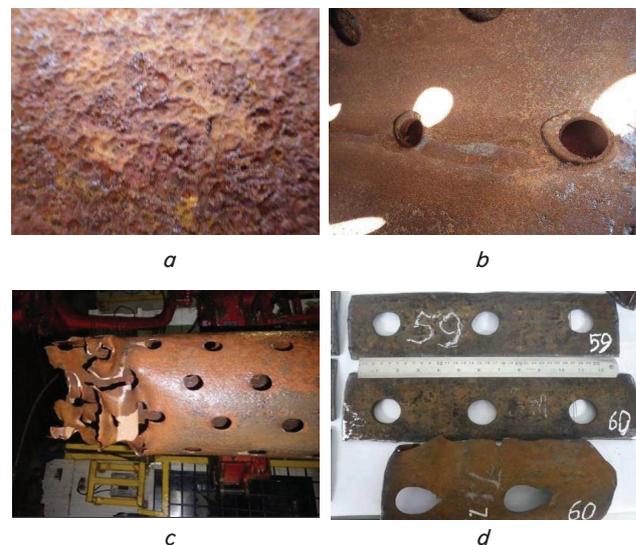
Visual examination is performed only on the specific tube where the severe corrosion occurred. Casing number 60 was attacked by external and internal corrosion. However, casing number #57–58 is only attacked by external corrosion. Casing number #62 was attacked by external corrosion. However, it has a different corrosion pattern compared to the casing number 57–58 as shown in Fig. 2. At casing above #60, the corrosion leaves a uniform and large crater on the external side of the tubing.

Fig. 2. Visual condition of casing tubing a – external; b – internal side condition of tubing; c – after fishing; d – external condition of each tubing

At the upper-level tubing, the corrosion was smooth, as shown in Fig. 2, *d*. Besides the corrosion morphology, as a higher depth of tubing, the corrosion product color is changing. The lower-level tube will have a more yellowish color, while the upper-level tube will be brownish.

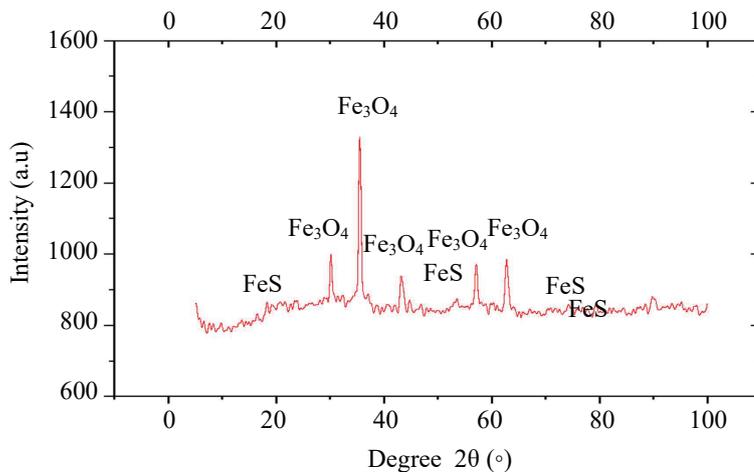
Fig. 3 showed the X-ray diffraction (XRD) result of corrosion products. It is found that magnetite and iron sulfide (FeS) dominated in the scale compound. Magnetite was formed by the oxidation process, while iron sulfide was a product of material and hydrogen sulfide reaction. This result indicated that casing tubing 60 exposed to them an abundance of H₂S gas service. Siderite (Fe₂CO₃) was not detected even though the environment had significant amounts of CO₂ gas.

Fig. 3. XRD test result of corrosion product

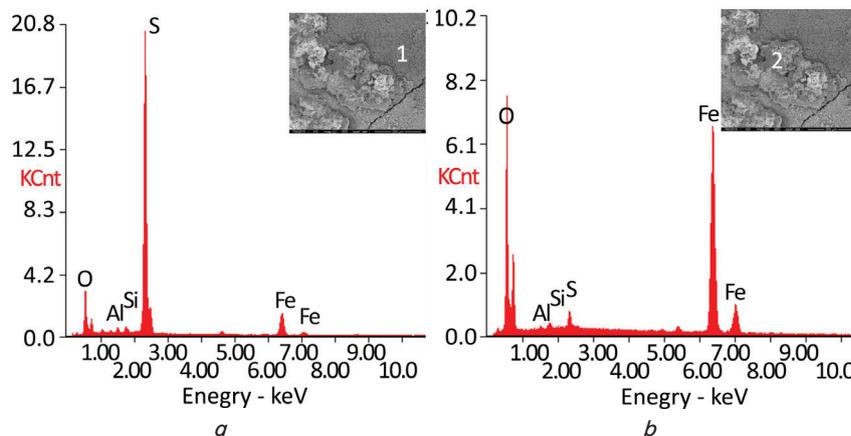
Scanning electron microscopy was conducted at corrosion products. The examination was taken on the inner side of the corrosion product. The result showed the formation of two layers of corrosion products. The first layer is iron sulfide (FeS) covered by magnetite (Fe₃O₄) as the second layer. The result is shown in Fig. 4.

Fig. 4. Corrosion product consisting of different layers: *a* – iron oxide; *b* – iron sulfide

From the SEM result, it appears that the Fe₃O₄ layer was formed above the FeS layer, which indicates that the presence of oxygen accelerated the corrosion as an additional reducing agent in the corrosion process. The first layer was iron sulfide. Iron sulfide has less solubility constant (KSP) than iron oxide. It made the iron sulfide as the first layer.

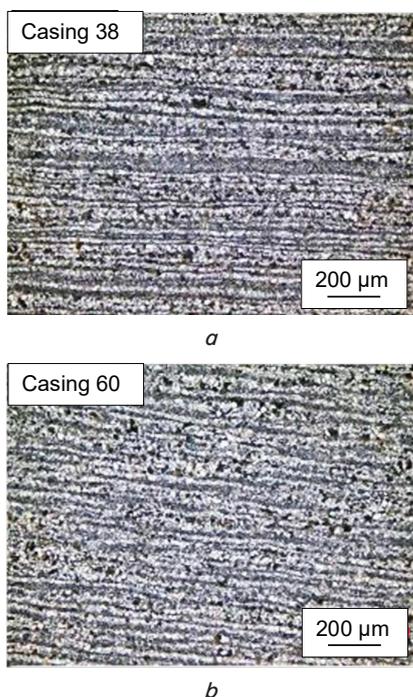
Microstructure analysis was done to investigate the effect of temperature or manufacturing defect. Fig. 5 was taken in a cross-section area and compared between tubing No. 38 and 60. The result reveals no differences in microstructure from casing 60 and 38. Both microstructures had pearlite (dark phase) and ferrite (white phase). The pearlite showed a pearlite band, which is a typical result of the extrusion product.

Fig. 5. Metallography of: *a* – normal casing; *b* – failure casing showed similar structure

All of the tubings had similar grain size numbers and did not show any grain growth or creep evidence. It revealed no indication of high-temperature condition exposure. Similar microstructure from both casing tubing indicated the failure did not relate with the material defects. There is no macro porosities nor crack found in both of the tubes.

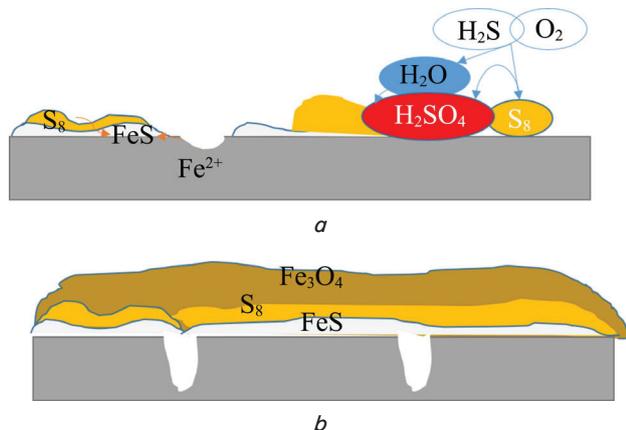
Fig. 6. Proposed mechanism of scale formation: *a* – formation of FeS as the first layer; *b* – oxidation product Fe₃O₄ is formed

In contrast, the KSP of iron oxide formation (magnetite) is higher than sulfide. The proposed corrosion mechanism is shown in Fig. 6.

The second layer was iron oxide. It was a product of further oxidation of iron hydroxide (Fe(OH)₂), which resulted

in magnetite (Fe₃O₄). Magnetite is a typical corrosion product that is formed in poor oxygen content in the environment. Air drilling process supplied and transported oxygen into the cathodic area while the anodic area will be attacked, and corrosion happened.
