IDENTIFICATION OF THE NATURE OF DEFECTS ARISING IN THE PRODUCTION OF CONTINUOUSLY CAST PIPE BILLETS FOR THE OIL AND GAS INDUSTRY

Arif Mammadov

How to Cite: Mammadov, A., Babaev, A., Ismailov, N., Huseinov, M., Guliyev, F. (2023). Identification of the nature of defects arising in the production of continuously cast pipe billets for the oil and gas industry. *Eastern-European Journal of Enterprise Technologies*, 4 (1 (124)), 125–133. doi: <https://doi.org/10.15587/1729-4061.2023.284387>

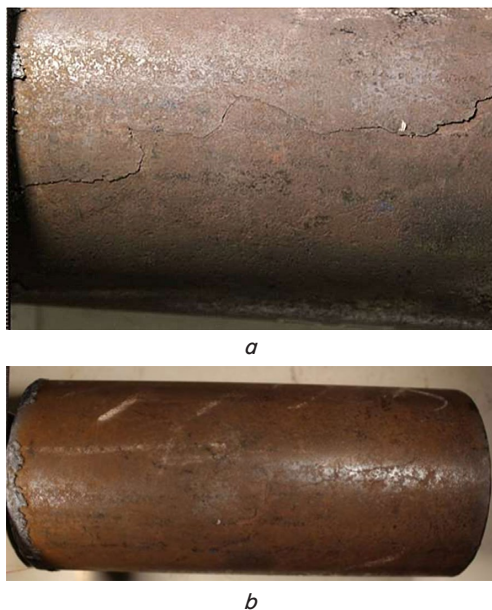
Fig. 1. View of the outer surface of the pipe fragment: marking Rp618: *a* – crack on the workpiece; *b* – oxide spot on the workpiece

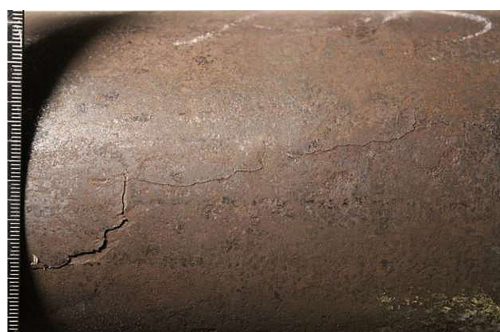
Fig. 2. View of the outer surface of the pipe fragment

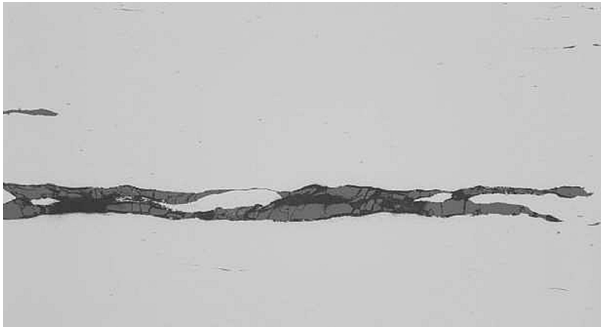
The characteristic appearance and chemical composition of non-metallic inclusions at a distance from surface defects are shown in Fig. 3. It has been found that the chemical composition of non-metallic inclusions in the metal of both pipes is basically similar: the largest inclusions are represented by complex oxides of silicon and manganese; less extended manganese sulfides were revealed, as evidenced by the data in Fig. 4, in regions 2 and 3.

Fig. 3. Characteristic appearance of non-metallic inclusions: marking Rp618

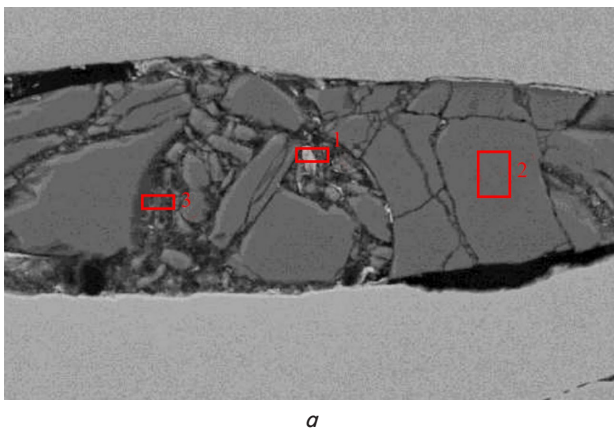
Region		C	O	Al	Si	S	Ti	Mn	Fe
Region 1		03.44	–	–	01.24	–	–	03.37	91.95
Region 2	Wt, %	01.78	21.00	00.99	25.53	00.44	00.66	49.59	–
Region 3		14.23	07.52	–	09.36	00.37	00.35	20.87	47.30

Fig. 4. Characteristic appearance and chemical composition of non-metallic inclusions: marking Rp618: *a* – defective areas; *b* – chemical composition of defective areas

The study of the microstructure of steel and its elemental analysis (Fig. 4) show that there are large inclusions in the defective areas, which are silicon and manganese oxides, as evidenced by a large amount of Si, Mn, and oxygen. Some large inclusions also contain Ca, K and Ti (Fig. 5). There are also decarburized areas as a result of metal oxidation at the stage of pouring liquid metal into an open ladle.

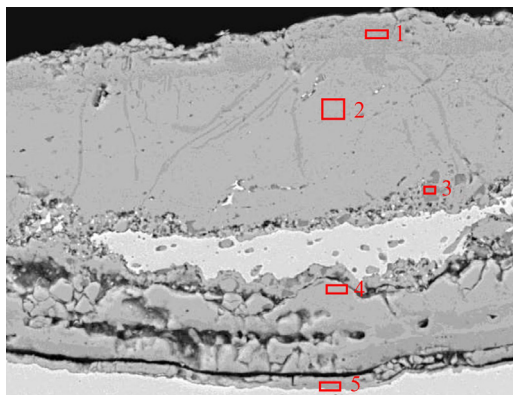
Region		C	O	Si	Mn	Fe
Region 1		0.218	13.59	–	1.12	83.11
Region 2		0.220	11.16	–	1.32	85.31
Region 3	Wt, %	0.357	11.75	0.474	1.66	78.27
Region 4		0.258	10.97	–	1.24	85.21
Region 5		0.222	–	0.58	1.36	95.86

Note: in area 4 found $K - 0.18$; $Ca - 0.57$; $Ti - 0.21$

Fig. 5. Type and chemical composition of non-metallic inclusions in the oxide spot: marking Rp618: *a* – defective areas; *b* – chemical composition of defective areas

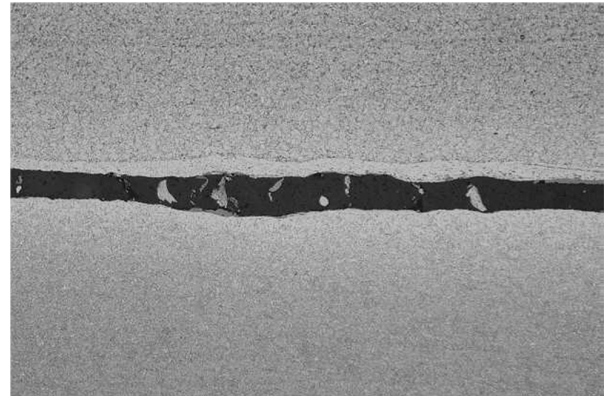
Some large inclusions also contain Ca, K, and Ti compounds, which could get into the metal from slag or a slag-forming mixture. The most likely reason for the formation of significantly large oxides is the ingress of slag into the liquid metal, due to a violation of the technological process of smelting and pouring (Fig. 5). The largest non-metallic inclusions acquire an elongated shape during rolling (Fig. 6) [16, 17].

Fig. 6. Type of oxide spot in the longitudinal section: marking Rp618

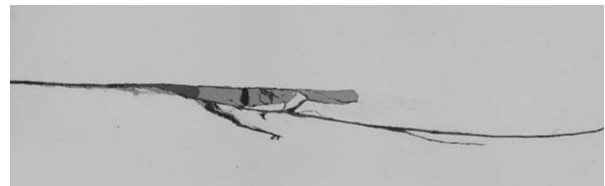
Obviously, large elongated inclusions are stress concentrators and can lead to brittle fracture of pipe metal during rolling or in operation. Fig. 7 shows a view of the oxide spot on the outer surface of a pipe fragment in a longitudinal section.

Fig. 7. View of the oxide spot on the outer surface of the pipe fragment in the longitudinal section (marking Rp618-2): *a* – before etching, *b* – after etching in Oberhofer's reagent

The etched samples show that the surface of oxide spot is decarburized, which is also explained by the oxidation of the metal under the surface of the defect. This indicates that at some stage of production, the exposed surface of the defect at high temperature was in contact with oxygen in the air.

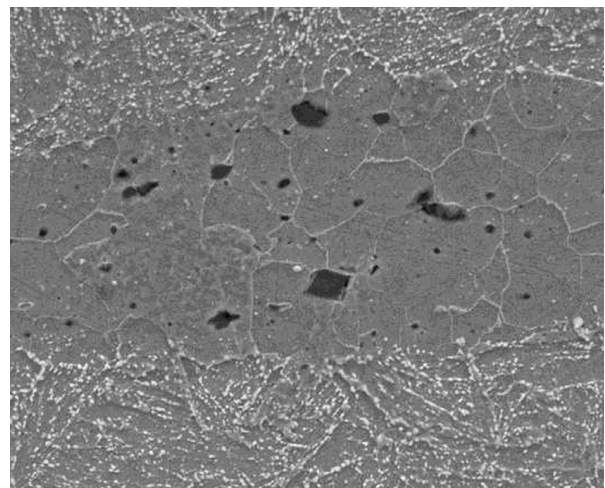
Fig. 8. Type and chemical composition of non-metallic inclusions in the oxide spot: marking Rp619

The above features are also characteristic of the Rp619 sample. It should be noted that on this sample, decarburization was detected not only around the opened oxide spots, but also in the form of stripes continuing the direction of the oxide spots. Also, decarburized bands were found far from the opened oxide spots. In this case, small oxide inclusions were revealed in the decarburized band, as well as around the oxide spot.
