This work reports the development of inline inspection (ILI) methodology to enhance the pigging activity for the dented pipeline, facilitate the pigging process to prevent Pipeline Inspection Gauge (PIG) from getting stuck and improve the safety passage for buckled pipelines. The recent report unveils the condition of the UNPIGGABLE pipelines, which reduce the inner diameter of pipelines to 257.51 mm, equivalent to 27.58 % of the initial diameter and restricts the pigging activity. In this report, the pull-through test coupled with the collapsibility test was conducted. The success of the test above allows the ILI equipment based on the magnetic flux leakage (MFL) technique to record the internal and external wall loss inwardly and geometric defect on diameter of the pipelines. The prepared artificial dented pipeline was made before it underwent several tests. Based on the pull-through test, the maximum force of 27000 N is more significant than the pipeline operating pressure to enable the MFL tool to pass through the pipelines despite exhibiting the geometry anomaly. Compressing the opposite magnetic yoke of the collapsibility test is critical, showing that the ILI MFL tool reache

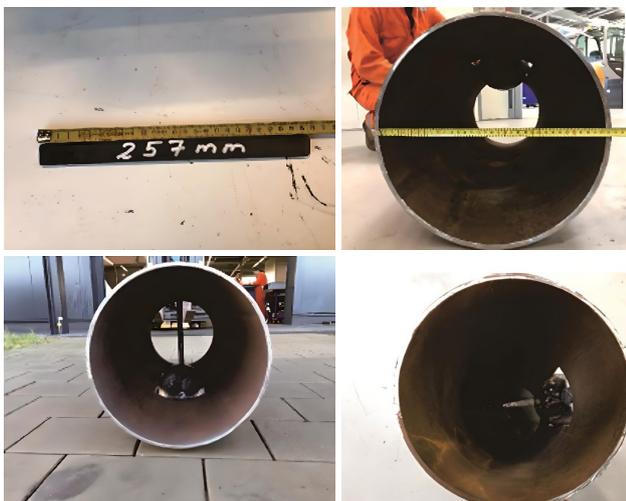
Based on Fig. 2, the pull-through test setup was conducted to mimic the actual dent of the pipelines. The artificial diameter represents the actual geometry anomaly in the pipeline during the previous geometry/caliper pig run of the 257 mm cross-section internal diameter.

Fig. 2. The simulation of the 14-inch dented pipeline before conducting the pull-through test

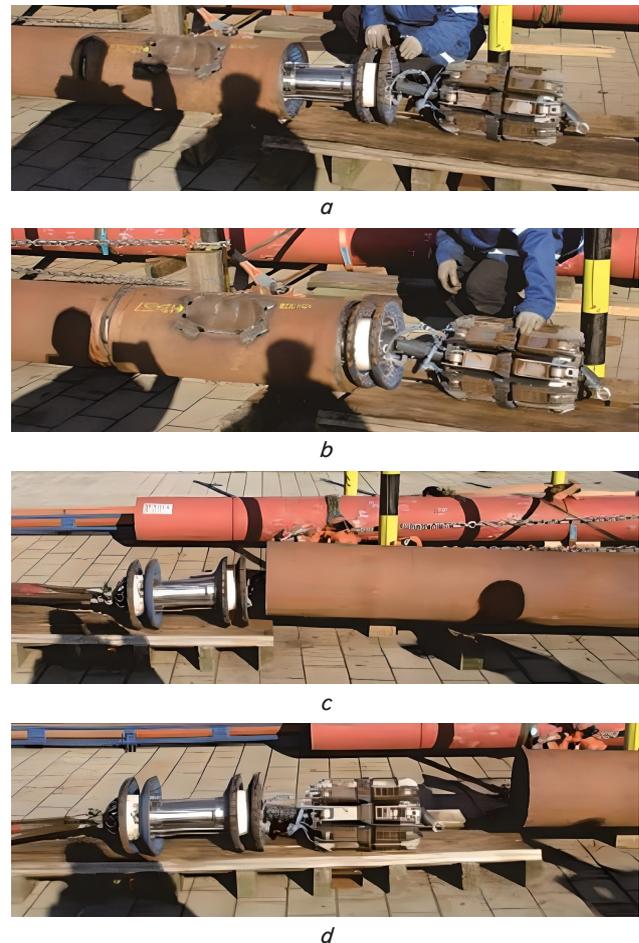
In this work, the number of tests was four times to ensure that the ILI instrument was successfully passed through the dented artificial pipelines, as depicted in Fig. 3.

Fig. 3. The demonstration of pull-through test: *a* – starting of insertion MFL tools; *b* – 1st MFL module fully inserted into spool; *c* – 1st MFL module completed run through the spool; *d* – all MFL module completed pull-through testing

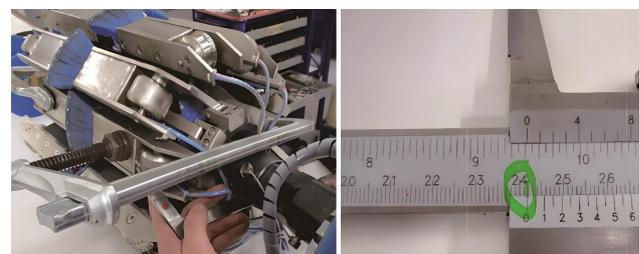
Fig. 4. Collapsibility test instrumentation

The collapsibility test squeezed up to a maximum of 242 mm (Fig. 4). This value is much better than the minimum ID clearance in the artificial geometry anomaly pipe spool for the pull-through test of 257 mm. It indicates that the inline inspection tool can pass through the geometry anomaly in the pipeline safely and with a high confidence level.

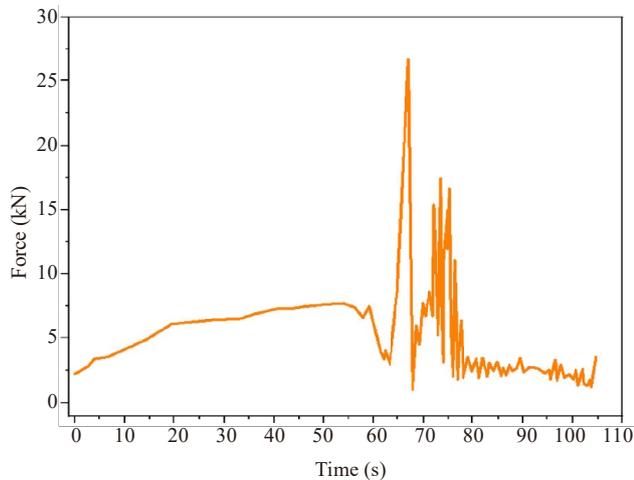
Fig. 5. The profile recorded based on the pull-through test

Based on Fig. 5, the force profile records the various force values in the time range to show the maximum force that can be incorporated when the artificial dent was created. The maximum force was approximately 27000 N, equivalent to 2.7 barg. Meanwhile, the rest of the peak remains significant to show the pressure within the range of force before it drops significantly to less than 5 N after allowing the tool for 94 s. Notably, the collapsibility test results show that the MFL can clean the pipelines as the equivalent stress is below the strength limit and may not cause cracking once the tools can enter the pipelines. The innovation of this work is to develop the simulated spool using the pull-through test with a minimum clearance of inside pipeline diameter of 257 mm,

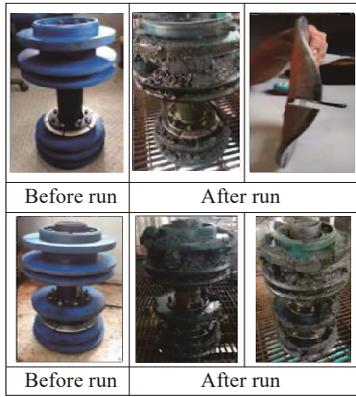
Standard Bi-directional PIGS are required to be run to remove as much as possible debris accumulated inside the pipeline. If pipeline cleanliness is not sufficient then debris such as wax or scale will cover ILI sensor during the run. This will effect to data degrade of ILI tool on detection capability and sizing accuracy. Bi-directional PIGS will be run several times until certain debris recovered at pig receiver barrel allowed for ILI tool run. Fig. 6 shows debris which stucked on disc of Bi-directional PIGS.

In this instance, there is a rapid deformation of the PIG before and after run in the pipelines. The geometry anomaly of the pipelines allows the PIG disk to follow their shapes when it follows the stream of fluid in the inner side of the pipelines (Fig. 6). It is critical to note that the plate diameter is 247 mm, and the value was received after the bi-directional PIG and the PIG receiver was obtained. The original outside diameter is 254 mm before the run, as depicted in Table 2. Hence, it is possible to note that the minimum pipeline diameter with dent area has a cross-section detected by the plate is 247 mm. The value ensures the ILI-MFL tool can pass through the cross-section area detected by the plate (247 mm) and run smoothly when the collapsibility test is conducted, which has a diameter of 242 mm. Eventually, plate diameter and previous geometry will work for both cases.

Fig. 6. The results of progressive pigging

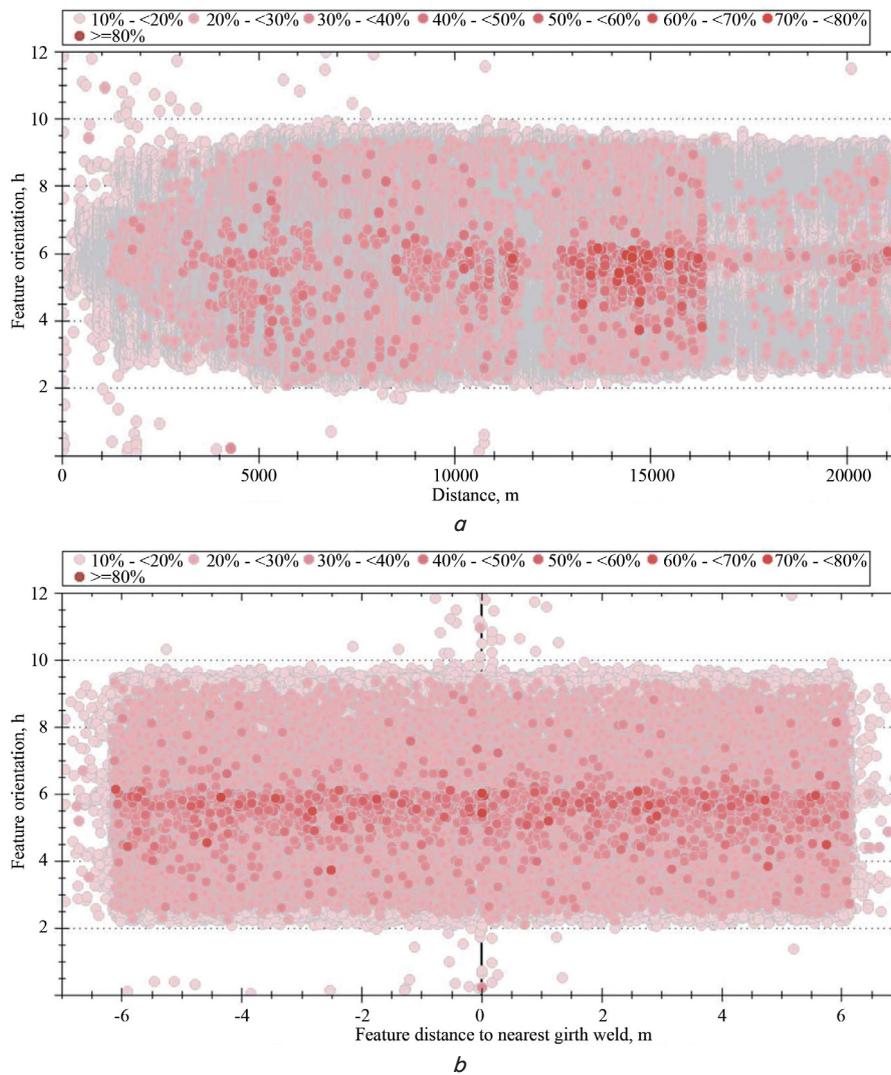
Fig. 7, *a* shows the internal metal loss at the pipe’s bottom half over the entire pipeline length. The most profound features accumulate between 13000 m and 16000 m. However, along the pipeline have already experienced by internal metal loss with difference level of loss. Notwithstanding,

several girth welds show indications of internal metal loss, reported with the comment ‘close to welding’. The most significant location is at log distance 15504 m with a depth of 73 %. Orientation of internal metal loss as shown in Fig. 7, *b* located from 2 o’clock to 10 o’clock position which explain the existence threat of BOLC – bottom of line corrosion (Fig. 7, *b*).

Fig. 7. The inline inspection result: *a* – distribution of internal metal loss over the pipeline length and circumference; *b* – distribution of internal metal loss to closest girth weld and circumference

According to Fig. 7, *a*, the most significant defect orientation is at 06:00, which may indicate the most critical wall loss. It can be related to extensive debris in the designated points despite the internal wall thinning [31]. Several girth welds indicate internal metal loss, which was reported with the comment 'close to welding'. The most significant one is located at 15504 m with considerable reduction due to the location within the heat-affected zone (HAZ), where the structure of the pipe material has changed due to the welding process, and thus, the magnetic properties are affected [32]. The poor HAZ exacerbates the corroding pipelines within the buckle region (Fig. 7, *b*).

3. The majority region that experiences corrosion defects is nearly 15500 m away from the pig launcher and to obtain a moderate amount of debris. Hence, it is inevitable to redo the inline inspection after five years and conduct the cut and replacement scenario due to the quicker thinning rate beyond their initial design.

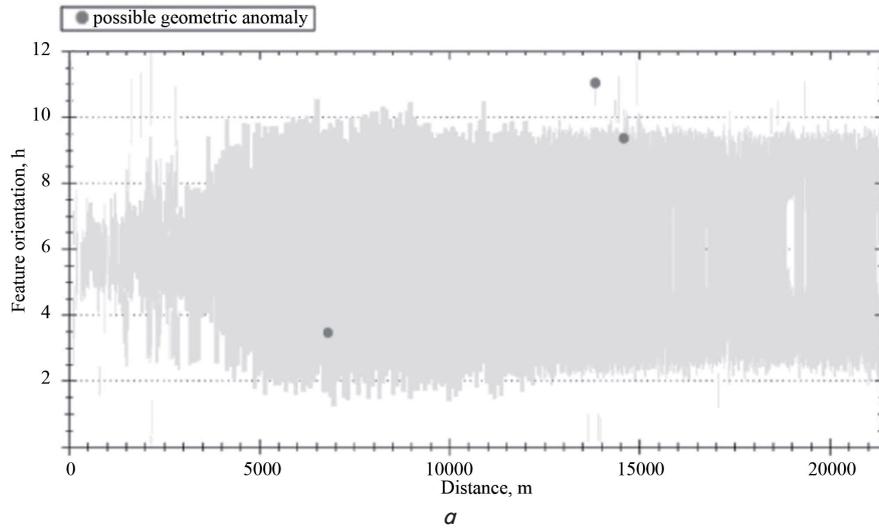
Fig. 8, *a* shows the significant geometric anomaly detected by ILI MFL during the inspection run at 14582 m at 10 o’clock. On the other hand, 10 % internal wall loss is observed at the 02:38 position. This detection reveals that dent is not associated with metal loss. However, the worst internal wall loss above 70 % is near the dent location, as depicted in Table 3. As stated in 5. 2, the diameter of the PIG tool is smaller than the dented area. Therefore, it is essential to note that the success of ILI is secured.

Moreover, the spool test model simulation shows that the dent depth is 98.6 mm with the internal diameter (ID) pipe at 257 mm. Since the result of the actual plate run is 247mm, the collapsibility test has gained a higher confidence level where the ILI MFL can pass through the dented area safely. This fact agrees well with the result of Fig. 4 during the collapsibility test where the ILI tool can be compressed, and the diameter of ILI MFL is squeezed up by 242 mm.

Fig. 8. The inline inspection result on: *a* – distribution of geometry anomalies over pipeline length and circumference; *b* – the profile PIG tool with multi-diameter aluminum plate size; *c* – the inspection MFL tool condition post retrieval

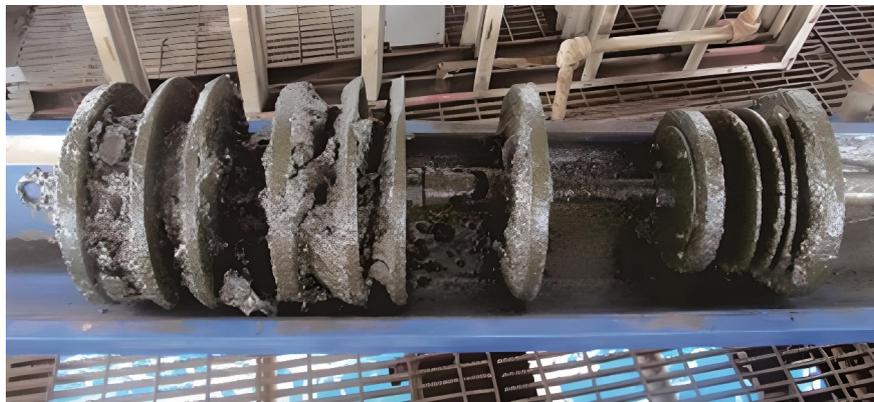
b

Based on Table 3, the further the location, the higher the amount of internal wall loss, with the orientation near the bottom part of the pipelines. It is predicted that the solid deposition may reduce the fluid flow despite creating a smaller defect length of 0.35 inches. It is a prime fact that the previous wall loss has declined 70 % of the wall thickness of pipelines, which has an identical root cause, although it is the most extensive defect length of 2.17 inches. The inspection outcome is obvious to confirm the result in Fig. 8, *b*, *c*. The solid, comprised of sand, ferrous material, sludge, wax, and scale, is attached to the aluminum gauge plate with a few

observable defects (Fig. 8, *b*) with a reported mass of seven kilograms. It indicates that the prepared design in PIGs shows good progress in cleaning the pipelines correctly [27]. On the other hand, the inline inspection MFL tool confirmed that it can safely pass through the known geometry anomaly inside the pipeline, as shown in Fig. 8, *b*, *c*, and a similar result was obtained in [28].
