*This paper presents the findings of a corrosion erosion failure analysis of elbow pipe materials used to flow high-pressure water from underground. The failed elbow pipe material was above the wellhead forming a straight line in the longitudinal direction with a pipe length of 6200 feet below the ground surface. The working fluid in the elbow pipe was 25 % steam and 75 % water, flowing in the elbow pipe with a media flow rate of 180 tons per hour, a pressure of 22 bar, and a temperature of 220 °C. Elbow tubes were made of low carbon steel with Standard ASTM A234 having an outer diameter of 304.8 mm and a wall thickness of 9.271 mm. Macroscopic testing, chemical composition analysis, metallographic testing, hardness testing, X-ray diffraction testing, SEM, and EDS are a few of the test types conducted. The study's findings showed that the elbow tubes experienced a thinning process on the inner wall of the outer curvature side with a rough and wavy surface texture or appearance. This type of failure is known as erosion-corrosion. The level of erosion-corrosion failure that occurs is greatly influenced by the pH of the fluid being flowed reaching 2.67–2.91, this is due to the very hi

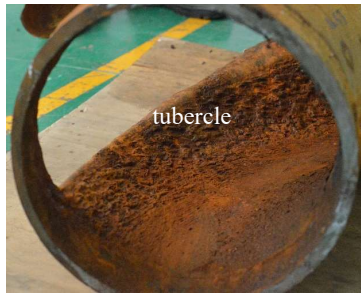
Fig. 1 displays typical macroscopic images of erosion-corrosion on the inner side of the ruptured area. The pipe elbow underwent a metallographic inspection at the position shown in Fig. 2, which corresponds to the visual examination.

Fig. 1. Erosion corrosion condition on the inner surface of the pipe

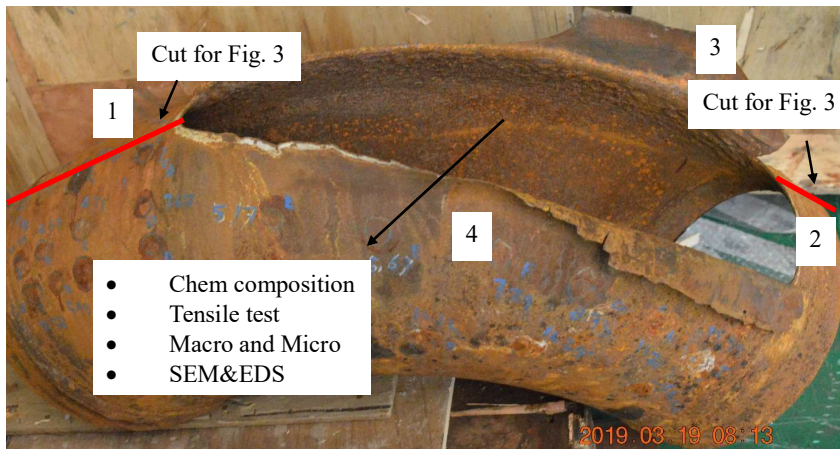
Fig. 2. Location of inspection and testing on the broken elbow pipe

The inspection begins by observing the technical data of the elbow pipe in the technical data table. A pipe sample has been sent as shown in Fig. 2, namely the broken pipe. This pipe will be tested for physical, mechanical, and metallographic properties. The image also shows the type of testing or inspection that will be carried out and its location. The inspection location is concentrated on the damage to the elbow pipe. Visually, a broken pipe can be seen at both ends of the broken pipe, it looks different, the left side (position 1) is thicker than the right side of the broken pipe (position 2). On the right side of the split pipe, there has been thinning at the top, and the upper lip is broken (position 3), with a thickness of between 0.8–1.2 mm, the right side is broken (position 2) has also been thinned by 0.8 mm–2.5 mm, the lower lip of the broken (position 4) with a thickness of 1.2–1.5 mm while the left edge of the broken area (position 1) is 2.6–3.1 mm thick.

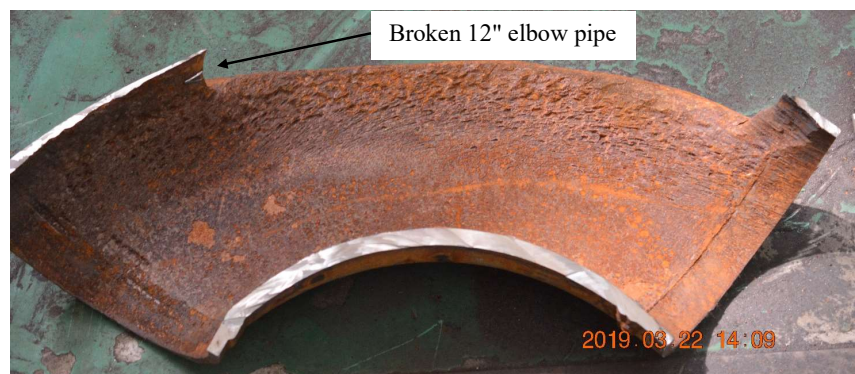
On the broken pipe, a cut was made according to the red line in Fig. 2 showing the shape and direction of the fracture, which is longitudinal. The results of macrostructure observations show that the location of the fracture begins in an area that is already very thin. Fig. 3 shows that fibrous fractures occur due to the mechanism of thinning of the surface area and excess load on the thinnest surface. The fibrous part is evidence that the area is still ductile when it breaks. Severe corrosion causes thinning of the material and excess load fracture. Gray sediment from pipe corrosion is found inside the pipe surface in the form of clustered tubercles

Fig. 3. Broken 12" elbow pipe with ASTM A234 low carbon steel specification and inspection location

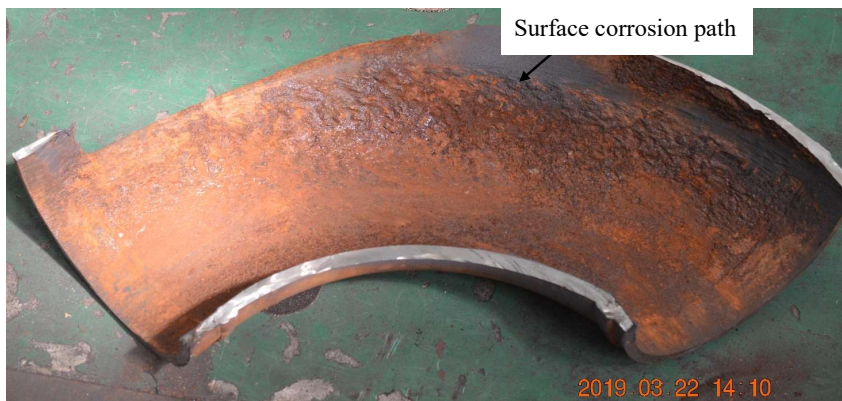
The corrosion path depicted in Fig. 4 appears to be rather deep. Compared with its surroundings, this location has a more open corrosion flow. Due to the long-term exposure to heat on the material and the decomposition of pearlite, decarburization occurs and the pearlite is less and has formed in the groove, so it has a lower hardness.

Fig. 4. Surface corrosion path in the defect area

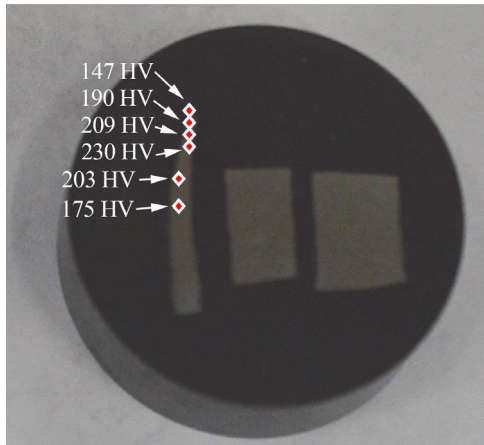
Fig. 5. Results and location of Vickers hardness test

The test findings show that the hardness is still at 230 HV in the ferrite pearlite area but is extremely low in the decarburization structure area, particularly in the vicinity of the fracture edge of 147 HV. Hardness has decreased by nearly 1.6 times. The aforementioned findings suggest that the microstructure has changed in a way that affects the hardness results similarly. The microstructure will largely not change if there is no fluid heat influence for an extended length of time. The pipe will burst as a result of erosion-corrosion occurring more quickly due to changes in the material's microstructure.

3. In the hardness test, the ferrite pearlite area still had a hardness of 230 HV, but the decarburization structure area had a relatively low hardness, particularly along the fracture edge at 147 HV. The hardness is now nearly 1.6 times lower. These results suggest that similar changes in the microstructure have an impact on the hardness outcomes. For an extended duration, the absence of fluid thermal impact will mostly preserve the microstructure. Because of the material's altered microstructure corrosion-erosion, corrosion-erosion will occur more quickly, causing the pipe to fail.

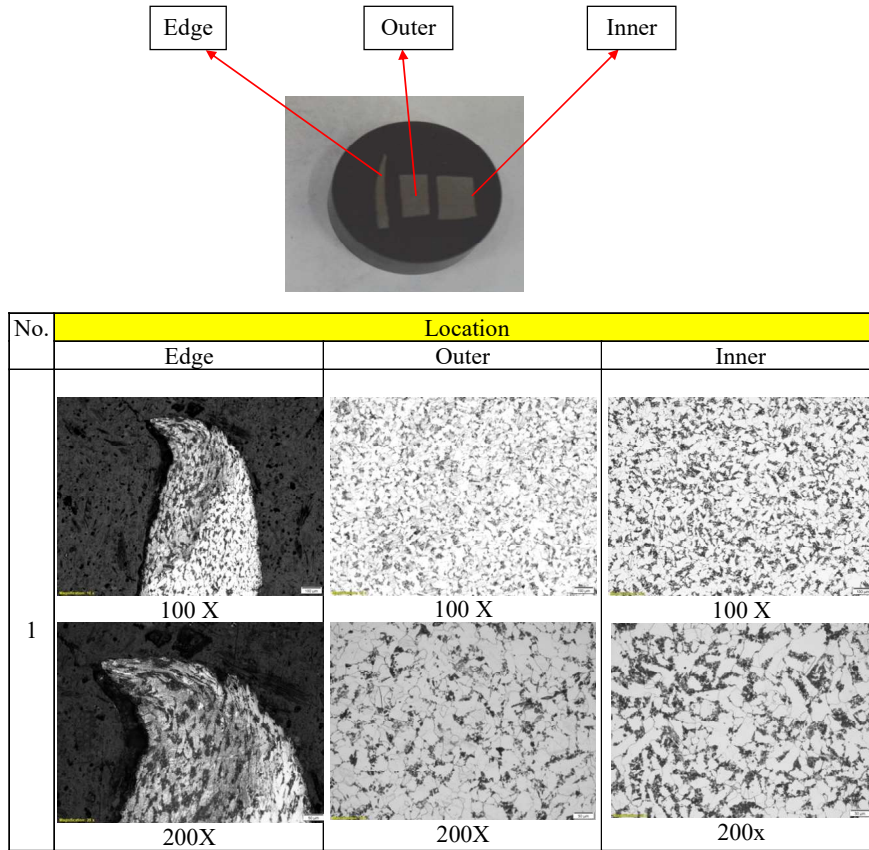
Based on the place indicated in the visual inspection, a metallographic test was performed on the used elbow pipe that was damaged (position 1, in Fig. 2). Fig. 6 (position 2, in Fig. 2) shows the microstructure photos of the elbow pipe at the broken end position, as well as the outside and inner areas. In Fig. 7, the microstructure is essentially the same as in Fig. 6. Based on Table 1 carbon content of 0.206 %, two microstructure phases ferrite and pearlite are discernible from the inner area's microstructure. The composition of pearlite is higher in this phase. On the other hand, the outer region has a lower percentage of pearlite due to decarburization and a comparatively bigger ferrite grain size. This is because the elbow pipe is exposed to prolonged heat and interacts with the surrounding environment, reducing the carbon content. Relatively bigger ferrite grains with pearlite and ferrite phases that also seem to have undergone decarburization are observed in the broken end area (edge). The portion that has undergone decarburization has a comparatively softer hardness than the area that is still in the ferrite pearlite structure, according to the hardness test results. An elongated microstructure is found in the edge area, specifically the edge area where the fracture will occur, indicating that the material is still ductile. When there is significant pressure applied to the thin material, there is a significant amount of deformation, causing the structure to change from equiaxial to elongated.

This also suggests that the elbow pipe has a fairly strong erosion mechanism. The results of the exterior and interior microstructures show that decarburization is generated on the outside, but the outer microstructure is still in the form of ferrite pearlite because the heat delivered by the fluid is not too great. This is because, in contrast to the outer portion, which is connected to the reduction environment, the area inside the pipe is more exposed to heat from the fluid for a longer period, but no material lowers carbon from the steel. When compared to the original microstructure, which was pearlite ferrite, the decarburized microstructure's hardness is significantly reduced.

Fig. 6. Microstructure of elbow pipe used in position 1

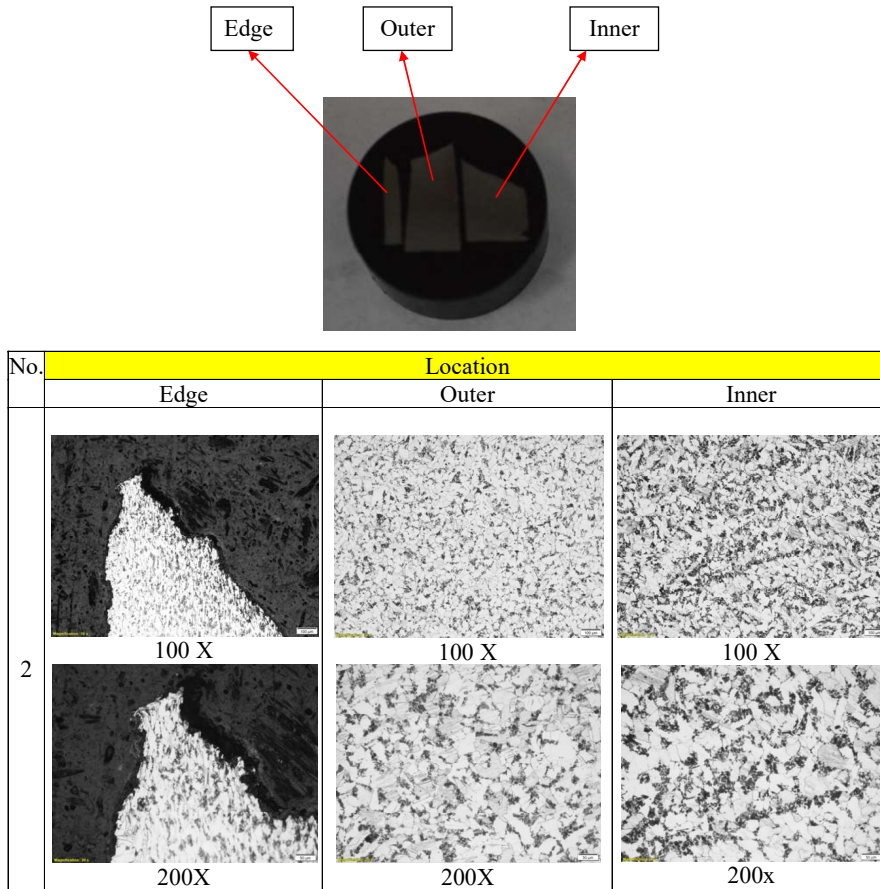
Fig. 7. Microstructure of elbow pipe used in position 2

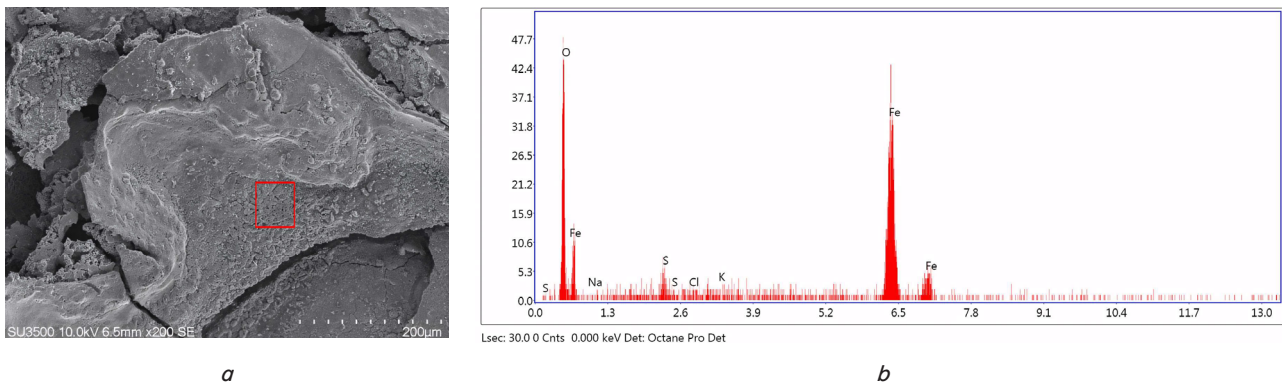
Using a scanning electron microscope, the erosion and corrosion-prone sample pieces were inspected. The primary goal was to examine the corrosion surface’s micromorphology close to the notch tip, as seen in Fig. 8. The SEM picture magnified 200 times revealed fine cracks in the erosion-corrosion area, with a width of approximately 50–200 μm. The direction of the cracks is not uniform. Regarding Fig. 9, the scale surface showed no cracks according to the SEM data in the non-defective area.

As can be observed in the SEM image, the examination was done at two specific spots, specifically in the erosion-corrosion defect area. Fig. 8,9 display the two areas that are free of flaws together with the EDS results. SEM and EDS analysis using a mapping model revealed essentially the same chemical composition at both sites. Generally speaking, the elements that predominate are oxygen (O), iron (Fe), carbon (C), Cl, and S in that order. At both sites, the components Cl- and S are present; their presence indicates that the fluid being conveyed contains both elements. It is well known that the presence of chlorine can facilitate the occurrence of erosion and pitting corrosion. The presence of Cl- and S causes holes in the metal, which leads to erosion and corro-

Fig. 8. The results of the EDS examination on location 1 of the surface: *a* – the red mark is position 1 of the chemical composition test shooting with energy dispersive X-ray; *b* – the results of the energy dispersive X-ray examination on location 1 of the surface

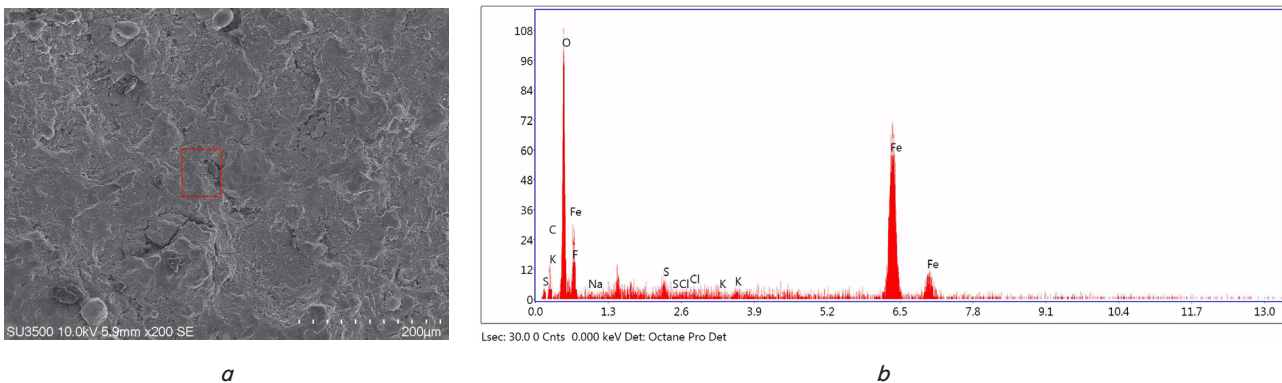
Fig. 9. The results of the EDS examination on location 2 of the surface: *a* – the red mark is position 2 of the chemical composition test shooting with energy dispersive X-ray; *b* – the results of the energy dispersive X-ray examination on location 2 of the surface

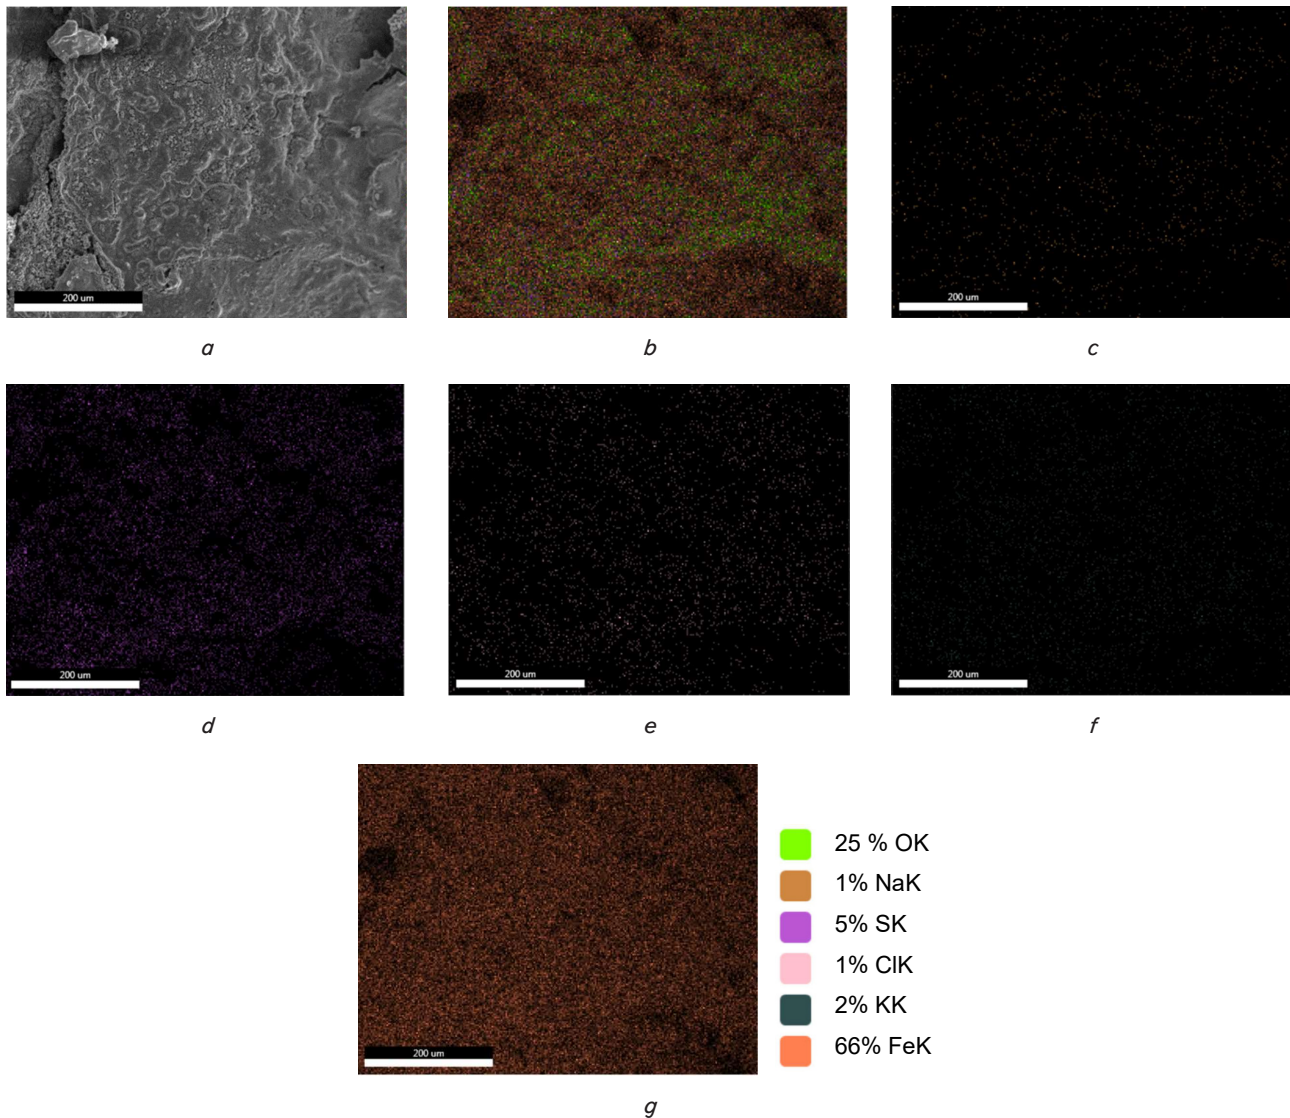
Fig. 10. Results of corrosion erosion mapping on the elbow surface using a scanning electron microscope (SEM):  
*a* – secondary electron image of steel; *b* – 25 % of the oxygen element’s surface in a steel X-ray image;  
*c* – 1 % of the natrium element’s surface in a steel X-ray image; *d* – 5 % of the sulfur element’s surface in a steel X-ray image;  
*e* – 1 % of the chloride element’s surface in a steel X-ray image; *f* – 2 % of the kalium element’s surface in a steel X-ray image;  
*g* – 66 % of the ferrum element’s surface in a steel X-ray image

tral fluid conditions, further supports this. Therefore, it is necessary to choose the appropriate material – that is, material that is resistant to erosion and corrosion – to accomplish the service life that the designer had intended.
