This paper introduces a methodology devised for thermographic inspection of concrete technical condition inside concrete dams. Water infiltration into a dam accelerates the processes of concrete degradation, so temperature fields provide important information about the dynamics of these processes. As a result of the thermal imaging survey of the observation gallery at a historic hydraulic structure, a formalized pattern of the temperature field inside the dam was acquired and the locations of temperature anomalies associated with infiltration were identified. At the leakage points, the water temperature differed from the concrete temperature by 1.0–2.9 °C, indicating different rates of water flow through the water wall and the gallery ceiling. The temperature of the gallery areas with increased infiltration was 1–2 °C higher than the 12.7 °C selected as the reference temperature. When recording the temperature fields, the optical axis of the thermal imager was directed along the gallery, and not perpendicular to the surfaces under study, as in construction thermography. To this end, a methodological approach was devised to eliminate distortions of the resulting thermograms caused b

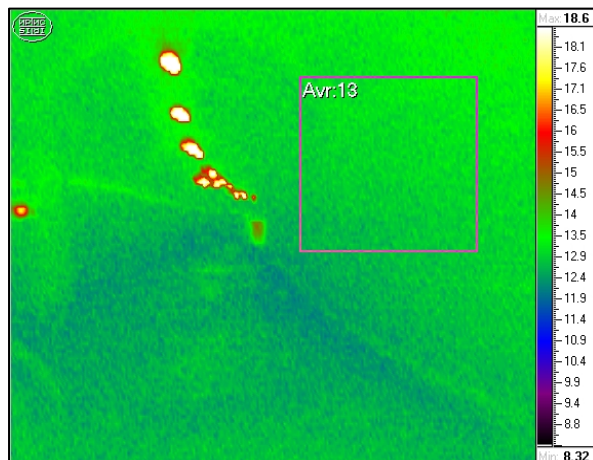
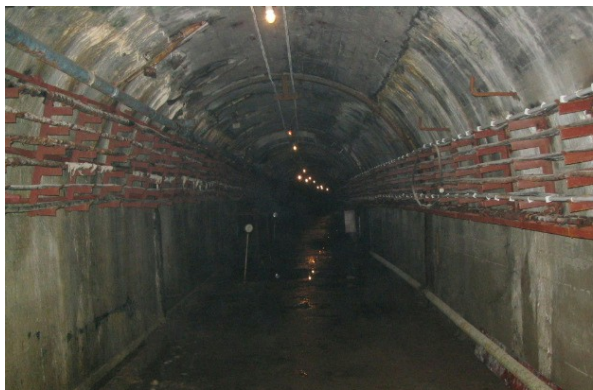
A surface with smooth and dry concrete with a temperature of 13 °C, close to the average temperature inside the gallery, was chosen as the reference area (Fig. 3).

Fig. 3. Reference surface of the dry section of the gallery: a – thermogram; b – visible image

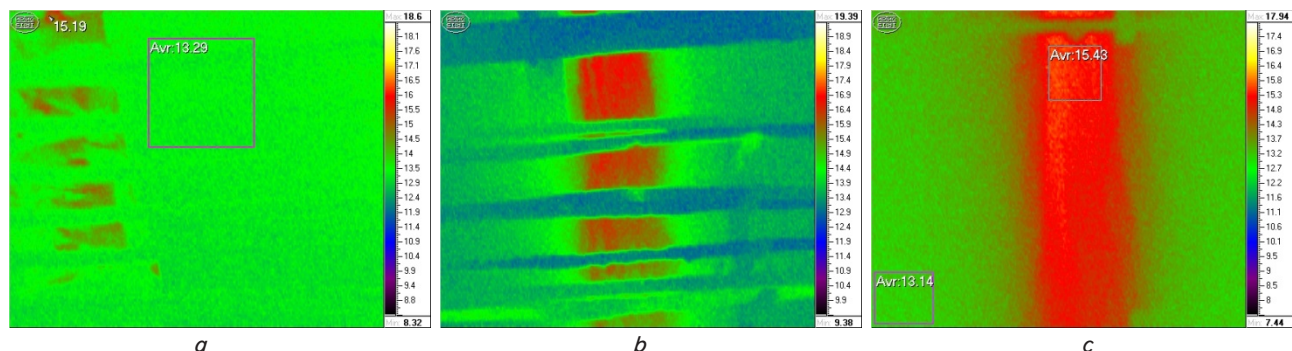
As a result of the survey, water infiltration was observed in some areas of the gallery. The temperature of the water differed in the places of the leaks, which indicated the different speed of its arrival through the water-head wall and the ceiling inside the gallery (Fig. 5) [10].

Analysis of 47 acquired thermograms revealed that the temperature contrast between the leaked water and the walls of the gallery was 1.0–3.0 °C.

Fig. 5. Temperature contrast ΔT of the infiltrated water on the water-head wall: a – $\Delta T=1.9$ °C; b – $\Delta T=2.8$ °C; c – $\Delta T=2.3$ °C

reservoir (Fig. 2) and the concrete of the dam. It was found that under such conditions, temperature drops caused by infiltration reach 0.7–2.8 °C (Fig. 5), i.e., values sufficient for recording by a thermal imager.

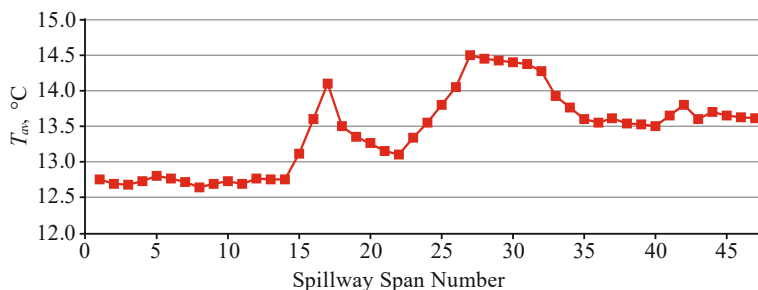
According to Fig. 10, the temperature distribution in the gallery is uneven, which is an indicator of the intensity of infiltration processes. Sections of the gallery adjacent to the left bank of the river (No. 27–45) stand out. They have a temperature criterion higher than the areas adjacent to the right bank. This difference sometimes reaches 1.8 °C. A noticeable anomaly is observed in the area of section No. 17. A comparison of the results of frame-by-frame processing of the temperature field of the gallery (Fig. 10) with the image of the destroyed part of the Dnipro HPP dam (Fig. 11) revealed the coincidence of abnormally warm areas with restored wartime destruction of the surface part.

Fig. 10. Dependence of the integrated temperature criterion T_{av} of the gallery surface on the number of spillway span

The higher temperature of the specified sections of the gallery is the result of water infiltration into the body of the dam. Comparing the results of frame-by-frame processing of the temperature field of the upper observation gallery (Fig. 10) with the image of the destroyed dam of the Dnipro HPP (Fig. 11) proved the coincidence of abnormally warm areas with restored wartime destruction of the upper surface part.

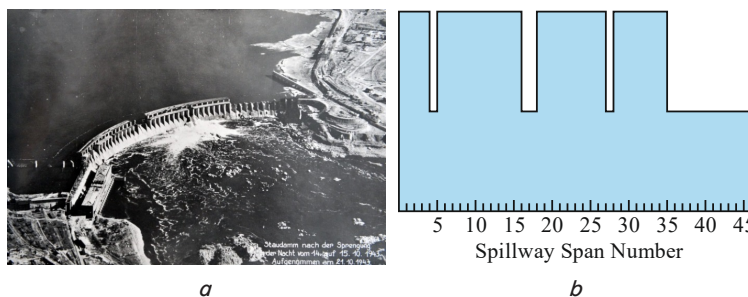
Fig. 11. Dnipro HPP Dam: *a* – after the explosion on October 15, 1943; *b* – diagram of destruction of the above-water part of the dam

According to Fig. 11, the following piers of spillway spans were destroyed:
