The object of this study is HSS API 5DP Gr 105 which has been used as drill pipe and was found leak during drilling activity, causing a delay in the delivery of drilling products. The interaction among the high partial pressure of H₂S, a high-hardness material, and the injection of high-density completion fluid (HDCF) remains poorly understood, leading to sulfide stress cracking. Despite offering substantial benefits, the detected trace amounts of hydrogen and sulfur indicate a localized corrosion, which can lead to unprecedented drilling shutdowns and consequently impose greater operational costs. Recently, the API 5DP 3-1/2" drill pipe experienced failure with a significant hardness value of 26 HRC, exceeding the standard specified by NACE MR 0175. The material was in service in rich H₂S gas well, where HDCF was injected to maintain hydrostatic pressure and serve as a control fluid. Multiple field and laboratory investigations have been undertaken to identify the root cause of this failure, including visual inspections, macrophotography, chemical composition analysis, completion fluid testing, tensile testing, metallography, and SEM-EDX analysis. The shear-slip and step-like mark

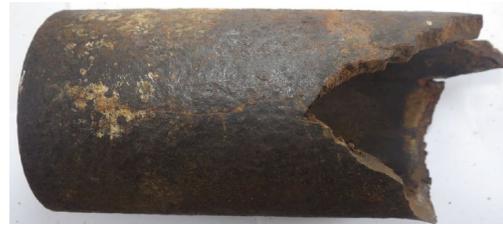
Fig. 1. The as-received failed material of API 5DP Grade 105 R2

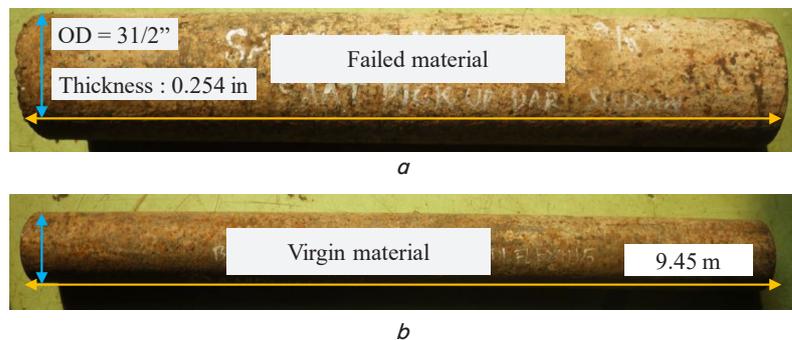
Fig. 2 shows the calculated length was 9.45 meters, the outer diameter (OD) was 88.9 mm, and the wall thickness was 9.35 mm. Recently, the material was selected and used as a drilling logger by a reputable oil and gas company, which reported the failure at a depth of 2743 mMD. In this case, HDCF with a specific gravity of 1.63 SG was introduced into the active well to replace the drill mud. The complete acronym of the manuscript is given in Table 1.

Fig. 2. The specimen: *a* – as-received fractured damage pipe exposed to chemicals; *b* – virgin pipe (non-exposed to chemicals)

axial, bending, pressure, thermal, and residual stress, during manufacture. Moreover, the sourness of the well was captured by measuring the partial pressure of H_2S at 0.06 psia, based on the average monthly monitoring H_2S sample, at both the wellhead and flowline locations. The transfer of HDCF was executed alongside 40 bbl of Hi-Vis and 700 bbl of water after the TCB 6" + BHA rotary assembly entered the well. The report indicates a failure in the drill pipe at joint 13 within the drill string (Fig. 2).

Based on the actual damage to the drill pipe, it is suspected that the material exposed to the HDCF experiences a more severe corrosion attack than that of virgin drill pipe (Fig. 2, *b*) that complies with mechanical, pressure, thermal, and environmental stresses during well completion. Accordingly, the emergence of a remarkable H_2S partial pressure and the continuous injection of HDCF-containing brine aggravate and accelerate the corrosion process.

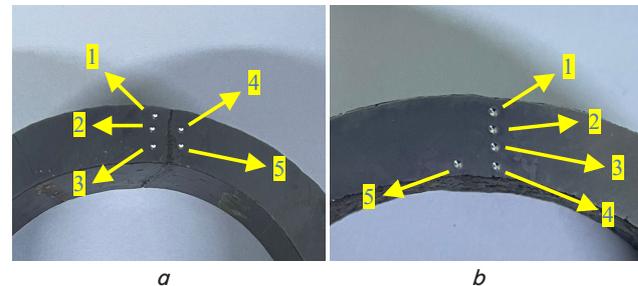
Fig. 3. The location of indentation on the test specimen: *a* – as-received fractured damage pipe exposed to chemical; 1 – crack tip; 2, 3 – crack propagation west side; 4 – crack propagation east side; 5 – crack termination; *b* – virgin pipe (non-exposed to chemical); 1 – crack tip, 2, 3 – crack propagation east side; 4 – crack termination east side; 5 – crack termination west side

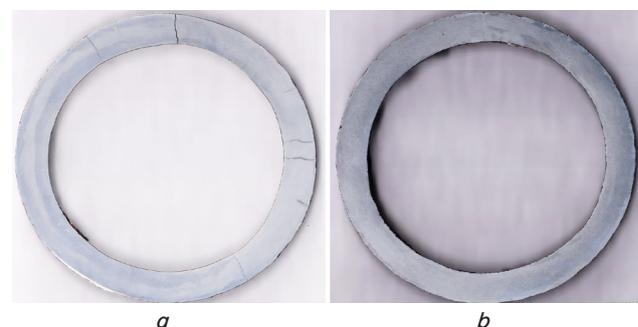
Fig. 4. The macrostructure of the test specimen for examination: *a* – failed specimen; *b* – virgin specimen

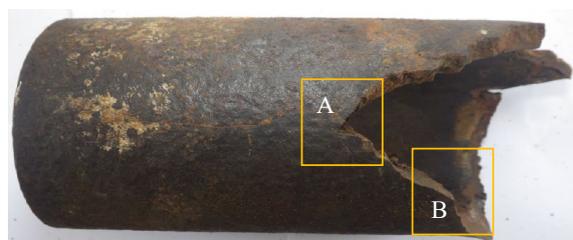
Fig. 5. The SEM-EDX location on the failed material: a – brittle crack; b – ductile failure

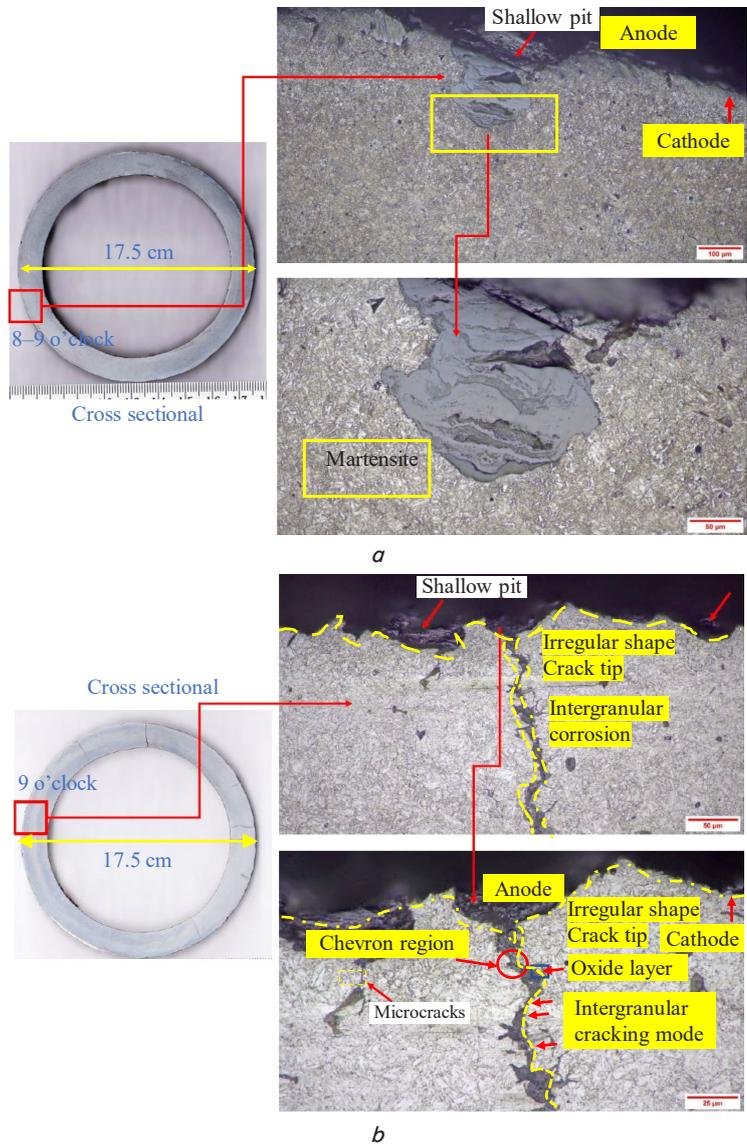
Fig. 6 shows the metallography characterization to reveal the failed and virgin material to elucidate the material’s susceptibility to SSC. In this case, the macrostructure of the virgin material shows no cracks detrimental to SSC resistance and no discontinuities (Fig. 3). In consonance, the macrostructural evaluation is acceptable for SSC service and meet acceptance requirements of NACE MR 0175/ISO 15156. On the contrary, the macrostructural examination for the failed material reveals a crack, where the presence of the macrostructural cracks renders the material rejection for SSC service as per the same standard.

Fig. 6. The metallography result of API 5DP Grade 105: a – virgin material; b – the failed material

The photograph was taken from a cross-sectional view, capturing the microstructure from the 8–9 o’clock position, with the specimen measuring 17.5 cm in diameter (Fig. 6, a). It is noteworthy to note that the region near the shallow pit was magnified as shown in the lower photograph. Shallow pits are visible on the outer surface of the test specimen, although these are not necessarily benign corrosion features. It is suspected that these sites could be sites where hydrogen

atoms accumulate, potentially leading to crack initiation when exposed to sour conditions with HDCF injection. The material was heat-treated through quenching and tempering, resulting in tempered martensite, as shown in Fig. 6, *a*. The surface appears free of microcracks, indicating no exposure to HDCF. Additionally, the material demonstrates ductility, with a ductility value exceeding that of the API 5DP Gr 105 standard material, at 18.47% compared to 12.5%. (Table 4).

In contrast, the failed material shows evidence of SSC, as seen in the macro view of the ring specimen with observable circumferential cracking. Additionally, metallographic evidence indicates that shallow surface pits act as initiation sites for cracks, with subsurface microcracks emanating from lower pits and coalescing into a main crack that propagates

occurs. Meanwhile, the cathodic site is highlighted at the crack flanks behind the crack tip and on the surrounding external surface (lower stress level). The formation of a micro-galvanic cell is obvious, including the anodic movement, which is critical in the longitudinal direction [28]. The high hardness value of 26.3 HRC vs 22 HRC (NACE MR 0175) signifies the hydrogen absorption and detection of anodic site and favorable condition for SSC (Fig. 6, *a, b*), including the presence of intergranular (IG) cracking and corrosion.

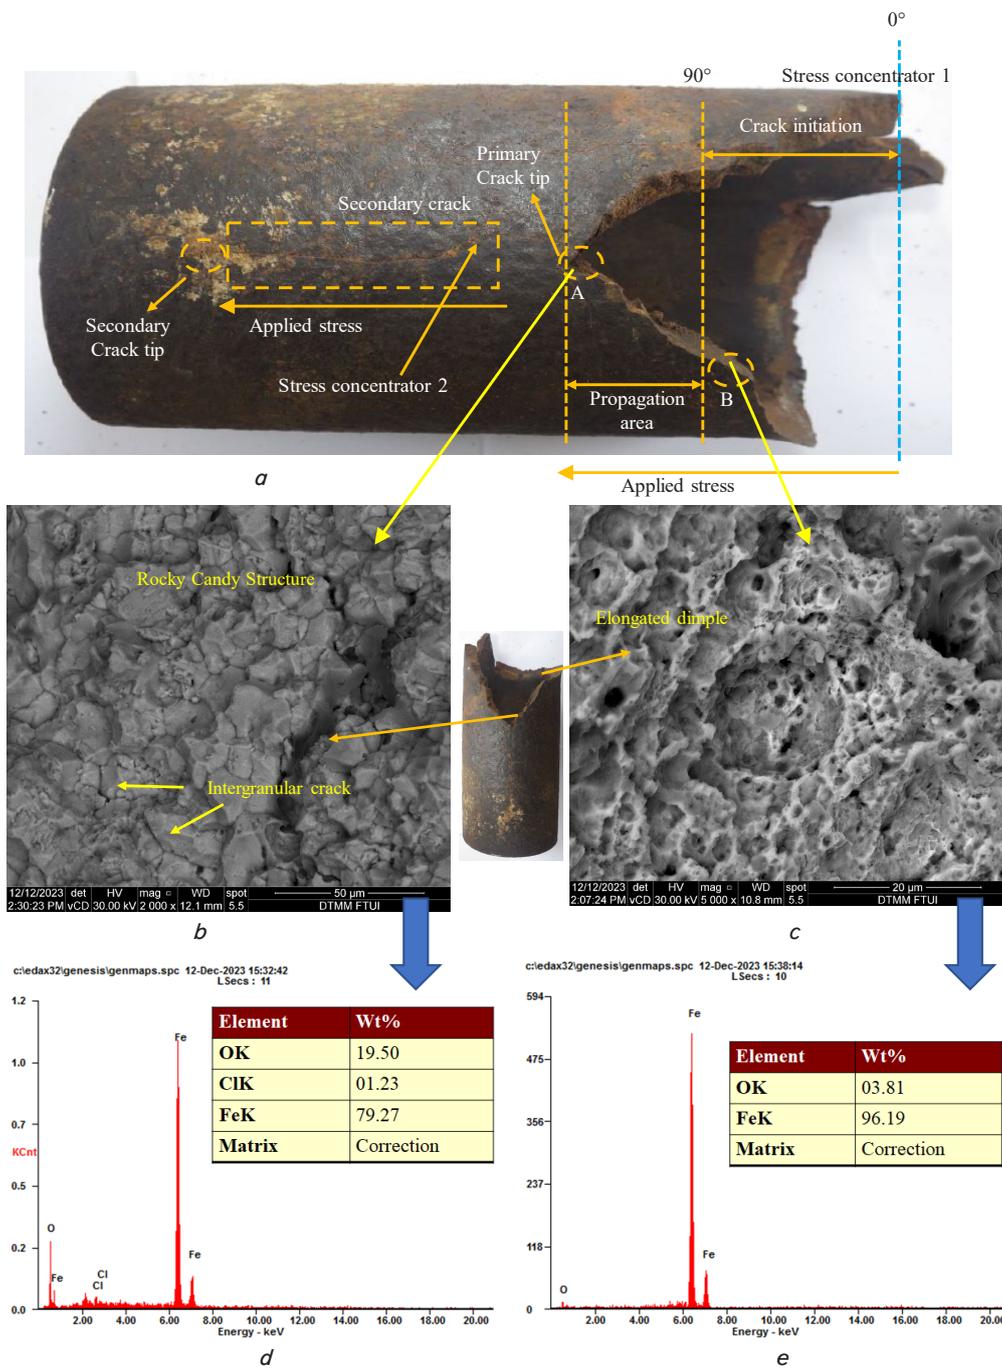
Fig. 7 shows full images of the fracture surfaces from the failed material, taken from two regions to better illustrate the material's brittle and ductile nature.

Fig. 7. The macrostructure and surface morphology results: *a* – visual macro surface analysis; *b* – brittle crack propagation; *c* – ductile failure (shear slip); *d* – elemental of brittle crack; *e* – elemental of ductile failure

Based on Fig. 7, *a*, there are at least two prominent stress concentrations at the shear slip edge and the center of the failed specimen. The ascertainment scenario is illustrated as follow; the stress concentrator acts as an initiation crack, starting early and propagating before reaching the pipe's center, where the angle shifts from 0° to 90°. It is worthy to note that the presence of HDCF intensifies the SSC mechanism especially in the presence of H₂S and high tensile stress. The region of crack initiation is significantly larger than the area of crack propagation before ceasing at the primary crack tip. Additionally, a secondary stress concentrator becomes evident, featuring a blunt edge that reduces tensile stress amplification, thereby promoting local hydrogen-assisted crack initiation.

The appearance of a brittle crack at location A indicates the presence of SSC, marked by plastic deformation at the crack tip (Fig. 7, *b*). This condition is strongly linked to a slightly lower yield strength of the failed material, measured at 831.03 MPa, compared to the original material. Although this value exceeds the yield strength of API 5DP standard material, it still increases SSC vulnerability. Additionally, the brittle crack is associated with a high elongation percentage, which allows SSC crack propagation to occur more readily (18.8% versus 12.5%). The SEM result confirms the metallography result, as the presence of intergranular cracks is evident in the brittle crack location. This result is comparable to the research result [20]. In the event of ductile failure at location B, the failed material demonstrates good plastic deformation capability, and the higher hardness correlates with the significant section loss and the presence of elongated dimples (Fig. 7, *c*). Apart from corrosion products of Fe and oxygen (O), EDX analysis indicates that the brittle fracture results from exposure to a chloride-rich sour environment, with 1.23 wt.% chloride present. In contrast, ductile failure is primarily influenced by Fe (96.19 wt.%) and O (3.81 wt.%), leaving little opportunity for aggressive chloride ions to participate in the fracture process.

Fig. 7 illustrates the mechanistic crack in the failed material, highlighting two potential stress concentrator points. The initial stress concentration occurs at the crack tip before it propagates leftward, causing the crack angle to increase from 0° to 90° (Fig. 7, *a*). Later, a secondary stress concentration appears at the center of the specimen before it extends in the same direction under the applied stress. The brittle nature at the primary crack tip is evident, with a rocky-candy structure and intergranular cracking confirming results from the metallography test (Fig. 7 *b*) [29]. Simultaneously, a few elements such as chloride at 1.23 wt.% and oxygen at 19.50 wt.% serve as strong indicators of HDCF dissolution in the failed material, as shown in Fig. 7, *d* in the A region. Additionally, Fig. 7, *c* clearly displays a porous structure with elongated dimples in the B region. The high content of Fe (96.19 wt.%) and O (3.81 wt.%) suggests that the material prolongs the transition from elastic to plastic deformation where the most possible general corrosion occur [30].

Additionally, a strategy should be in place to prevent the initial failure of the material. Several approaches can be proposed and implemented, such as limiting H₂S with H₂S scavenger injection to reduce the presence of HS⁻ and S²⁻ ions and to control the overall H₂S partial pressure in the gas phase. Since the welding activity involves significant chloride ions, applying a corrosion inhibitor could be effective. This chemical also helps reduce hydrogen production by controlling electrochemical reactions when API 5DP pipe is exposed to corrosive environments containing H₂S, CO₂, and chloride in gas and water phases. This strategy is aligned with the result of low pH of the well fluid based on the laboratory outcome. Accordingly, the dosage of HDCF should also be pondered despite their effectiveness in commencing the drilling process. Upgrading the material, like choosing low-strength carbon steel compliant with NACE MR 0175, can also be advantageous. Furthermore, consistent inspection and monitoring such as measuring H₂S concentration, pH, and water content are essential to ensure the drill pipe's reliability.
