The object of this study is high-strength steel of API 5DP Gr 105 that has been used during well completion in a corrosive environment. This work emphasizes key factors affecting material damage caused by slip marks, tensile load, and hydrogen content in contaminated brine and completion fluid, which were not addressed in previous studies. Several tests, including chemical, mechanical, and surface characterization, were conducted. The chemical composition test of the fluid shows that the brine has been contaminated by H₂S gas and sulfur, with inevitable traces of chloride, bicarbonate, carbonate, bisulfide, and sulfide, providing active sites for hydrogen atom diffusion at the slip marks. The material composition test confirms that the failed material is API 5DP Gr 105. A noticeable amount of phosphorus increases grain boundary segregation and weakens the cohesive metallic bond. A hardness at 28 Rockwell C is inevitable and increases the material's vulnerability to embrittlement, despite the Charpy energy test showing a manageable level, confirming local brittleness. The high tensile strength of 914 MPa is evidence of embrittlement, even though the material remains ductile, with a

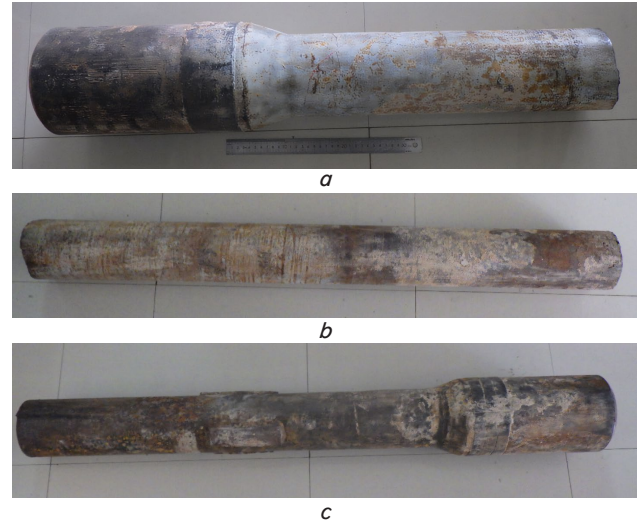
Fig. 1. The as-received drill pipe material: a – drill pipe A; b – drill pipe B; c – drill pipe C

Fig. 4 presents a designated test specimen for each drill pipe. In this study, the drill pipe specimen exhibits notable material degradation, including die marks, pitting, and localized rust. The specimen was subjected to mechanical property assessments and surface characterization.

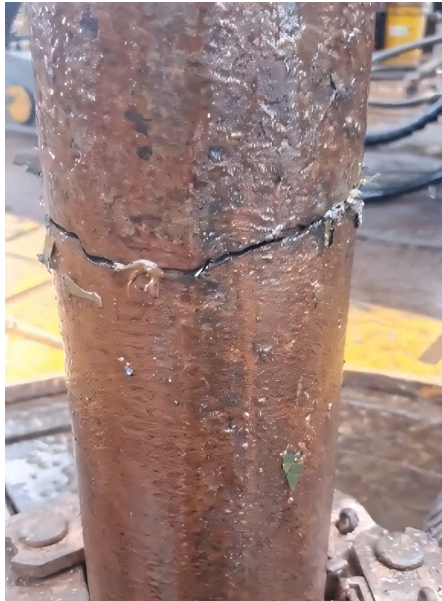
Fig. 2. The crack location of the fractured drill pipe

It is clear that the corroded steel pipe exhibits circumferential crack where the crack is perpendicular to axial stress (Fig. 2). In this work, the sample A and B were delivered to lab to obtain several tests such as impact, tensile, optical emission spectroscopy (OES), hardness, scanning electronic microscope-energy dispersive X-ray spectroscopy, and microstructure (metallography), where the location is depicted in Fig. 3.

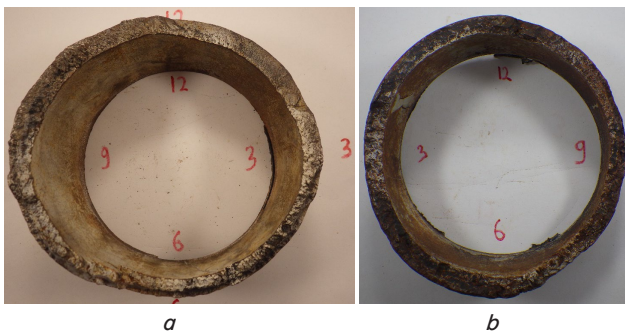
Fig. 8. The surface macrophotograph: *a* – drill pipe A; *b* – drill pipe B

It is noteworthy to observe that the thickness of the affected fractured material exhibits no thinning on either the outer or inner surface of the pipe. The thickness at the 12 o'clock position remains unchanged, confirming the brittle fracture mechanism. This mechanism is consistent with hydrogen embrittlement, particularly when the material shows no evidence of plastic deformation. The cup-and-cone fracture is observed, which correlates with the higher Charpy impact energy attributable to the greater energy-absorbing capacity of drill pipes A and B (Table 5).

Fig. 8 shows the macro-observation of two specimens of the fracture specimen and to show the features of hydrogen assisted fracture. Based on Fig. 8 *a*, the rough and granular outer region appear to show the irregular while faceted edge surface although the surface shows a cup-and-cone of ductile fracture [30]. In consonance, the presence of rocky texture becomes more apparent to show the intergranular fracture and consistent with the result of surface characterization (Fig. 10, *a*, *b*).

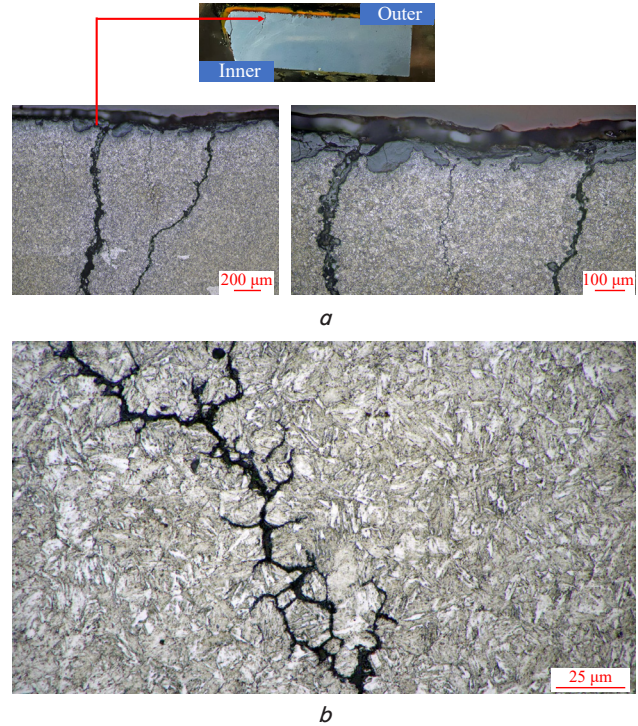
Fig. 9, *a* illustrates a surface-connected crack prior to the appearance of a propagation crack, exhibiting a relatively straightforward crack pathway and minimal branching. Furthermore, the dark, sharply defined crack edges are consistent with the material’s brittle nature, which lacks ductile tearing properties [19]. Surface crack initiation begins near the surface and indicates a reduction in ductility as the material propagates inward. Furthermore, the crack morphology reveals a propagation path that aligns with a high tensile strength value [20].

Fig. 9. The micro-structure photograph of the failed specimen: *a* – cross-section; *b* – crack propagation along austenitic grain boundary

Fig. 9, *b* highlights the presence of highly branched cracks with irregular crack directions. The crack propagation features secondary cracks, which are typically associated with hydrogen embrittlement. However, this result remains consistent with the SEM-EDX analysis to substantiate the metallography findings (Fig. 10).

Based on Fig. 9, the outer surface of the pipe (OD) exhibits numerous shallow depressions, which are suspected to be traces of slip marks and pitting. Cracks are frequently observed initiating from these stress concentrations. These cracks propagate extensively from the outer surface toward the inner surface of the pipe and display a branched morphology. Observations at 500 \times magnification (Fig. 9) reveal that the cracks propagate along the austenite grain boundaries, forming small island-like features. It is also possible to note that the martensitic structure renders it more prone to HE as high-density of dislocations is produced [31]. A high concentration of hydrogen enables the crack to grow along the grain boundary, resulting in intergranular fracture. It is also possible to note that the crack propagate inward to indicate the hydrogen diffused inward due to stress during flexing activity and the martensitic microstructure.

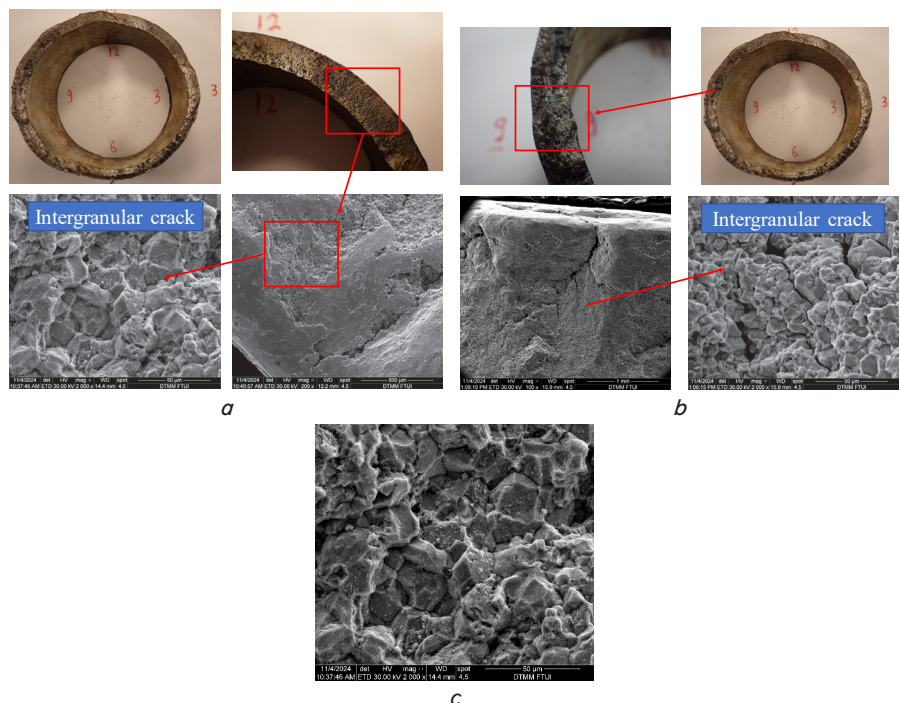
Fig. 10. The surface morphology result: *a* – initiation crack of the fractured surface; *b* – the underneath of fractured location; *c* – rocky-candy intergranular crack

Fig. 10 provisions the scanning electronic microscope of the fracture analysis of the failed drill pipe. It is essential to note that the rocky-candy structure of the API 5DP material adheres to the intergranular fracture. In this case, the SEM result is in good agreement with the metallography findings where the intergranular crack appears on the drill pipe material and propagate on the austenitic grain boundary. The similar observation was aligned with the study [21] in which the material of Fe-Cr-Ni-Mn-Mo-Si-N-C alloys experiences electrochemical hydrogen charged along grain boundaries. In this work, the rocky-candy structure is equivalent as austenite grain of the drill pipe. The intergranular fracture mode is considered a brittle fracture where the alloy exhibits crack propagation on the grain boundary of the material. Hence, it is essential to describe the damage mechanism of the material as illustrated in Fig. 11.

Fig. 10 confirms the result of metallography where the intergranular crack on the drill pipe remains propagate on the grain boundary austenite. The rocky-candy structure enhances the visibility and length of slip marks and describe the grain boundary deformation. This behavior related to the crack initiation and hydrogen embrittlement behavior. The presence of slip marks on the outer diameter of failed material behaves as a stress concentrator and serves as initiation crack. This fracture is worsen when the API 5DP material is exposed with the HDCF material. As illustrated in equation (1), the hydrogen ions in the brine well fluid adsorb onto the surface of API 5DP material, enhancing its embrittlement. Because of their extremely small atomic size, hydrogen atoms can diffuse into the solid metal lattice. Once absorbed, hydrogen lowers

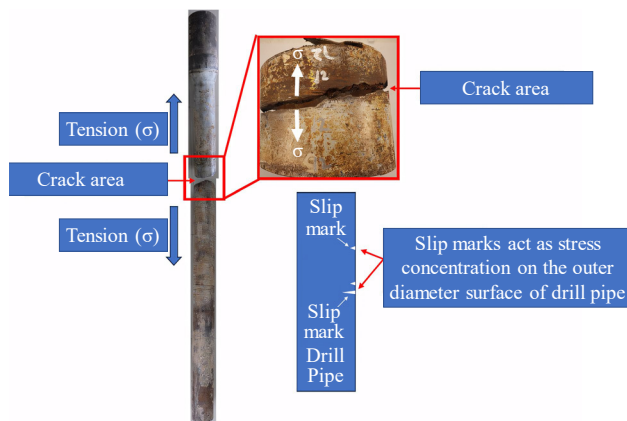
Fig. 11 depicts the drill pipe condition when they simulated during flexing process. During well completion, the drill pipe was hung on the HDCF fluid leads to increase the tension downward, where the density of HDCF is 13.6 lb/gal.

Fig. 11. The illustration of the tension and slip marks as a stress concentration

Based on Fig. 11, the disappearance of deformation on the crack area is evident and aligns with the result of the tensile test. It is also prime to test whether the brittleness appears globally or locally on the crack area by considering the pressure loaded to cause the ductile crack. Based on the data in Table 1, it is concluded that brittleness appears locally in the cracked area rather than globally.

Conversely, the specimen drill pipe C demonstrates resistance of the API 5DP material against HE. Its yield strength, tensile strength, and elongation are 831 MPa, 908 MPa, and 20%, respectively, which are associated with a decrease in crack propagation resistance despite prolonged exposure to a corrosive environment, thereby rendering the material susceptible to degradation [28]. The data remains consistent with actual conditions, where slip marks were observable as stress concentrators on the failed material (Fig. 11).
