DOI: 10.15587/1729-4061.2019.157307

CHANGE IN THE PHYSICAL-MECHANICAL AND DECORATIVE PROPERTIES OF LABRADORITE UNDER THERMAL EXPOSURE

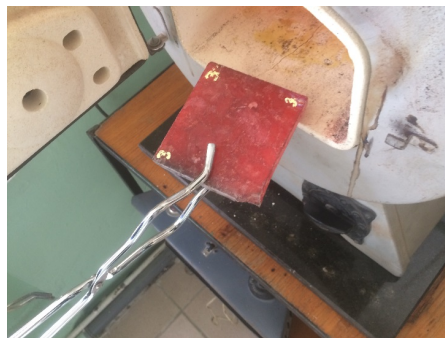
Fig. 2. Physical appearance of labradorite sample when heated to 800 °C

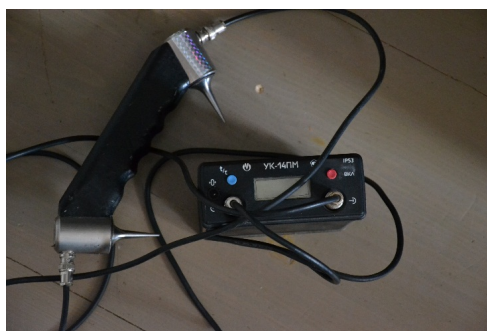
Fig. 3. Ultrasonic device UK-14MP

After each heating, we measured gloss of the polished front surface of samples using the gloss-meter PCE-100 GM with a measurement geometry of 20°/60°/85°. The front surface of labradorite samples was digitized using the Canon scanner CanoScan LiDE 700F. To determine the strength of natural stone and patterns in the development of cracks, we measured in a stone sample the velocity of surface ultrasonic wave propagation using the ultrasonic device UK-14MP, which is equipped with a surface sound sensor with a fixed base of 120 mm (Fig. 3). This surface sound sensor with a

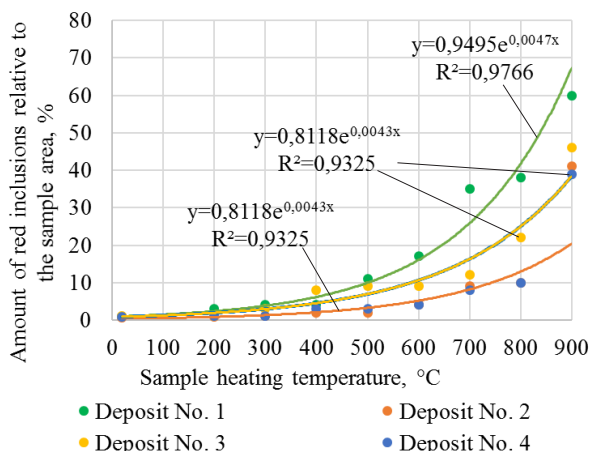
in the labradorite samples (Fig. 5) increased when heated to 300 °C. For example, for the Ocheretyansky labradorite, from 0.91 % to 4 %, for the Osnikovske labradorite, from 1 % to 3 %, and for other samples from deposits the growth amounted to 1 %. At a temperature of 400 °C, one observes an increase in red spots in labradorite samples from the Osnikovske deposit by 2.7 times, from 3 to 8 %. A sharp increase in red spots was observed in labradorite samples from the Ocheretyansky deposit at a temperature of 600 °C. At 900 °C, red spots cover the surface of the samples by 39 to 60 % of the area. The spots manifested themselves the least on labradorite samples from the Neviryvsky and Katerinovskiy deposits, by 41 and 39 %, respectively. Red spots were most visible on labradorite samples from the Ocheretyansky and Osnikovske deposits, by, respectively, 60 and 46 %, due to a higher content of such minerals as ilmenite (FeTiO₃) and dusty magnetite (FeO·Fe₂O₃).

Fig. 5. Dependence of the area of red inclusions at the surface of labradorite samples on the temperature of heating: deposit No. 1 – Ocheretyansky; deposit No. 2 – Neviryvsky; deposit No. 3 – Osnikovske; deposit No. 4 – Katerinovskiy

Fig. 5 shows that the largest number of red spots appeared at the surface of labradorite from the Ocheretyansky deposit. This is due to the presence in the mineral composition of labradorite of FeO in the amount of 4.68 %, which is the highest indicator among the represented deposits of labradorites.

The dependence of red inclusions at the surface of labradorite samples on the temperature of heating is the same for the Osnikivske and Katerinivsky deposits and is described by a power function. This is due to the presence in the mineral composition of labradorite from the Osnikivske and Katerinivsky deposits of FeO in almost the same amount, 3.91 and 3.81 %, respectively. The smallest value for red inclusions relative to the area of samples from the Neviryvsky deposit of labradorites at heating among the represented deposits of labradorites can be explained by the smallest content of FeO in the mineral composition – 1.58 %.

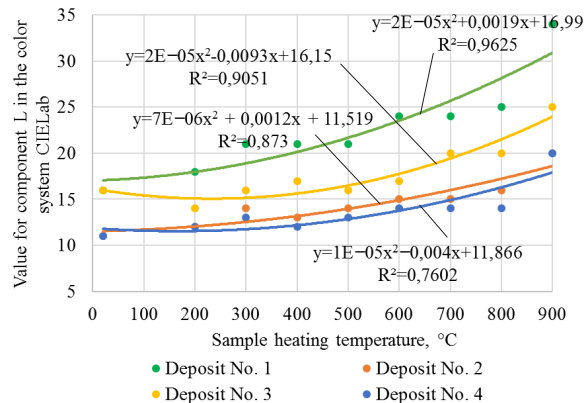
Fig. 6 shows that the samples become lighter with an increased temperature of heating, a sharp increase in the brightness of samples takes place at a temperature from 800 to 900 °C. The highest value for component L in the color system CIELab (the brightest image) was demonstrated by the Ocheretyansky deposit of labradorite. The darkest samples, based on the value for component L in the color system CIELab, were demonstrated by the Osnikovske and Katerinovskiy deposits of labradorite.

Fig. 6. Dependence of the polished brightness of labradorite samples surface on a temperature of heating: deposit No. 1 – Ocheretyansky; deposit 2 – Neviryvsky; deposit No. 3 – Osnikovske; deposit No. 4 – Katerinovskiy

When heated, labradorite samples become lighter by up to 50 % of the initial values for indicator L in the color system of CIELab.

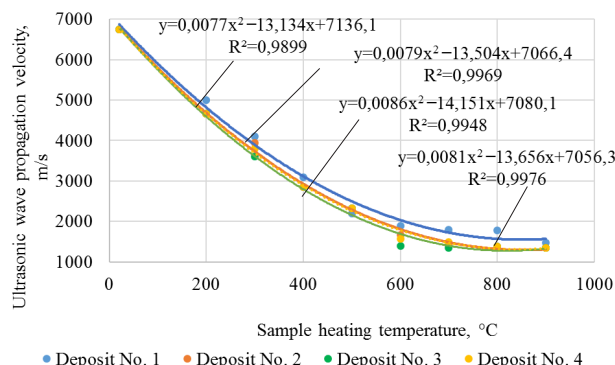
In the temperature range of 200–400 °C, labradorite demonstrates the disclosure of previously existing micro-cracks. The most significant changes occur in a range from 500 to 600 °C, where there is an increase in pore openness. This is due to the formation of gaps between minerals, and merging the breaks with open pores. These phenomena are caused by the anisotropy of natural stone. The dependence of propagation velocity of ultrasonic wave on temperature is almost the same in labradorite samples. A decrease in the ultrasonic wave velocity by 80 % of the initial values occurs when heating the samples to a temperature of 900 °C. At a temperature of 700–900 °C, most labradorite samples demonstrate a decrease in the velocity of ultrasonic wave. This is explained by that the number of cracks in the studied samples reaches a threshold value.

Fig. 7. Dependence of ultrasonic wave propagation velocity in labradorite samples on temperature, sample from: deposit No. 1 – Ocheretyansky; deposit No. 2 – Neviryvsky; deposit No. 3 – Osnikovske; deposit No. 4 – Katerinovskiy

A change in the velocity of ultrasonic wave propagation in labradorite samples under the influence of temperature is nearly the same for all represented deposits.

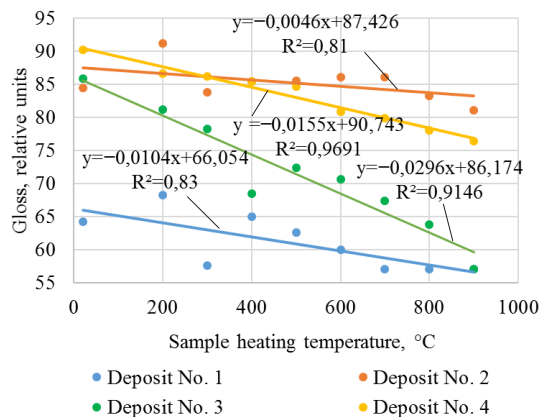
When investigating gloss at the polished surface of labradorite samples, it was found that at a temperature of 200 °C there is an increase in the indicators of gloss for samples from the Ocheretyansky and Neviryvsky deposits of labradorites. At a temperature of 300 °C, there is a decrease in gloss indicators for the Ocheretyansky and Neviryvsky deposits of labradorites with the further rise at a temperature of 400 °C. For samples from the Osnikivske deposit of labradorite, a decrease in gloss indicators occurs at a temperature of 400 °C and an increase at a temperature of 500 °C. This is associated with the structural changes in minerals that make up the labradorite. In general, when heating labradorite to 900 °C, samples of the Ocheretyansky labradorite lost 11.21 % of gloss, Neviryvsky – 4.03 %, Osnikivske – 33.57 %, Katerinivsky – 15.3 %.

Fig. 8. Dependence of gloss on the heating temperature: deposit No. 1 – Ocheretyansky; deposit No. 2 – Neviryvsky; deposit No. 3 – Osnikivske; deposit No. 4 – Katerinivsky

At 400 °C, samples from the Ocheretyansky deposit became opaque, samples from the Osnikivske deposit lost their irisation, and samples from the Katerinivsky deposit demonstrated a change in ilmenite. At a temperature of 500 °C, one visually observes a better expressed gloss and cracks between minerals, samples from the Ocheretyansky deposit almost did not change, all other labradorite samples exhibited the gloss of ilmenite.
