**Keywords:** restoration of reinforced concrete structures, fiber-reinforced plastics, pre-stress, single-span reinforced concrete beam

# STRENGTHENING AND RESTORATION OF DAMAGED REINFORCED CONCRETE STRUCTURES WITH COMPOSITE PLASTICS

**How to Cite:** Mukhanbetzhanova, Z., Besspayev, A. (2021). Strengthening and restoration of damaged reinforced concrete structures with composite plastics. *Eastern-European Journal of Enterprise Technologies*, 2 (1 (116)), 81–86. doi: <https://doi.org/10.15587/1729-4061.2022.254728>

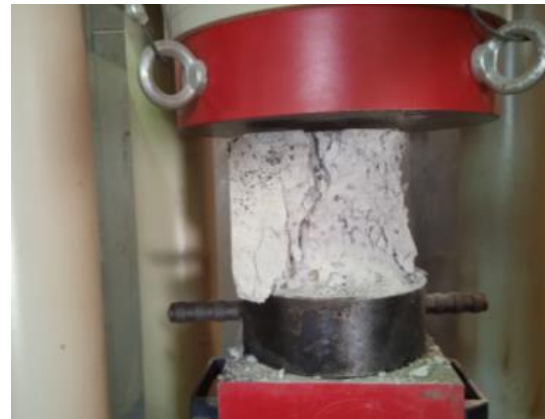
The strength of concrete in the cubes was in the range of 27.9–32.7 MPa, with an average of 30.4 MPa (Fig. 1). The cylindrical strength of class B25 concrete is in the range of 19.9–21.5 MPa and averages 20.6 MPa (Fig. 2, *a, b*). Fig. 3 shows diagrams of the longitudinal and transverse strains of concrete obtained from cylinder tests, where each line is indicated by a separate color, indicating the number of cylinders tested. The marginal longitudinal strains of concrete at compression were in the range of  $-(23\text{--}25)\cdot 10^{-4}$  relative units, and the transverse strains of  $+(7\text{--}8)\cdot 10^{-4}$  relative units.

Fig. 1. Testing a concrete cube at the hydraulic press ALPHA 3-3000S

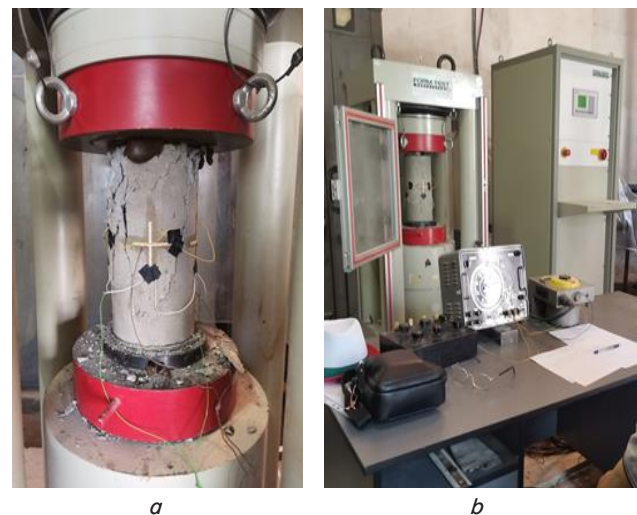
Fig. 2. Concrete cylinder: *a* – test at the hydraulic press ALPHA 3-3000S; *b* – devices to register strains

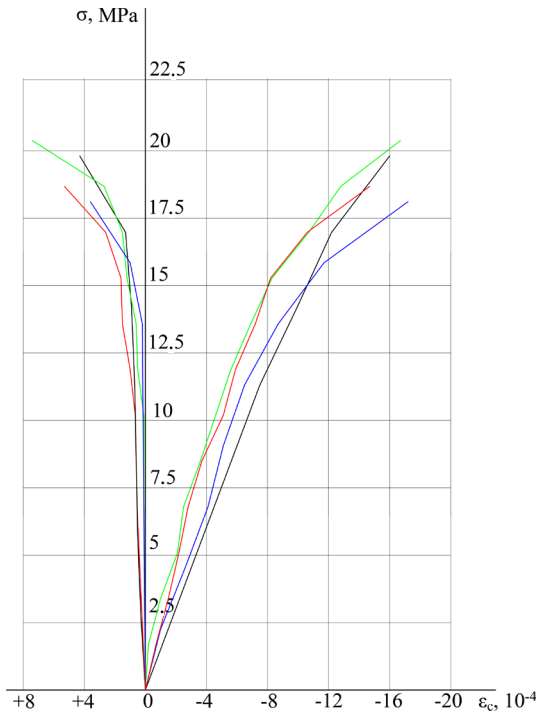
Fig. 3. Diagram of longitudinal and transverse strains of concrete cylinders

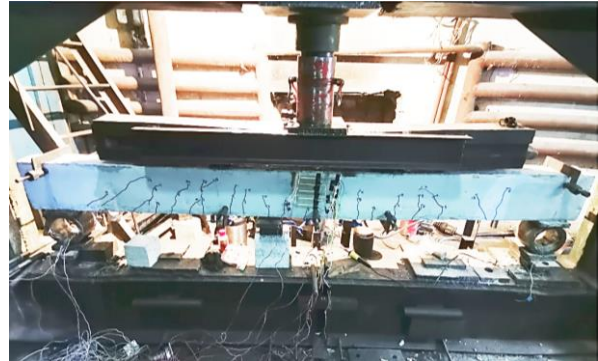
of the crack opening was measured using a microscope with a division unit of 0.02 mm; the magnitude of the transverse load was recorded on the high-precision manometer of the hand pumping station (Fig. 4, 5). The load cells were connected to an automatic strain gauge. With their help, mechanical effects are converted into electrical signals and transmitted to the strain gauge bridge. Calibration of load cells was carried out using the readings of the strain gauge bridge and measuring the initial imbalance, as well as according to the data specified in the passport, which indicate the operating power transmission coefficient of the sensor.

Fig. 4. General view of reinforced concrete beam tests

Our static tests were performed when the samples were loaded with a hydraulic jack (Fig. 4). The destruction of reinforced concrete beams without reinforcement was caused by the crushing of the compressed concrete zone in the zone of pure bending with the fluidity of the stretched steel reinforcement. When reinforcing the beams in the stretched zone with laminate tapes, along with the conventional scheme of the destruction of reinforced concrete structures, additional destruction schemes were revealed caused by the separation of the protective layer of concrete in the stretched zone or the separation of stretched laminate tapes from concrete. At the same time, an increase in the crack resistance and stiffness of

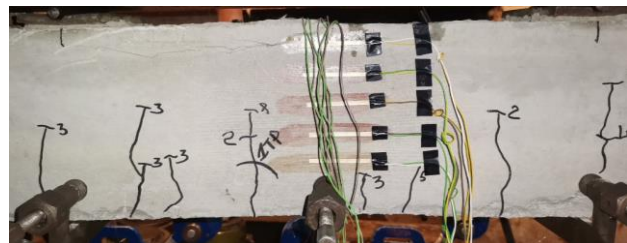
Fig. 5. General view of load cells on concrete, normal cracks, and damage area of compressed concrete zone

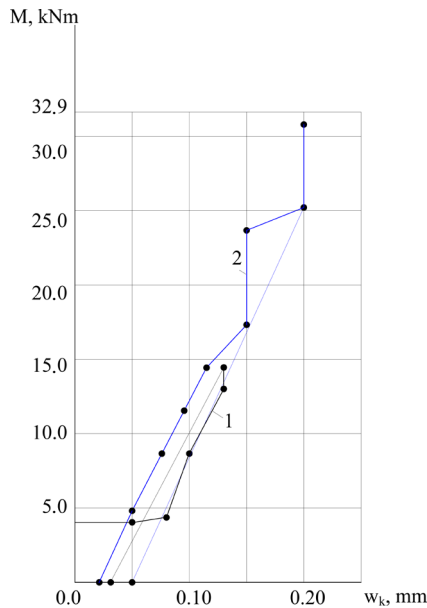
After generating a bending moment of  $M=14.17$  kNm, the vertical load was reset: that ended the first stage of our testing. Fig. 7 shows the plot of crack opening at all subsequent loading stages: each line indicates loading.

Fig. 7. Evolution plot of normal cracks in the beam B-18-1

In the second stage of the tests, the vertical load was increased to  $M=19.12$  kNm, and the opening width of normal cracks increased to 0.15 mm.

In the next stages of loading, the load value was increased to  $M=21.09$  kNm,  $M=25.51$  kNm, and  $M=26.0$  kNm: no increase in the width of the normal crack opening was observed. Since the width of the crack opening has not increased, the pattern of the opening of normal cracks is given only for the first two stages of loading.

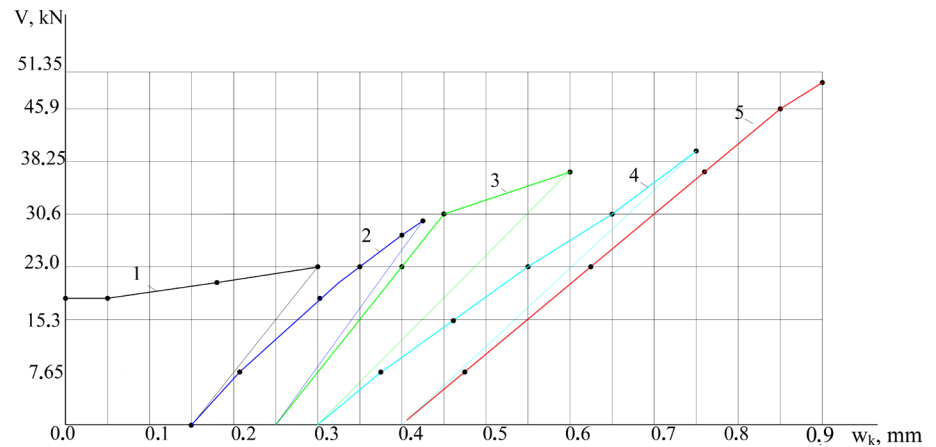
Along with the normal cracks in the zone of pure bending of the beam, there was an accelerated development of inclined cracks in the support zones. The first oblique crack was formed in the first stage of the test at a transverse force of  $V=16.1$  kN, and the opening width of the inclined cracks in the first stage of the tests at the transverse test  $V=23.0$  kN reached 0.30 mm. In the second stage of the tests at a transverse force of  $V=23$  kN, the opening width of the inclined cracks reached 0.40 mm. Further, with a transverse force of  $V=23$  kN, the width of the opening of inclined cracks reached 0.40 mm, and with a transverse force of  $V=301$  kN, the opening width of inclined cracks reached 0.45 mm. In the third stage of tests at  $V=33$  kN, the opening width of inclined cracks reached 0.60 mm, and in the fourth stage of the test at  $V=39.8$  kN, the opening width of the inclined cracks reached 0.75 mm. In the fifth stage of the tests at  $V=51.35$  kN, the opening width of the inclined cracks reached 0.90 mm (Fig. 8). Loads are indicated under each line.

Fig. 8. Evolution plot of inclined cracks in the beam B-18-1

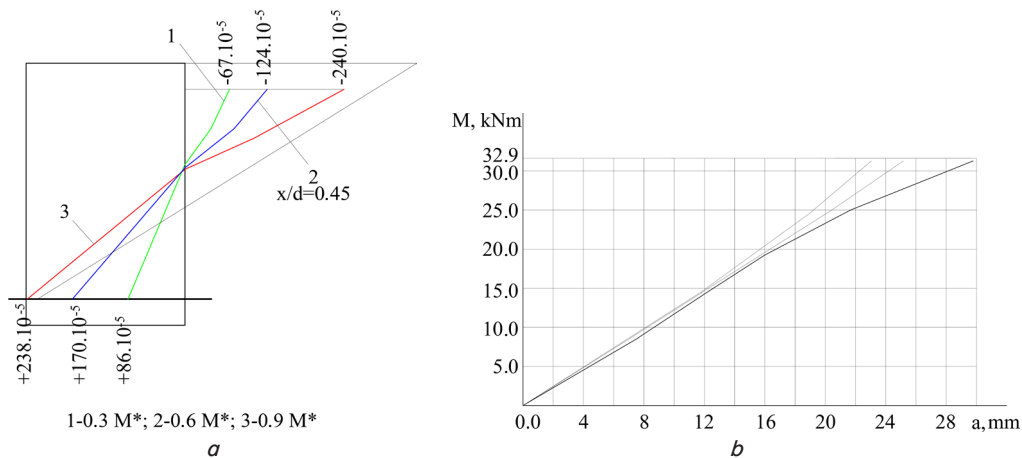
The beam collapsed in the zone of pure bending from the crushing of the compressed zone of concrete at a bending moment of  $M=32.86$  kNm (Fig. 9, a).

Fig. 9. Diagram of beam destruction: a – distribution of strains across the cross-section height of the beam B-18-1; b – vertical deflections of the span of the beam B-18-1

The relative value of the compressed concrete zone was  $\xi=d/h=0.45$  (Fig. 9, *b*), the magnitude of the vertical movements of the span part reached 28.6 mm, and the places of application of vertical forces were 22.8–25.1 mm, which were 1/70 and 1/63 of the span. Each line corresponds to the applied load.

Based on the results obtained from static tests (Fig. 9, *b*), it was determined that the strengthening of beams by gluing one layer of laminate on the stretched zone led to an increase in strength by 75 %. Strains of stretched steel reinforcement decreased by almost 10 %. This is due to an increase in the strength of the stretched reinforcement.
