*The object of this study is the permissible limits of aging of bus bodies during operation and the formation of appropriate recommendations to control them based on the conditions of compliance of the body with passive safety rules.*

# DEVELOPMENT OF TECHNOLOGICAL PRINCIPLES OF TECHNICAL CONTROL OF BUS BODIES DURING OPERATION BASED ON PASSIVE SAFETY CONDITIONS

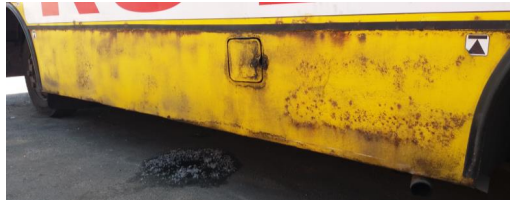
In the first version of the technical control, the buses are checked for corrosion damage and cracks. Fig. 5 shows the bus «Bogdan» A092, during the inspection of which corrosive damage to the body cladding was found.

Fig. 5. Bus «Bogdan» A092 with corrosion damage to the body cladding

When visually inspecting the outer cladding of the bus body, it was assumed that under the cladding with such corrosive damage, manifestations of structural corrosion are

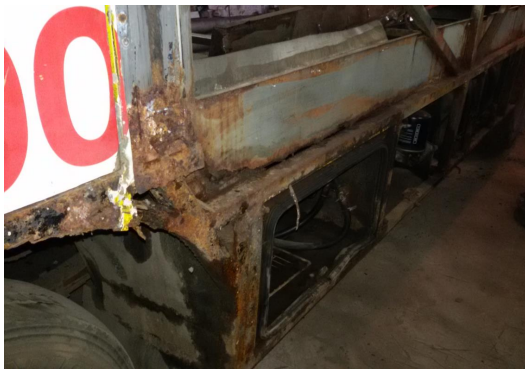
Fig. 6. Corrosion damage to the body under the cladding of the city bus «Bogdan» A092

Fig. 6 shows that significant manifestations of structural corrosion were discovered under the cladding, which confirmed the assumption based on a visual inspection of the outer cladding.

Significant structural destruction (Fig. 6) is explained by the fact that the technology of manufacturing the body is imperfect. The bus body is welded completely, and, after that, anti-corrosion protection is carried out. As a result, uncovered places remain between the body frame and the cladding. Such a bus will be allowed to operate subject to full restoration of the body. As the repair practice shows, basically all buses that have corrosive damage to the cladding (Fig. 5) also have manifestations of structural corrosion of the body frame. Thus, the presence of corrosion of the body cladding will be the basis for the prohibition of the operation of the bus. Structural corrosion leads to a violation of the geometry of the body. Therefore, high-quality repairs can be carried out in the factory using special technological equipment. Repair organizations can also ensure proper repairs. In addition, this technology needs to be improved as follows. The pipes of the body frame under the cladding should be covered with anti-corrosion, and in the places of welding the cladding with conductive high-temperature primer.

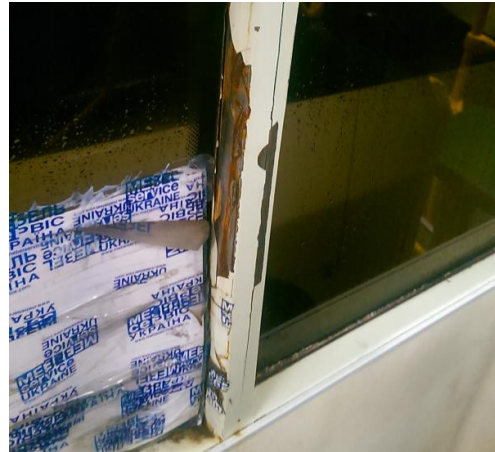
at negative temperatures, this can lead to the destruction of the frame pipes. Fig. 8 shows a rack that was damaged by the freezing of water in it in winter.

Fig. 8. Crack in the vertical rack of the cabin as a result of freezing of the accumulated moisture of the city bus «Ataman» A092H6

Such a rack (Fig. 8) is completely replaced since the compliance of the bus with the UN ECE rules No. 66 will directly depend on its strength. Drainage holes are also drilled to flow out the condensate from the rack.

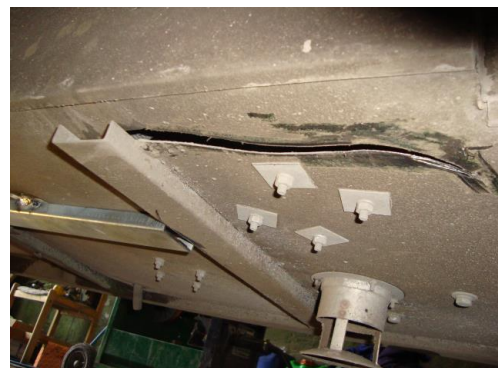
Fig. 9. Fatigue crack in the bottom of the compartment of the autonomous heater of the city bus «Ataman» A092N6

During the control of this type of damage (Fig. 9), a prerequisite is the opening of all the hatches of the bus, which will make it possible to track cracks in the light.

The formation of such cracks does not have a significant impact on the passive safety of the bus body. In this case, a complaint is filed with the bus manufacturer. In the department of the chief designer, a technical solution is being developed to eliminate this deficiency. Usually, a new technical solution involves welding cracks and welding additional reinforcing elements.

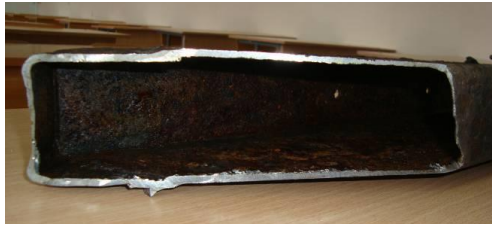
Fig. 10. Pipe fragment (140×60×3 mm) of the base of the body frame is affected by corrosion

Fig. 10 demonstrates that full control will be carried out when cutting out individual fragments of the body frame pipes. However, this method is irrational and requires an alternative method of control. A rational method would be the use of ultrasonic metal thickness gauge. Fig. 11 shows the ultrasonic metal thickness gauge Walcom TM-881 (China).

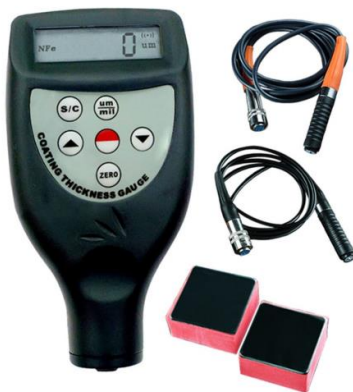
Fig. 11. Ultrasonic metal thickness gauge Walcom TM-881

The ultrasonic metal thickness gauge allows the metal thickness to be measured in a non-destructive way. Walcom TM-8816 is an ultrasonic metal thickness gauge with a built-in sensor and the ability to set the appropriate sound speed depending on the material being measured. It is designed to measure the thickness of metal products and the thickness of materials, for example: steel, cast iron, aluminum, red copper, brass, zinc, quartz glass, polyethylene, gray cast iron. The measurement range is from 1.0–200 mm, which makes it possible to estimate the thickness of the body frame pipes (from 2 to 4 mm depending on the pipe profile). The speed of sound varies between 500–9990 m/s. Accuracy of the device is ±0.5 % of the measured value. The operating temperature range is in the range of 0–40 °C, at a relative humidity of <85 %.

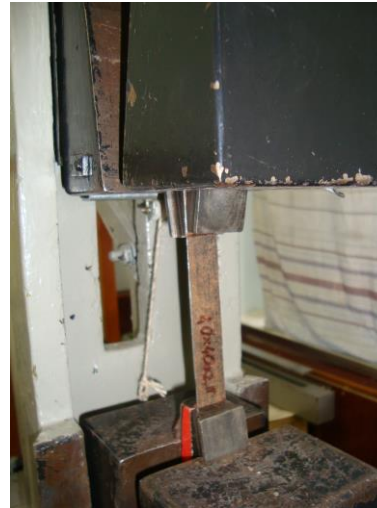
Fig. 12. Testing samples of body frame elements on the breaking machine R-5 according to ISO 6892-1:2019

Fig. 12 depicts the test of one of the fragments of the body frame of the eight-year-old Bogdan A092 bus with a mileage of 850 thousand km. For testing, 6 samples of body frame elements were cut that do not have obvious corrosion damage. Such elements of the body frame, as repair practice shows, are not cut out during the restoration of the body.

According to the developed control technology to determine the mechanical properties of the elements of the body frame, six samples were tested on the breaking machine P-5 according to ISO 6892-1:2019 (Fig. 12).
