A CASE STUDY OF QUALITY CONTROL APPLICATION WITH BIM-LASER SCANNING COLLABORATION IN BUILDING CONSTRUCTION PROCESS

Object of research is Atışalanı 580 unit apartment construction site. With the Building Information Modelling (BIM) and 3D Laser Scanning integration technique, Atışalanı district 2nd Stage 3 Region 580 apartment construction site was selected as the application area within the scope of obtaining the errors and defects in the x, y, z dimensions of the wall building element on the façade surfaces of traditional buildings, dimensional deviations caused by manufacturing, and dimensional quality assessment.

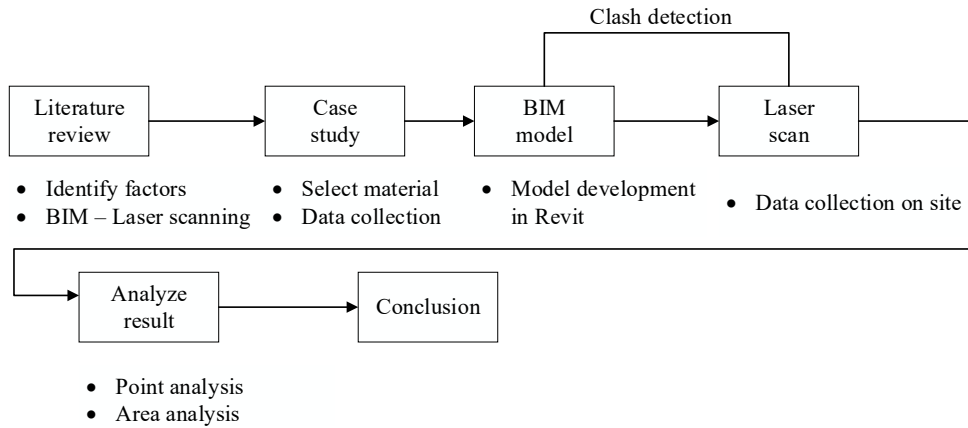
Fig. 2. Flowchart was shown study step method

As it is clearly seen in the workflow chart above, firstly, deficiencies were identified by conducting a literature review. Then, the study area was determined and the data of this study area were obtained. The data obtained were analyzed in BIM environment and the findings were discussed and conclusions were reached.

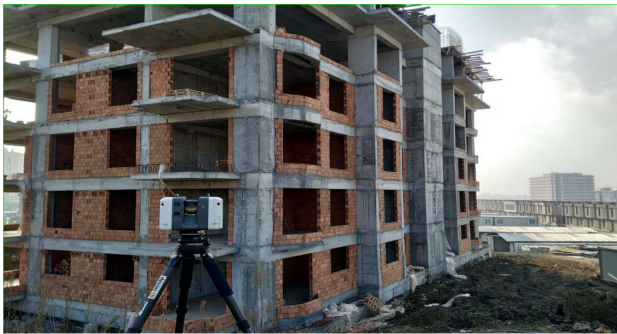
Fig. 4. The photograph was taken during laser scanning in the work area (prepared by authors)

The laser scanning study was carried out with the Leica RTC360 as illustrated in Fig. 4. The RTC360 is a terrestrial laser scanner that makes 2 million points in seconds, can take HDR photos in 1 minute, has a range of 130 m, and has a distance accuracy of 1.0 mm+10 ppm.

Within the scope of the study, a total of 69 stations were scanned at 6mm resolution at 10 m and HDR photographs were taken. Leica Cyclone Register software was used in the data integration and control phase, and Leica Cyclone 3DR software was used in the 3D analysis phase.

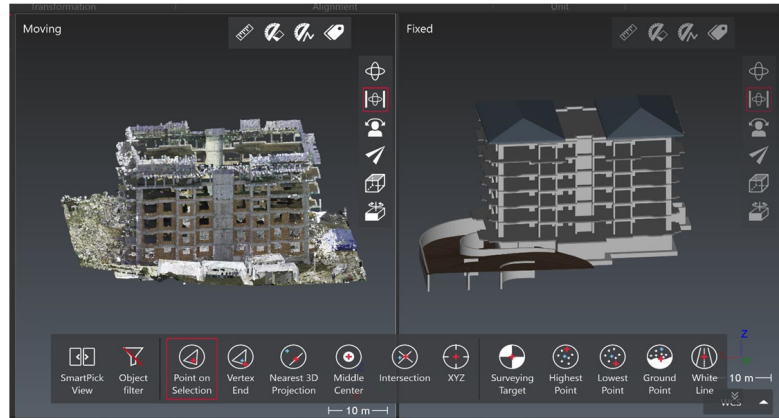
Fig. 5. Three-dimensional point cloud view in Leica Cyclone Register software (prepared by authors)

After the data obtained during the laser scanning process was transferred to a laptop with sufficient storage space, the three-dimensional point clouds obtained as a result of 69 different station installations in the office environment were first combined. This joining process was carried out with the help of Leica Cyclone Register software based on the common points of different three-dimensional point clouds on a predetermined reference coordinate plane and as a result, the point clouds obtained as a result of the installation of different stations were turned into a single point cloud as shown in Fig. 5.

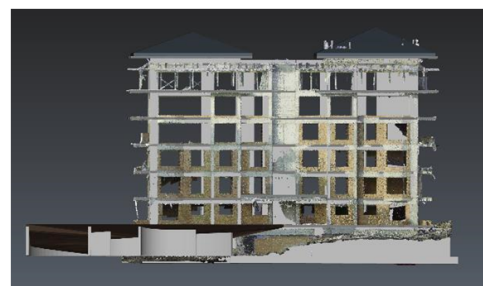
Fig. 6. Examples of deletion of unnecessary point clouds in Leica Cyclone 3DR software; *a* – axonometric perspective; *b* – axonometric perspective from the other angle (prepared by authors)

In the second stage, the necessary format conversions of the working information model were carried out in the office environment and the Leica Cyclone 3DR software was used to make a three-dimensional comparison as shown in Fig. 6. A preliminary comparison of the point cloud model obtained as a result of laser scanning and the BIM model was made and the background modeling outside the façade in the model, which is not in the point cloud, will affect the overlapping process, so the cleaning process is made and made ready for the overlapping process. Construction wastes that are found in the three-dimensional point cloud but not in the building information model and external point clouds such as construction materials on the ground will not be taken into consideration in the analysis and interpretations within the scope of the study.

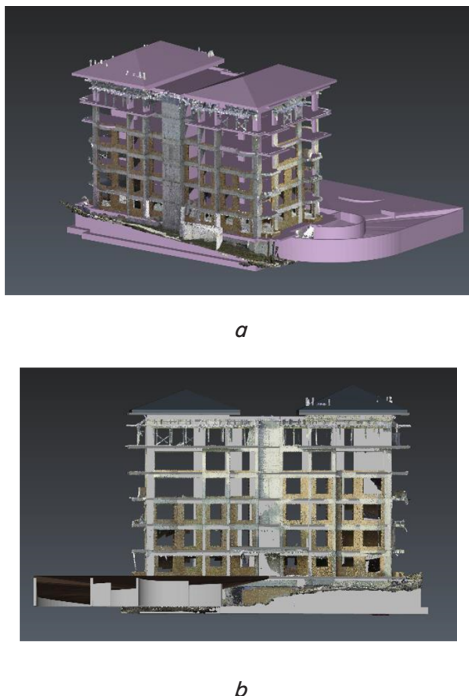
Fig. 7. Overlapping BIM model with laser scan model; *a* – front view; *b* – axonometric perspective (prepared by authors)

After the necessary cleaning and sorting of the three-dimensional virtual information model created with the help of the three-dimensional point cloud and structure information modeling technology obtained as a result of laser scanning in the application area, the overlapping process was carried out with the help of Leica Cyclone 3DR software to make a three-dimensional comparison of the front the relay as shown in (Fig. 7). The image of the overlapping process is shown in Fig. 7 below.

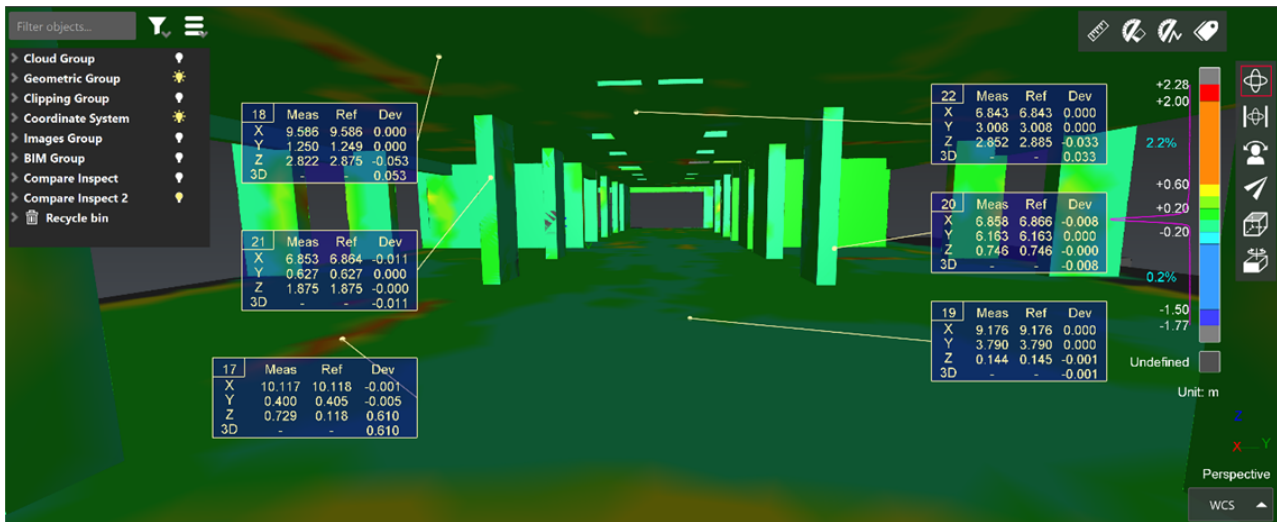
Fig. 12. Ground floor data point analysis data

After the spatial analyzes made within the scope of the study carried out on the bearing structural elements on the ground floor of the building, the point analyzes were obtained by overlapping the laser scanning and building information modeling technology. Overlapping labels were assigned to 6 different points on the ground floor where the analysis was done as shown below in Fig. 12. Green labels in the model represent areas within the tolerance range, and red labels refer to areas outside the tolerance range.

Table 5 with the results of the comparison of the found values it is also shown. In the table, green result values are within the tolerance limits and red result values are outside the tolerance limit. All 6 different points (points 17–22) are within the tolerance limits.
