The main objective of the research study is to identify the status and analyze the problems in Chameliya hydropower plants in Nepal. In this paper, the hydropower has been studied to identify some regularities of hydropower components on proper operation and generation through primary and secondary data. Further, it been analyzed by bottlenecking through mechanical components testing for the detail study to find the actual problems. Hydropower contributes about 86 % of total internal generation to available energy in Nepal with 93 % of people having access to electricity through the national grid. Small hydropower plants (less than 30 MW) are 90 % of the installed plants contributing the major electricity demands of nearly 50 % in the country. Though hydropower is one of the major export commodities in the past few years, it still has deficits in the dry season. Chameliya hydropower plant, 30 MW situated in the far-western part of Nepal, generates 670 MWh of energy in the wet season and which declines to 384 MWh in the dry season. Even though the plant does not have the problem of much erosion and has a sufficient flow in the dry season, the generation value is still below the desi

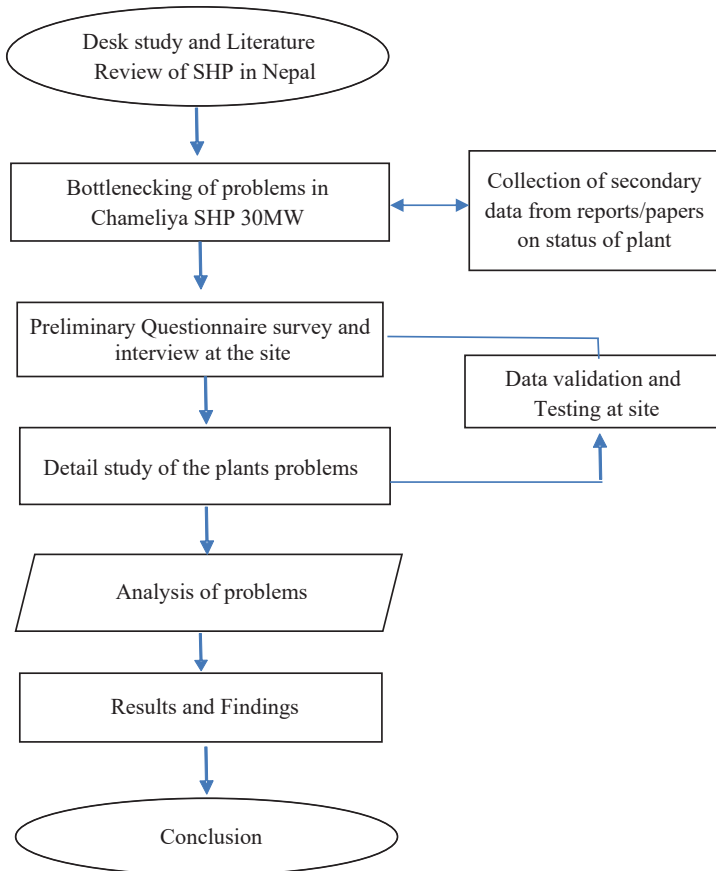
Fig. 1. Activities during Field Research at Chameliya Hydropower Plant

The methods process adopted for this research starts with literature review with on-desk study of abnormalities observed in the Chameliya SHP of Nepal which includes hydrological data, secondary data from reports and papers on generation and operation. After then, bottlenecking the study with problems identification, with collection of actual field based data through questionnaire methods. Then, detail studied of the SHP plant was done to collect genuine data by conducting field based survey for a week, which includes real-time monitoring of various components, recording the on-time data with external testing equipment and valid it with data log. Then analysis of these data and validation of them gives the required results. The conclusion and recommendation are drawn with the results. The detail methodology process adopted has been illustrated in Fig. 1.

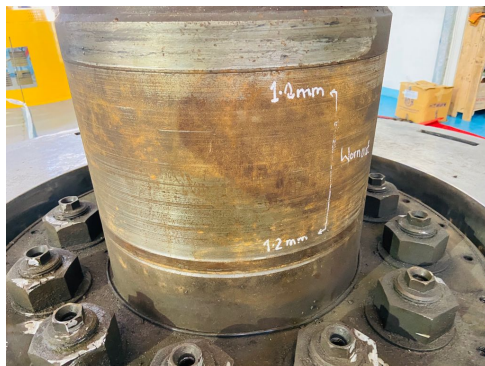
Fig. 2. Shaft wear in the bearing section

a) Shaft: the shaft is one of the main components that have been observed to deviate from data of the last two years. The length of the shaft is short as compared to its 400 mm diameter of it so, the deviation observed is also not much overall besides wear on it.

Depending on the load, the runner is subjected to vibrations. More vibration was observed for fewer loads, with observing machine running hours to be 11,100 hours. Similarly, permissible skewness and eccentricity up to 750 rpm is 0.1 mm as standards but was observed as 0.5 mm at 428.6 rpm in 2020 March and 1.2 mm in 2021 August [21]. This wear value has been observed from 0.05 in 2019 to 0.5 in 2020 and finally 1.2 in 2021 as shown in the Fig. 2.

Shaft actual rotational speed is 428.6 rpm and which has been exceeded with varying in load up to 450 rpm in some instant with vibration and deflections. Due to this circumferential 30 % of the turbine guide part has been observed to have worn with large eccentricity in alignment.

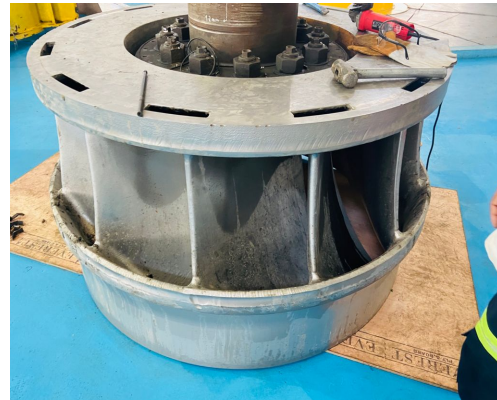
Fig. 4. Francis runner of Chameliya plant [23]

c) Runner: Francis runner are used in both the units having no major erosion problem till 20,000 hours of effective running. Cavitation zone for the system is observed from 6 to 8 MW only so, no operation below 6 MW was practiced to date. Fig. 4 illustrates the runner disassembled for maintenance in one of the unit of HPS.

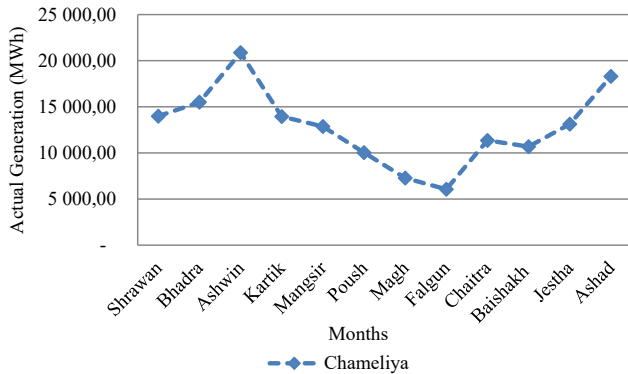
Fig. 7. Monthly Actual Generated from Chameliya HPP [25]

The minimum energy was generated in Magh (January/February) and maximum energy was generated on Ashwin (September/October) is about 670 MWh daily as in Fig. 7. The energy generation pattern of Chaitra (March/April), during study period is shown in Fig. 8. These patterns help to study the generation of plants season wise comparing designed and targeted one.

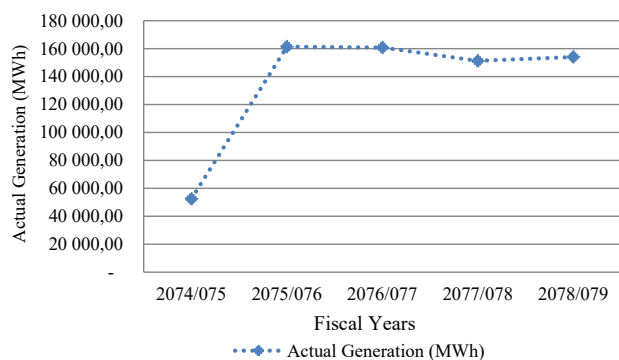
Fig. 9. Five Fiscal Year Actual Generated from Chameliya HPP [25]

The last five fiscal years generation also shows the lowering value of actual generation as compare to design generation. The fiscal year 2075/76 has higher generation than in fiscal years 2076/77, 2077/79 and 2078/79 whereas the fiscal year 2074/75 has the minimum generation with starting year after commissioning as in Fig. 9.

The actual generation curves from fiscal year 2076/77 to 2078/79 shows the decrease in generation annually and then remain constant. These decrease in generation value can be further analyze to find the frequency of maintenance and repairs of plants.

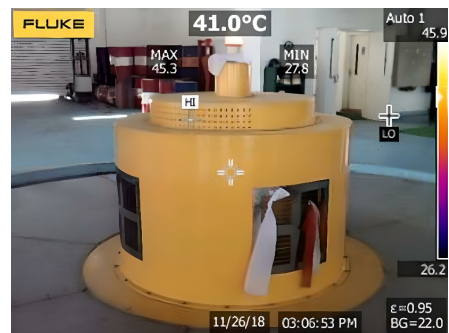
Fig. 10. Thermal data around the generator section

a) generator: the temperature around the generator section recorded was 28–45 °C, which is comparatively high observed at the shaft speed of 500 rpm. Fig. 10 shows the temperature gradient around the generator which is recorded through Fluke TiS10 Infrared Thermal Imaging Camera. This temperature dropped to 25 °C near the shaft section;

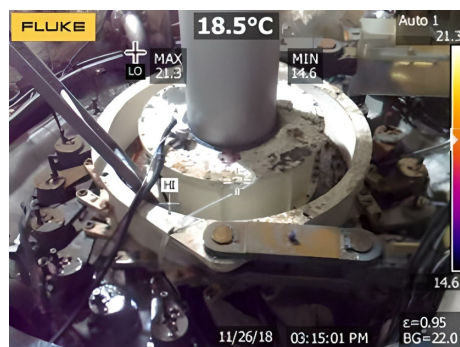
Fig. 12. Thermal data around the turbine surrounding

c) turbine: the temperature distribution is found at 15–21 °C around the outside of the turbine section. The temperature of the shaft near the turbine has been measured with a lower value relative to other components shown in Fig. 12.

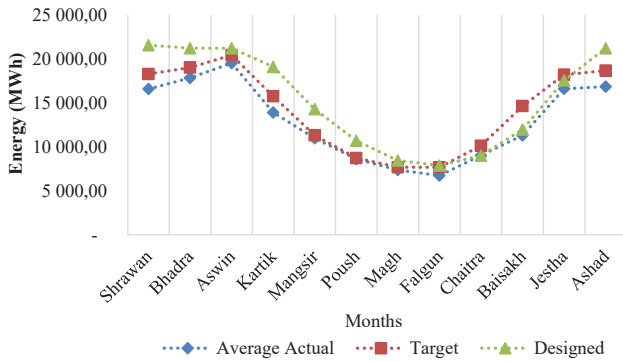
Fig. 15. Actual generation versus target and design generation of last three year

The average actual generation value is always below the designed and targeted generation value in last three years as in Fig. 15 additionally supports results of observation data on 5.1 sub-section which shows the mechanical issues in the components rather than monthly flow variation.

design generation from the analysis section can be further discussed as results of other factor like mechanical issues and failures as shown in result of Fig. 15.

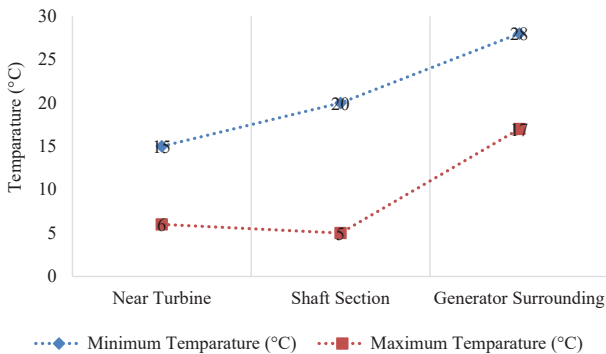
Fig. 16. Temperature variation in different components of the Chameliya Hydropower Plant

The average temperature variation graph measured in each component in the Fig. 16 with both minimum and maximum values:

- a) external surface of generator measured to have 28–45 °C temperature variation, which is even high as compare to temperature at internal surface measured by sensor at 428 rpm;
- b) shaft surface temperature taken externally measured to be 20–25 °C and this variation in temperature from thrust bearing to surface of shaft results critical lead to damages the Babbitt materials or pads causing deflection and failures in such hydro turbines;
- c) though, the temperature in the turbine section has little lowered in temperature 15–21 °C, the leakage of water from the elbow of the balance pipe inside the head case causes the oil layer to wash out with water and also replaced the oil level in the oil tank leading to adding issues for wear in the bearing and shaft.

These values in graph, further supports the data observed from inbuilt testing equipment’s sensor data on display panel. The variation inside the components has the similar trend and correlation profile of temperature outside the body parts results in critical damages in bearing and shaft materials if expose for long run.

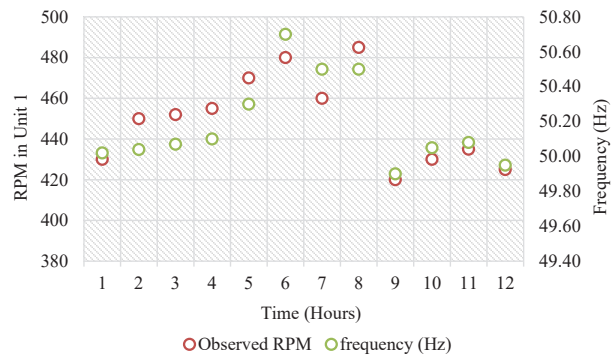
Fig. 17. Observed RPM of shaft with display frequency in each hour in Unit 1

The rated speed of the shaft is 428.6 rpm. The actual average speed recorded by the tachometer is quite high around 450 rpm in average which is about +/-15 % more than the rated speed and it is above the tolerable limit. When the speed varies, the frequency of the system also varies accordingly, and hence equipment within the areas would lose synchronicity in grid connection. The rpm of the shafts along with actual and display frequency of system in an hour of time interval for a week has been illustrated in Fig. 17, 18 for unit-1.
