*This paper presents the results of the study of stress-strain state of reinforced concrete spans of two overpasses. With increasing volumes of cargo transportation by rail, the axle load increases up to 25 tons. Bridges and overpasses built about 100 years ago have acquired hidden defects during the years of operation. The safe operation of artificial structures requires additional research using the TENZO software and hardware complex, which processes digital records from primary transducers based on strain gauges. In 2018 and 2023, deflections, strains and stresses were obtained for typical beam spans of 11.5 m and 16.5 m of two reinforced concrete overpasses, from static and dynamic loads. For example, in 2018, the "spread" of stresses from the test load (TEM18) for the right-hand blocks of the 11.5 m spans ranged from 3.7 MPa to 3.71 MPa at different loading stages, and for the left-hand blocks of the 11.5 m spans ranged from 3.46 MPa to 3.9 MPa at different loading stages. In 2023, the stress range was from 2.58 MPa to 4.65 MPa for the right span blocks of 11.5 m span and from 2.67 MPa to 4.7 MPa for the left span blocks at different stages of loading. The 2018 data show unev

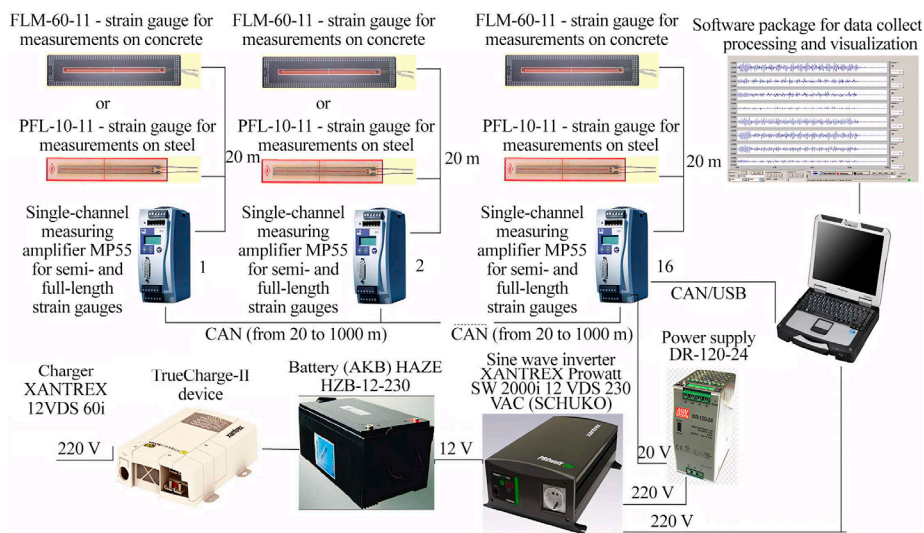
Fig. 6. Configuration of the tensometric measuring and computing complex for testing artificial structures

Configuration of the TMCC for testing artificial structure components, as shown in Fig. 6.

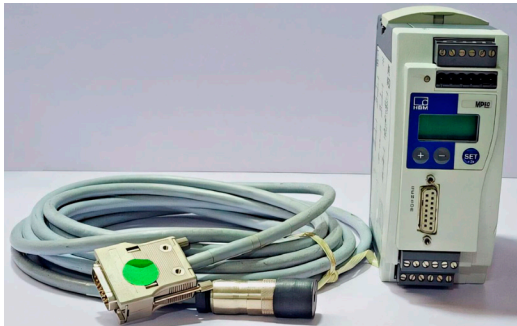
Fig. 7. Measuring electronics «Module PME-55»

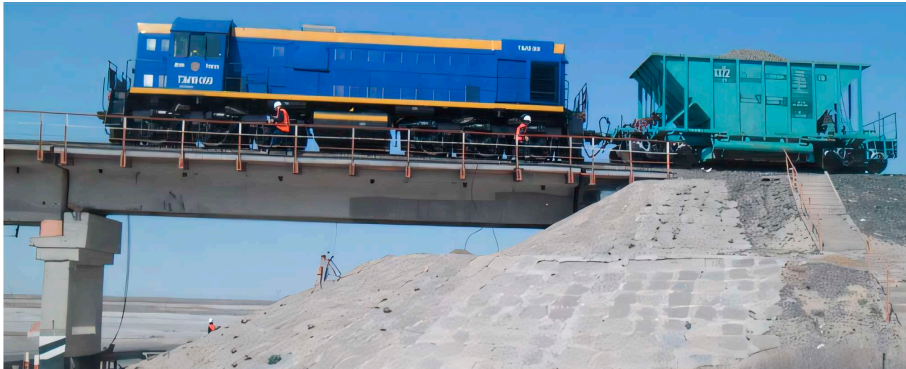
Fig. 10. Pipeline according to the scheme 16.5 + 23.6 + 16.5 in 2018: *a* – loading diagram for diesel locomotive TEM18 PS0-1 = 16.5 m; *b* – photo of test of superstructure PS0-1 = 16.5 m diesel locomotive TEM18

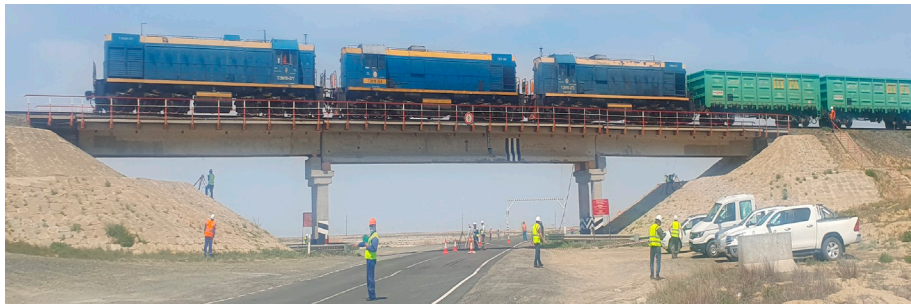
Fig. 12. Pipeline according to the scheme 16.5 + 23.6 + 16.5: *a* – loading diagram for diesel locomotive TEM18 PS0-1 = 16.5 m; *b* – photo of test of superstructure PS0-1 = 16.5 m diesel locomotive TEM18

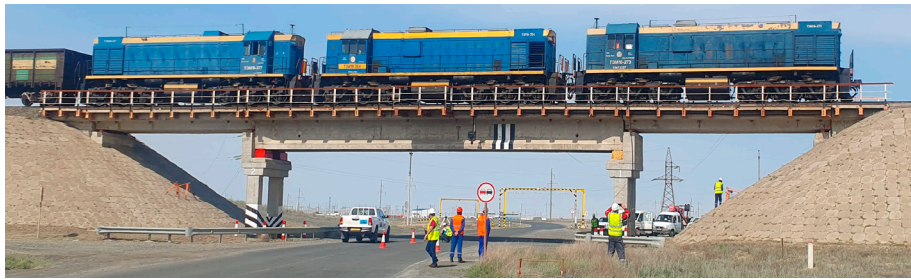
Fig. 13. Pipeline according to the scheme 11.5 + 23.6 + 11.5: *a* – loading diagram for diesel locomotive TEM18 PS0-1 = 11.5 m; *b* – photo of test of superstructure PS0-1 = 11.5 m diesel locomotive TEM18

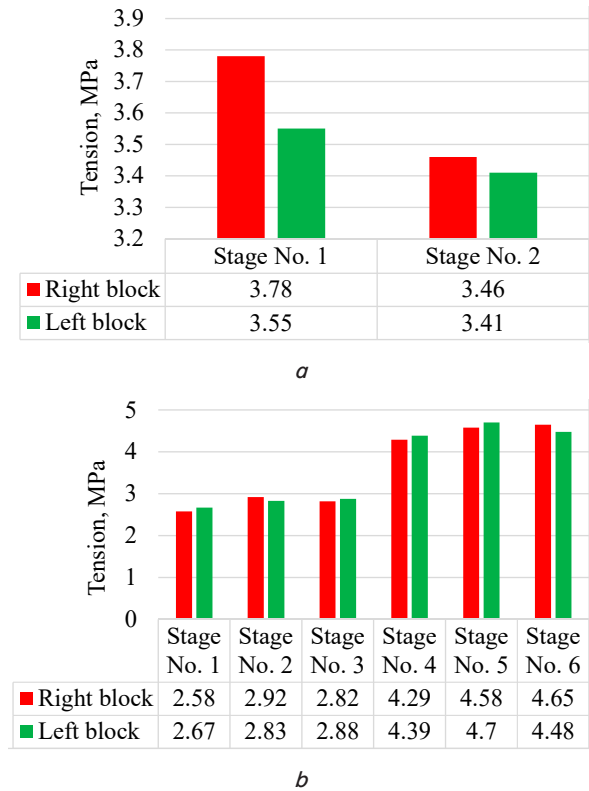
Fig. 15 shows the stress diagrams of reinforced concrete spans 11.5 m long PS 0-1 and PS 2-3: on the left are the data obtained in 2018, on the right are the data obtained in 2023. The stress distribution patterns shown in Fig. 14 reflect a stable structural performance under applied static loads. The obtained results demonstrate that the recorded stress levels do not exceed the design limits, confirming the adequacy of the structural system and the effectiveness of reinforcement. Minor discrepancies between individual measurements are attributed to local material heterogeneities and boundary conditions, but overall, the spans exhibit uniform load-bearing behavior with no critical stress concentrations.

Fig. 15. Span stress diagrams = 11.5 m of buildings in 2018 and 2023: a – PS 0-1 and PS 2-3 with a length of 16.5 m in 2018 from loading No. 1 and No. 5; b – PS 0-1 and PS 2-3 with a length of 16.5 m in 2023 from loading No. 1–No. 6

Analysis of Fig. 14, 15 allows conclusions to be drawn about the stresses in 2018 and 2023. The graphs indicate stable performance of the structure under static loads. The stress levels do not exceed the design values, which confirms the reliability of the structure and correct reinforcement. Small variations in the measurements can be attributed to variations in materials and operating conditions, but overall, the structures exhibit uniform behavior without dangerous stress concentrations. In 2018, the span blocks experienced non-uniform loads, indicating track axis displacement. In 2023, the blocks performed more uniformly, indicating alignment of the track axis and structure.
