# DESIGN OF AN AUTOMATIC SYSTEM FOR MONITORING THE TECHNICAL CONDITION OF FIBER-OPTIC CABLES

*This study examines the process of monitoring the technical condition of fiber-optic cables based on the recording and analysis of changes in the pixel structure of the optical spot formed by cladding radiation under mechanical stress. The task addressed relates to the lack of affordable and easy-to-implement means for continuous monitoring of the integrity of fiber-optic communication lines capable of promptly detecting mechanical stress and unauthorized access attempts.*

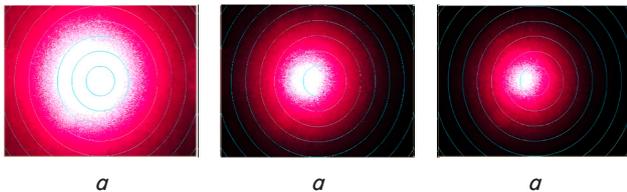
Fig. 1. Change in the optical spot on the surface of the photomatrix at different levels of mechanical load:

- a* – optical spot at no load (no microbending);
- b* – optical spot at medium mechanical load (formation of microbending);
- c* – optical spot at maximum load (significant microbending and increase in additional losses)

Fig. 1 shows an image of the optical spot under increasing mechanical stress. Increasing stress leads to increased microbending of the optical fiber and, consequently, to increased additional optical loss. In this study, the pixel pattern monitoring (PPM) method was used to record and analyze changes in the optical spot.

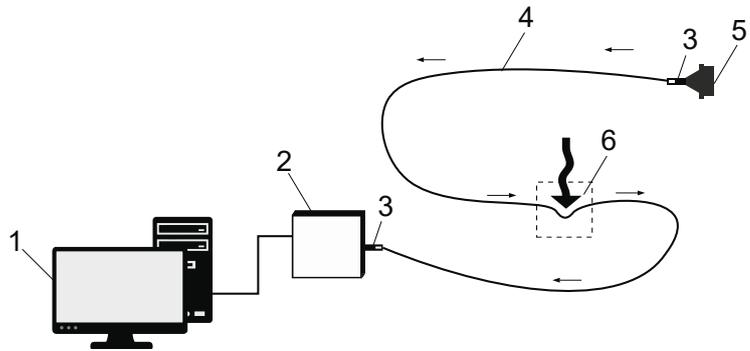
Fig. 2. Operating principle of the fiber-optic sensor:

- 1 – personal computer equipped with specialized software for processing and analyzing information;
- 2 – data processing unit with a highly sensitive photodetector (photomatrix);
- 3 – optical connector (detachable or non-detachable connector);
- 4 – single-mode optical fiber (OF);
- 5 – radiation source – semiconductor laser with a wavelength of 650–1550 nm;
- 6 – area of application of mechanical action on the optical fiber

The experiments were conducted using single-mode optical fiber complying with the ITU-T G.652.D standard, which is widely used in telecommunications systems. The Shijia Optical Cable GYFJH-2B1.3 IEC60332-3-16 (made in China), optical fiber type G-652 with a core diameter of 9  $\mu\text{m}$ , and a cladding diameter of 125  $\mu\text{m}$  was used as the object of study. The cable contained a total of 4 modules, each module containing 4 optical conductors. The optical fiber is coated with an acrylic layer on the outside to protect it from moisture; with the coating, the optical conductor thickness is 248  $\mu\text{m}$ . Reserve fibers of the optical cable, which are not involved in the information transmission process, were used as fiber-optic sensors. To understand the basics of the proposed fiber optic cable design, Fig. 2 shows the general operating principle.

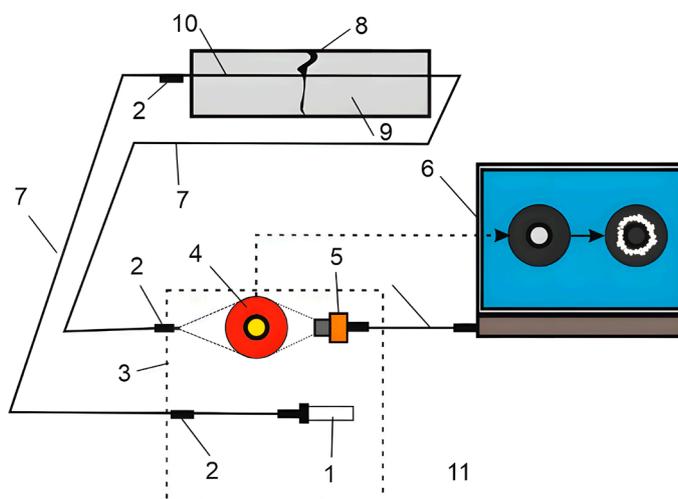
Fig. 3. Explaining the method for monitoring changes in the numerical pattern of pixels: 1 – radiation source; 2 – fiber-optic connector for optical connection of conductors. 3 – preliminary data processing unit; 4 – optical spot formed on the surface of the photodetector; 5 – photomatrix with a graphic processor; 6 – computer with specialized software; 7 – fiber-optic conductors; 8 – cable break point; 9 – section of fiber-optic cable; 10 – optical sensor located inside the fiber-optic cable

Fig. 3 shows a diagram illustrating the operating principle of the method for monitoring changes in the pixel digital image. Photomatrix 5 has its own graphics processor for pre-processing the video image of the optical spot. Photomatrix 5 converts optical signals into electrical signals, which are digitized and sent to the hardware and software system for further processing.

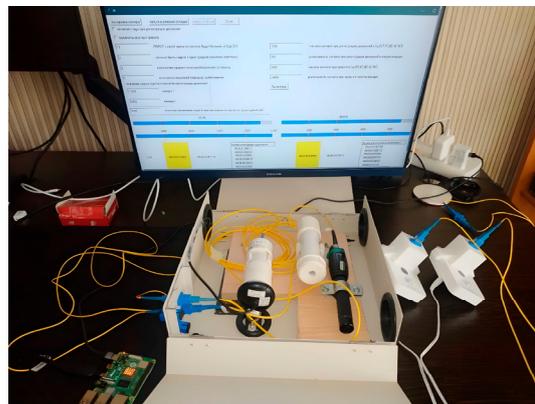
Fig. 4. Internal contents of the data preprocessing module

Fig. 4 shows the internal contents of the pre-processing unit. During the development of the laboratory prototype of the automated system for monitoring the technical condition of fiber-optic cables, several modifications of the optical modules were manufactured. Each module includes a photomatrix with a graphics microprocessor, an optical adapter, a light guide, an optical connector, and an optical waveguide. The waveguide cross-section can be either round or square.

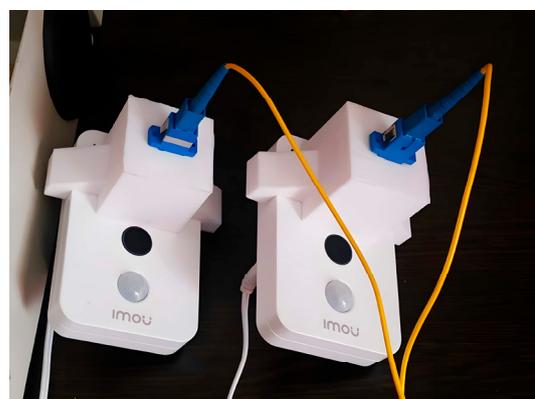
Fig. 5. Optical module with square waveguide geometry: 1 – photomatrix equipped with a graphic microprocessor; 2 – optical adapter; 3 – light guide; 4 – optical connector; 5 – square optical waveguide

Optical adapters and SC-type connectors with a 2.5 mm diameter ferrule were used to connect the fiber optic cables. Optical power loss at each connector did not exceed 0.3 dB. To ensure reliable monitoring of the cables' technical condition using the ATCMS system and reliable detection of unauthorized access attempts, preliminary equipment configuration was required. The structure of the optical module is shown separately in Fig. 5, which demonstrates its basic components.

Microbending simulation results (Fig. 11) and cladding radiation analysis (Fig. 5) confirm that mechanical stress causes a noticeable increase in intensity and a change in the shape of the spot on the image sensor, which underlies

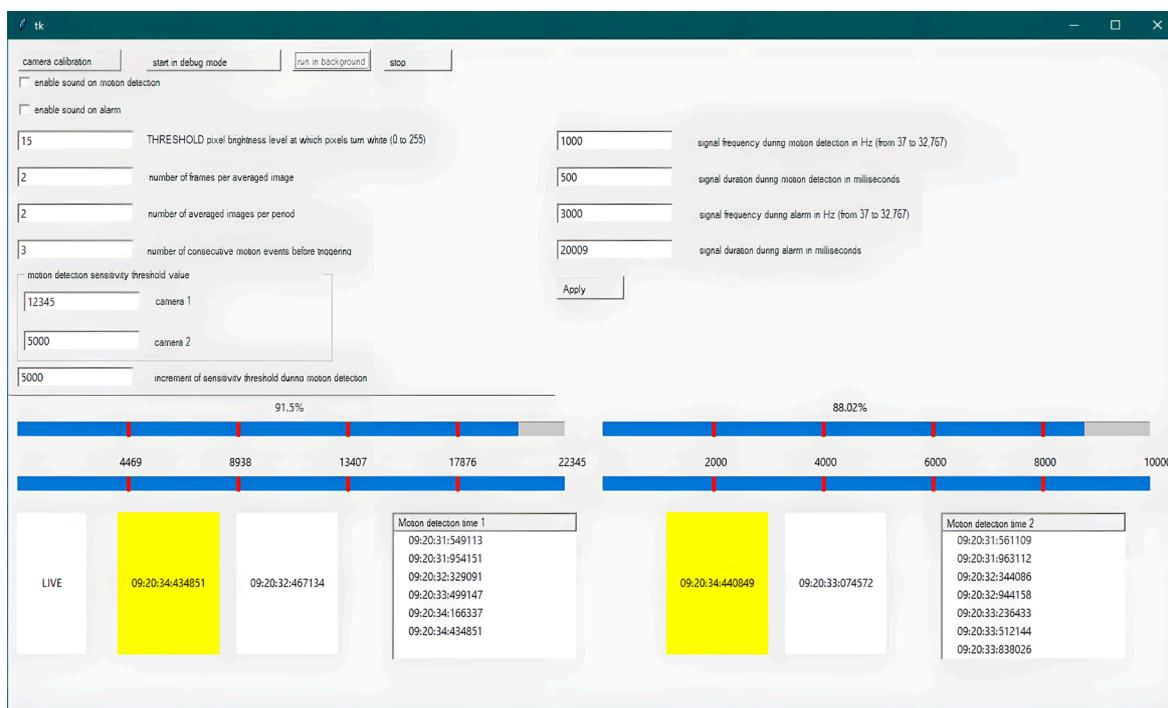
Fig. 6. Interface of the automatic technical condition monitoring system

The ATCMS has several operating modes. During normal operation, the yellow and red indicators are off. If the fiber optic cable is subjected to mechanical or vibroacoustic impact, a yellow warning indicator lights up, alerting you to a changing situation. If the impact is weaker than the response threshold or has not exceeded the repetition limit, the yellow indicator goes out after 5 seconds. If the impacts are repeated multiple times and their value exceeds the response threshold, the red indicator lights up. When the red indicator lights up, an alarm is triggered, and the operator receives a message on their mobile device

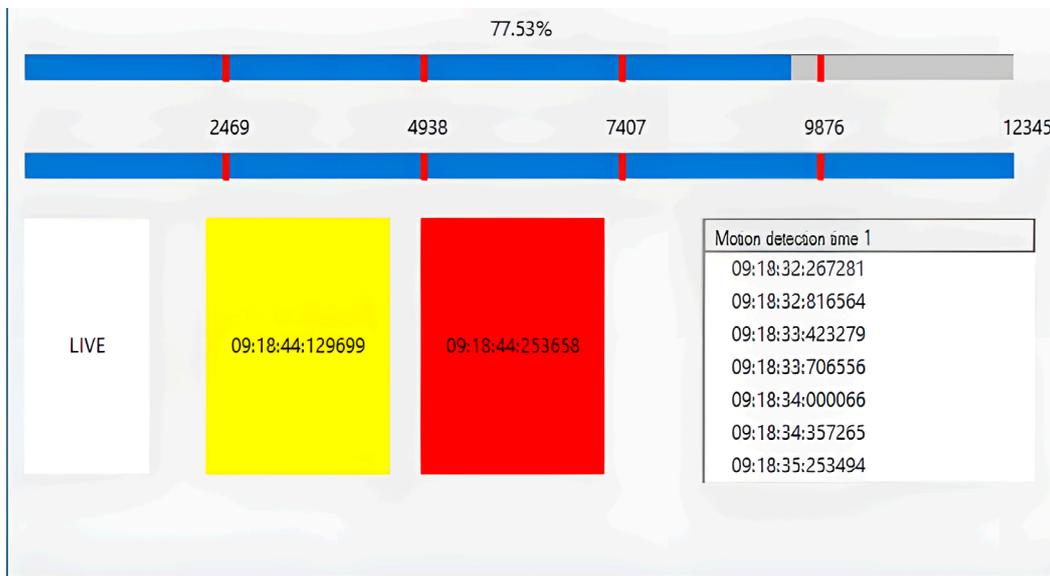
Fig. 7. Indicators and scales of the automatic technical condition monitoring system

(smartphone). Each channel contains two measurement scales: the lower scale shows the value of the white pixels, corresponding to the impact strength. The upper scale shows the percentage of the response threshold reached, which is related to the strength and number of impacts applied to the fiber optic cable within a set time interval (Fig. 7). When started in background mode, the ATCMS enters the operating mode for continuous monitoring of the technical condition of the fiber optic cable.

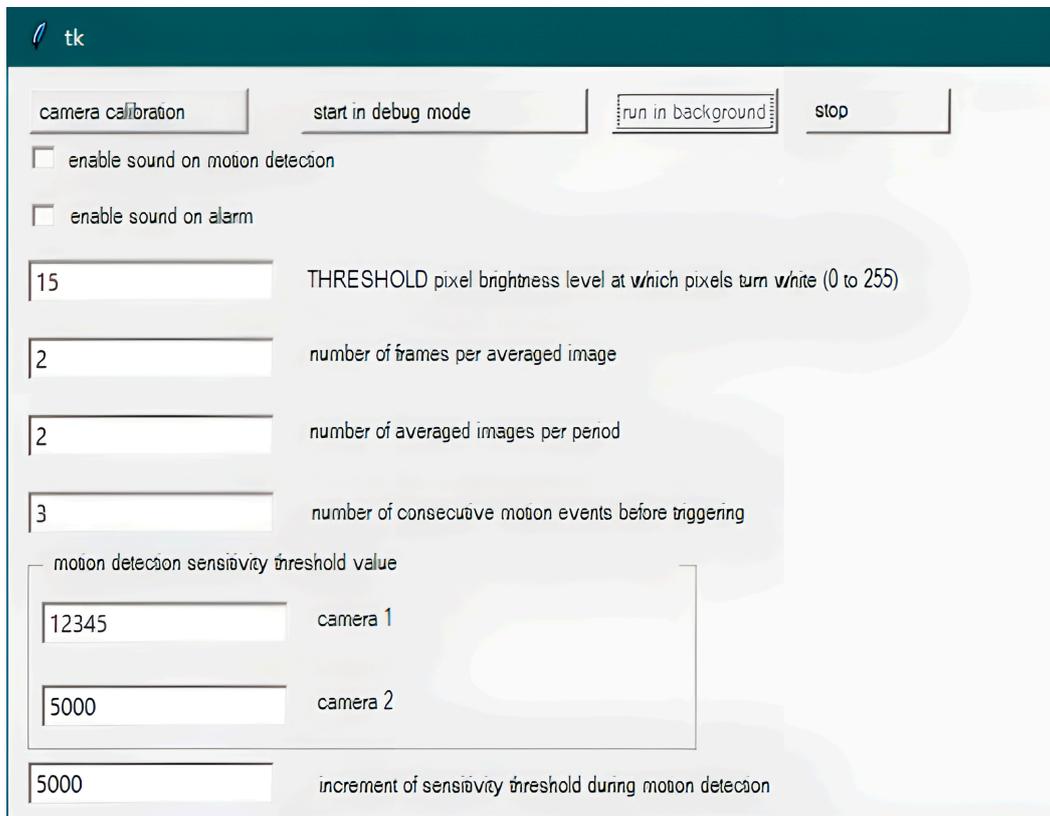
Fig. 8. Module of settings for the response threshold of the automatic technical condition monitoring system

Fig. 8 shows the module for setting the ATCMS response threshold.

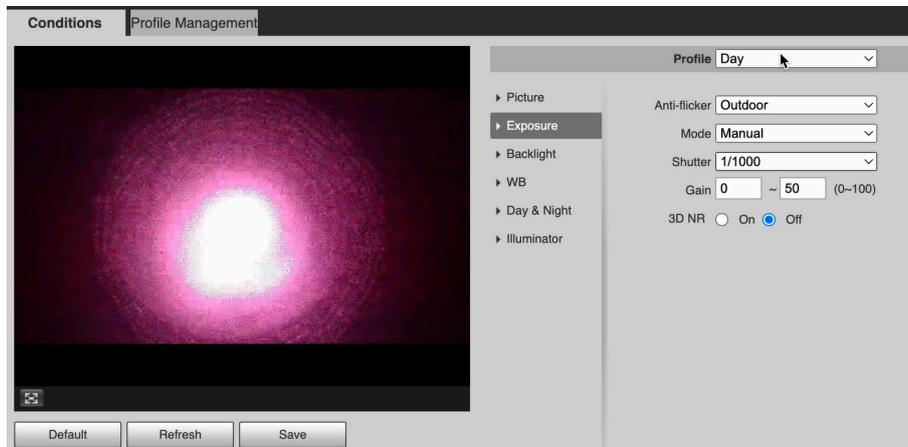
Fig. 10. Window for adjusting the photo sensor

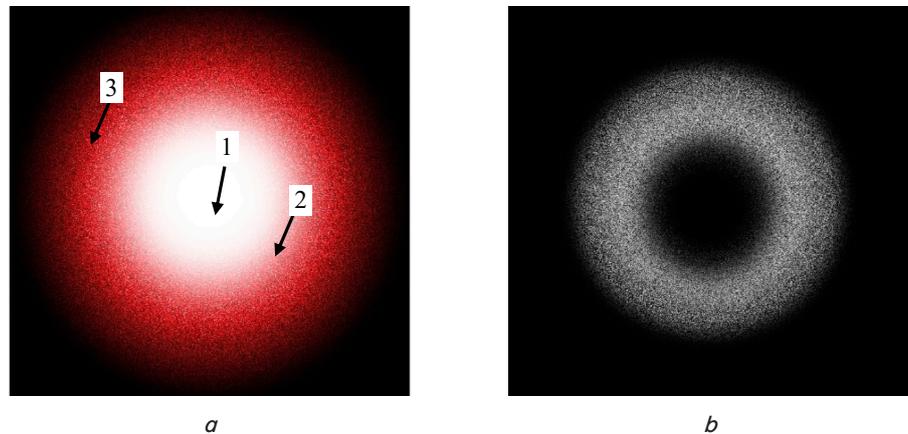
Fig. 11. Image of pixels on the surface of a photomatrix: a – positive image of a light spot formed on the surface of a photomatrix when radiation passes through an optical fiber; b – negative of a light spot used to highlight informative areas in optical-digital analysis

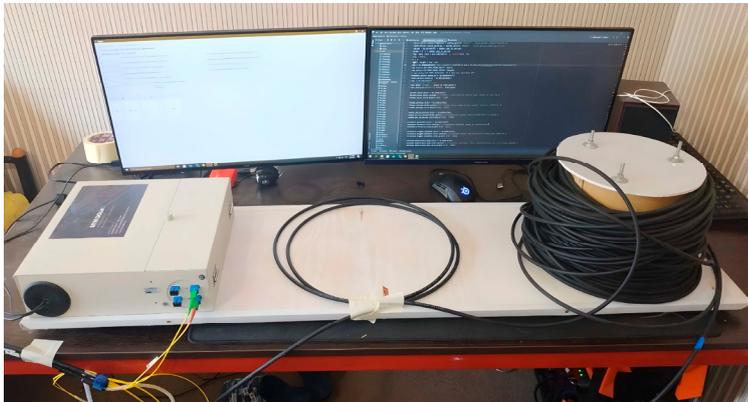
Fig. 12. General view of a laboratory sample of an automatic system for monitoring the technical condition of fiber-optic cables

A laboratory prototype (Fig. 12) was specially designed for the experiments, allowing for testing of the ATCMS hardware and software. This setup was later used as the basis for a future experimental prototype, which is planned for testing under critical conditions in real production. The setup has a simple design and includes the following main components: a computer 1, a pre-processing unit 2, optical connectors 3 for connecting a fiber-optic sensor 4, and a spool 5 on which the fiber-optic cable is wound.

The bench consists of a structure with a 16 mm thick plywood base, onto which a reel with a fiber optic cable approximately 200 meters long is attached. The Shijia Optical Cable GYFJH-2B1.3 IEC60332-3-16 (made in China) was used as the test object. Mechanical action was applied to loop 4, located on the base of the bench. The loop was specially formed from several turns of fiber optic cable and was used as a sensing element responding to external influences. The impact object was a hammer with a head weighing 500 g and a soft rubber striker. The technique involved a free fall from a height of 2–7 cm (without swinging), followed by controlled tapping of random nature. This method was chosen to simulate unauthorized access, in which the impact is random. The hammer exerted an impact without applying external force to eliminate the increase in impact energy. The drop height was recorded using a measuring ruler, with an error of within 5 mm. After the impact, the hammer returned to its original position, and its height was again recorded. The room temperature and humidity remained constant throughout the experiment, which had no effect on the linear dimensions of the cable. When the ATCMS was launched, the program window displayed a zero value of white pixels, indicating the level of additional losses generated in the fiber optic cable due to microbending. Microbending occurs through mechanical action directly on the fiber optic cable jacket. Microbending can be caused by various methods, such as bending or by striking the side of the fiber optic cable with a heavy object. The latter method was chosen for the experiment. The measurement results were slightly affected by generated interference, which was recorded by ATCMS. The maximum value of generated white pixels did not exceed 100 units. Under mechanical stress, the values of the

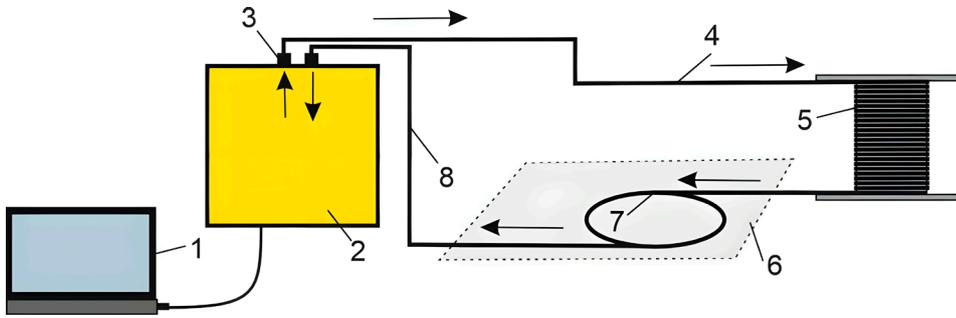
Fig. 13. Schematic diagram of a laboratory prototype of an automatic technical condition monitoring system: 1 – personal computer with specialized software; 2 – pulse generation and data pre-processing unit; 3 – connectors for connecting a fiber-optic cable; 4 – forward fiber-optic cable; 5 – spool with optical fiber; 6 – base for fixing the spool; 7 – fiber-optic loop; 8 – reverse fiber-optic cable

Fig. 13 shows a schematic diagram of a laboratory-scale ATCMS prototype. When mechanical stress is applied to the optical fiber, a microbend is formed at point 7, causing some of the optical radiation to escape the core and propagate within the fiber cladding. Additional losses, directly related to the stress intensity and the optical radiation intensity level, correspondingly alter the optical spot pattern, or pixel pattern. The greater the stress force causing the microbend, the higher the additional losses and the lower the intensity. These changes are linear. Solid arrows indicate the propagation of optical radiation from the laser toward the photodetector. The laboratory setup makes it possible to simulate unauthorized access or damage to the cladding, as well as various mechanical stresses. A diagram of the setup is shown in Fig. 13.

When a fiber-optic cable is subjected to mechanical stress, deformation is transmitted to the optical conductors. Consequently, when a mechanical stress is applied to the side of the cable, the stress is transmitted to the optical waves beneath its cladding. Changes in the optical radiation parameters are recorded by a photodetector, and a hardware and software system processes the data and produces numerical results for the pixel pattern changes.

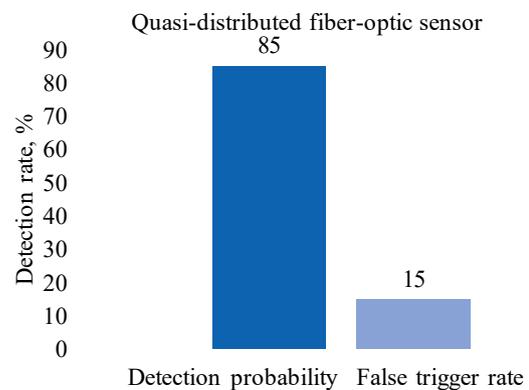
Fig. 14. Analysis of probabilistic characteristics of a quasi-distributed fiber-optic sensor

The results of testing the ATCMS prototype confirmed its functionality and demonstrated the high reliability of the quasi-distributed fiber optic sensor when impacting the fiber optic cable. During the experiments, the probability of correct system response to impact on the fiber optic cable was 0.85, with the error rate not exceeding 15%. In the future, it is planned to increase the response probability to 0.9, while simultaneously reducing the probability of false alarms to no more than 0.1. An analysis of the probabilistic characteristics of the quasi-distributed fiber-optic sensor is depicted in Fig. 14.

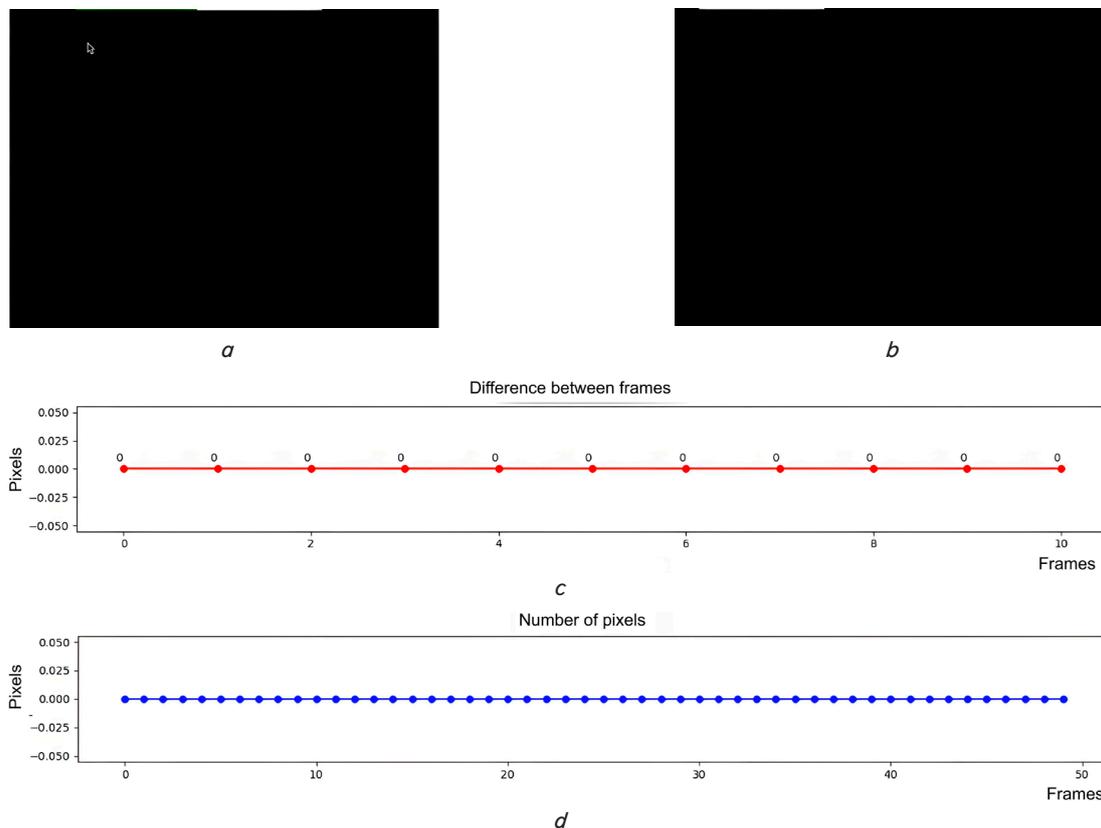
Fig. 15. Parameters of the monitoring system operation under a normal mode: *a* – image of the difference between the reference and current frame in the absence of external influences; *b* – binarized image with a minimum number of white pixels not exceeding the sensitivity threshold; *c* – plot of the instantaneous rate of change in the number of white pixels over time; *d* – plot of the total number of white pixels in successive frames

The absence of a visible light spot is explained by the fact that, after stabilization, residual pulsations in the radiation source are reduced to a minimum (Fig. 15, 16). The fiber optic cable experiences no mechanical stress, such as bending, compression, or vibration. Optical radiation propagates along the path with virtually no additional loss, and a uniformly dark field with minimal intrinsic noise is formed on the image sensor. As a result, the brightness

Therefore, completely black windows and virtually zero graph values under an operating mode are not an error but a reliable indication that the monitored section of fiber optic cable is in perfect technical condition, and the monitoring system is functioning properly and is ready to detect and record even the slightest external impact at any time. During the initial launch, there was no interference generated by the semiconductor laser, which later appeared due to its heating.

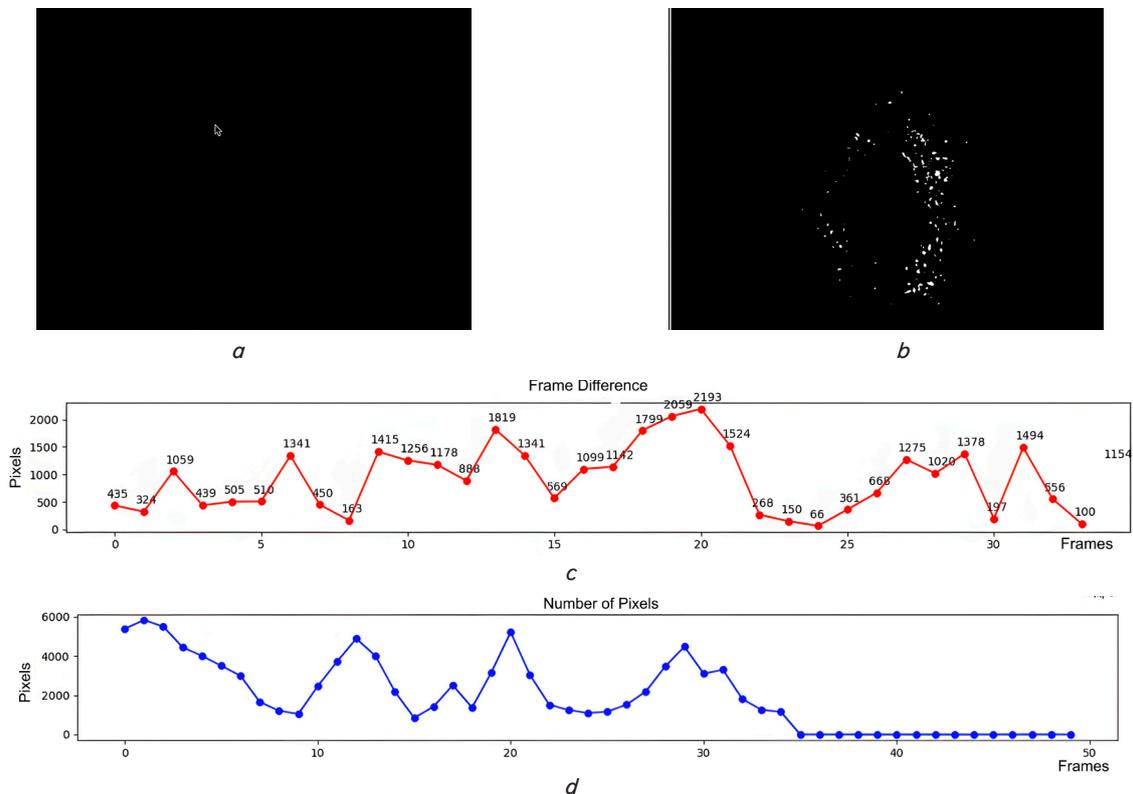
Fig. 16. Plots that record mechanical impacts on a fiber-optic cable during the simulation of unauthorized access: *a* – change in the spatial structure of the light spot with minimal mechanical impact; *b* – binarized image of activated pixels after exceeding the threshold value; *c* – plot of the rate of change in the number of white pixels with repeated impacts; *d* – plot of the total number of white pixels over time

and prompt detection of external interference. Fig. 16–19 show plots of recording mechanical impacts of varying intensity on the fiber-optic cable under conditions of simulated unauthorized access. The key conclusion is that the ATCMS system reliably responds to external impacts, recording them based on additional losses occurring in the line. Moreover, the optical monitoring channel with reduced sensitivity demonstrates immunity to external interference and parasitic influences. Fig. 16 shows a screenshot of the fiber-optic cable subjected to the weakest repeatedly verified mechanical impact: dropping a hammer with a head weighing 500 g and a soft rubber striker from a height of 3 cm (without swinging). Fig. 16 shows how the pixel pattern has changed and their maximum value has reached 2193 units.

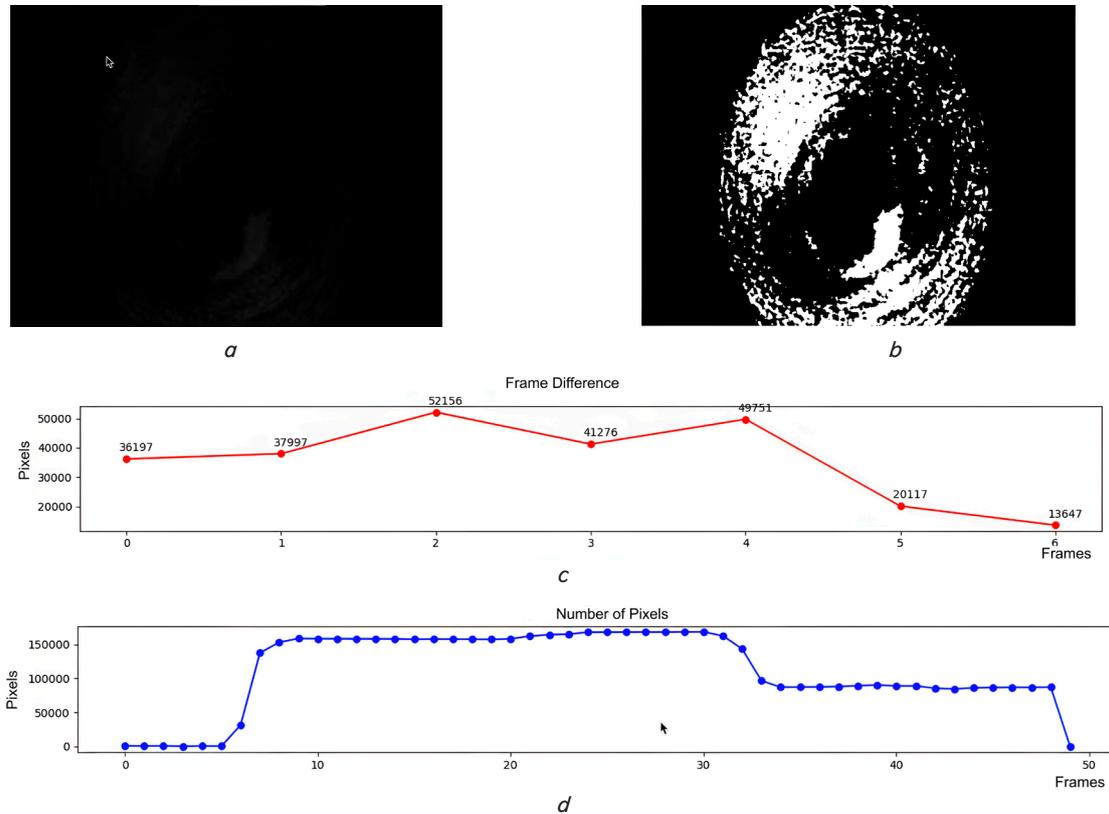
Fig. 17. Plots that record impacts on a fiber-optic cable during the simulation of an attempt at unauthorized access: *a* – deformation of the light spot during a strong mechanical impact on the fiber-optic cable; *b* – binarized image with a high density of white pixels; *c* – plot of the intensive growth rate of change in the number of white pixels; *d* – plot of the total number of white pixels during the impact

In the first case, changes in the pixel pattern are visible, with their maximum values reaching 52,156 and 49,751 units (Fig. 17). In the second case, two effects were recorded, which were stronger than in the first case. The maximum values of white pixels reached 52,156 and 49,751 units.

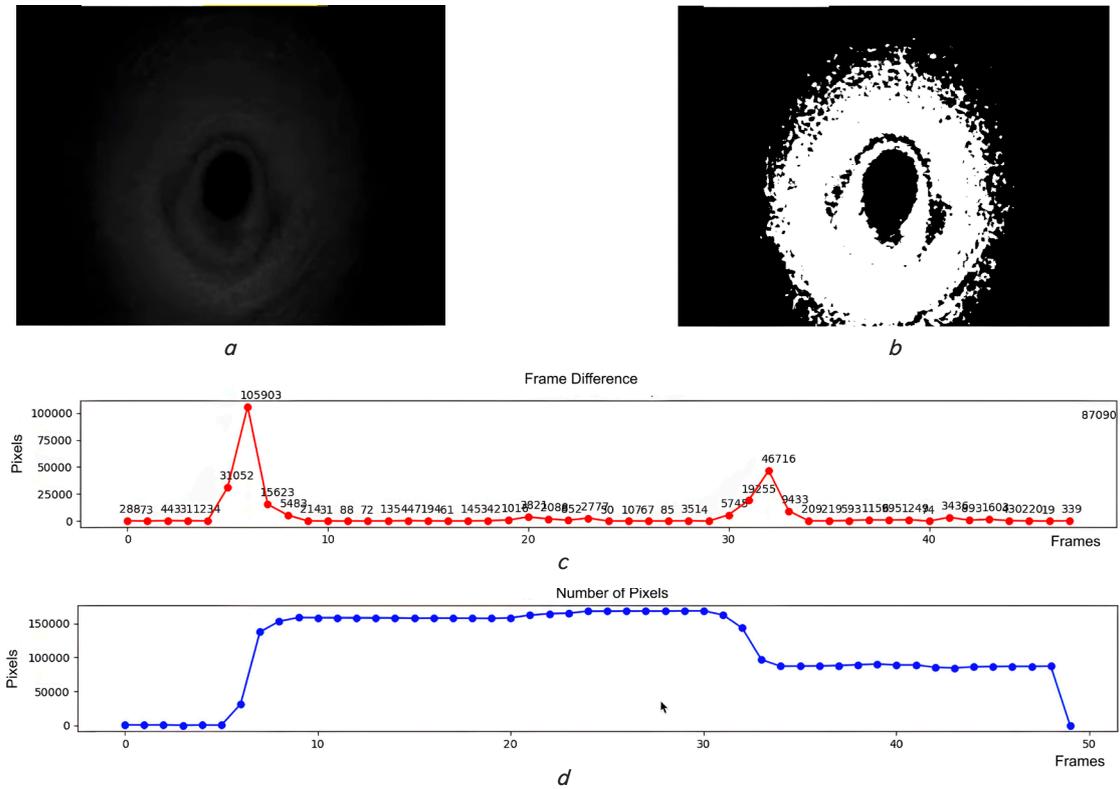
Fig. 18. Plots that record impacts on a fiber-optic cable during an attempt to achieve unauthorized access: *a* – change in the image of a light spot with repeated mechanical impacts; *b* – binarized image of pixels registered by the system; *c* – plot of the rate of change in the number of white pixels with successive impacts; *d* – plot of the total number of white pixels over time

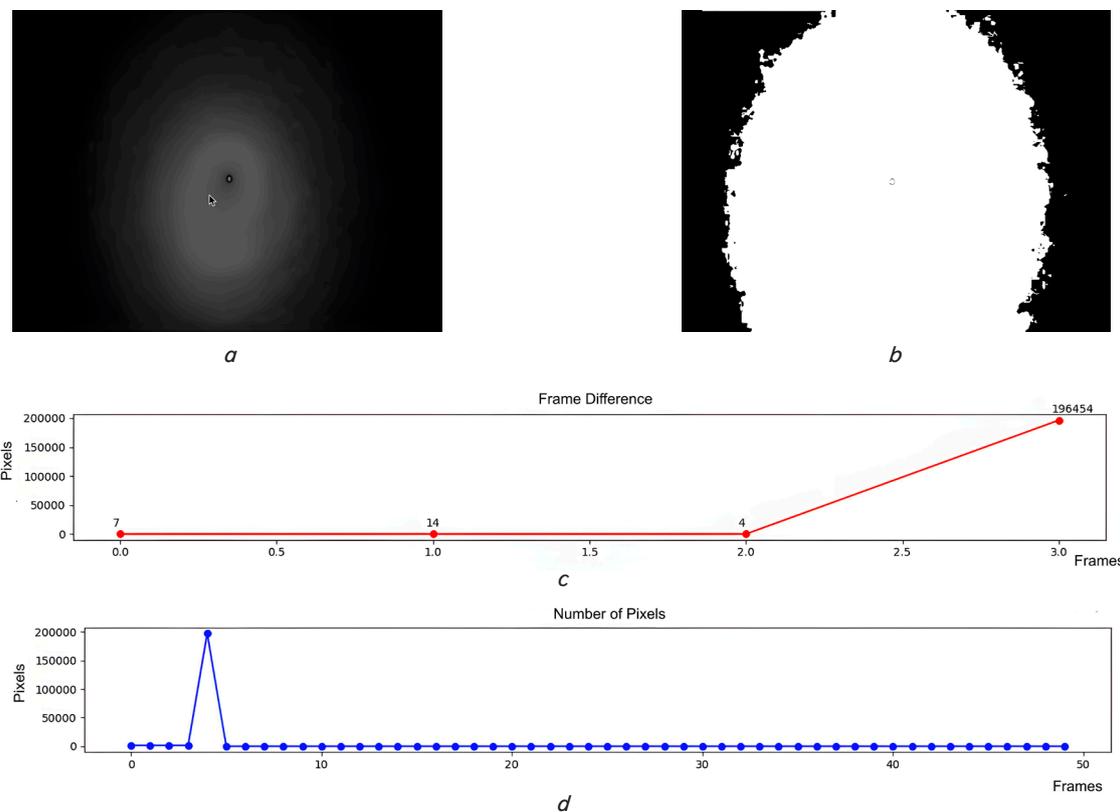
Fig. 19. Plots that record impacts on a fiber-optic cable during an attempt to achieve unauthorized access: *a* – growth and deformation of the light spot at maximum bending of the fiber-optic cable; *b* – binarized image with the maximum number of activated pixels; *c* – plot of a sharp increase in the rate of change of the number of white pixels; *d* – plot of the maximum total number of white pixels registered by the system

Fig. 19 shows the increasing white spot on the computer screen and the number of white pixels. In these cases, the optical fiber was subjected to mechanical impact by dropping a hammer with a 500-g head and a soft rubber striker from a height of 7 cm (without swinging), inducing maximum bending of the optical fiber.

Changes in the pixel pattern are visible, and their maximum value reached 196,554 units (Fig. 19). In the second case, stronger changes were recorded than in the first.

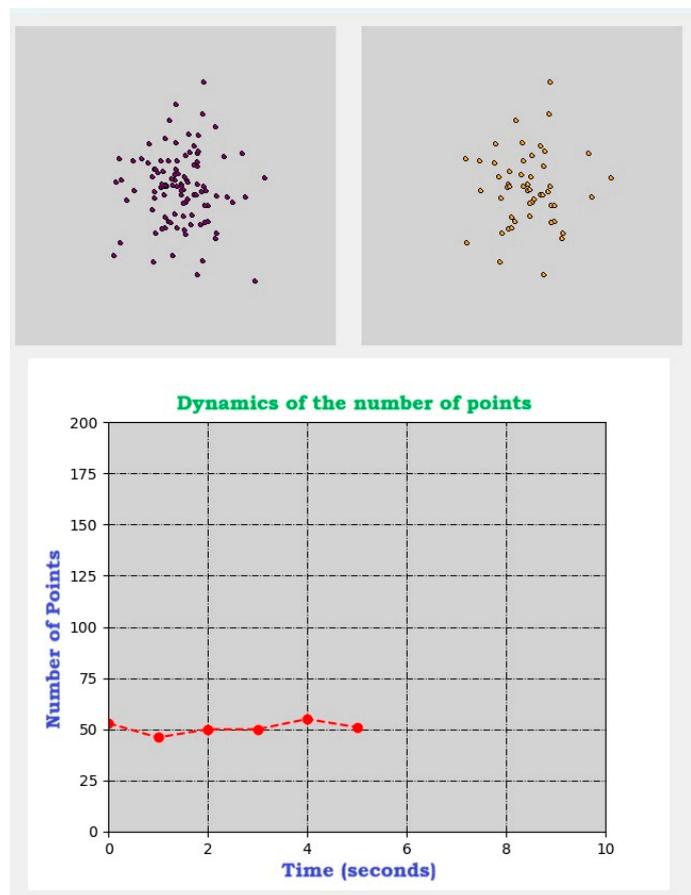
Fig. 20. Noise interference from laser radiation in the hardware and software system

During the experiments, it was established that one of the main problems is noise generated by the light source itself. Fig. 21 shows a screenshot of the recorded interference caused by source noise; the total number of white pixels did not exceed 100.

This noise interference is detected by the photomatrix and can lead to false alarms. To improve the system's accuracy, it is necessary to reduce the laser beam pulsation level.

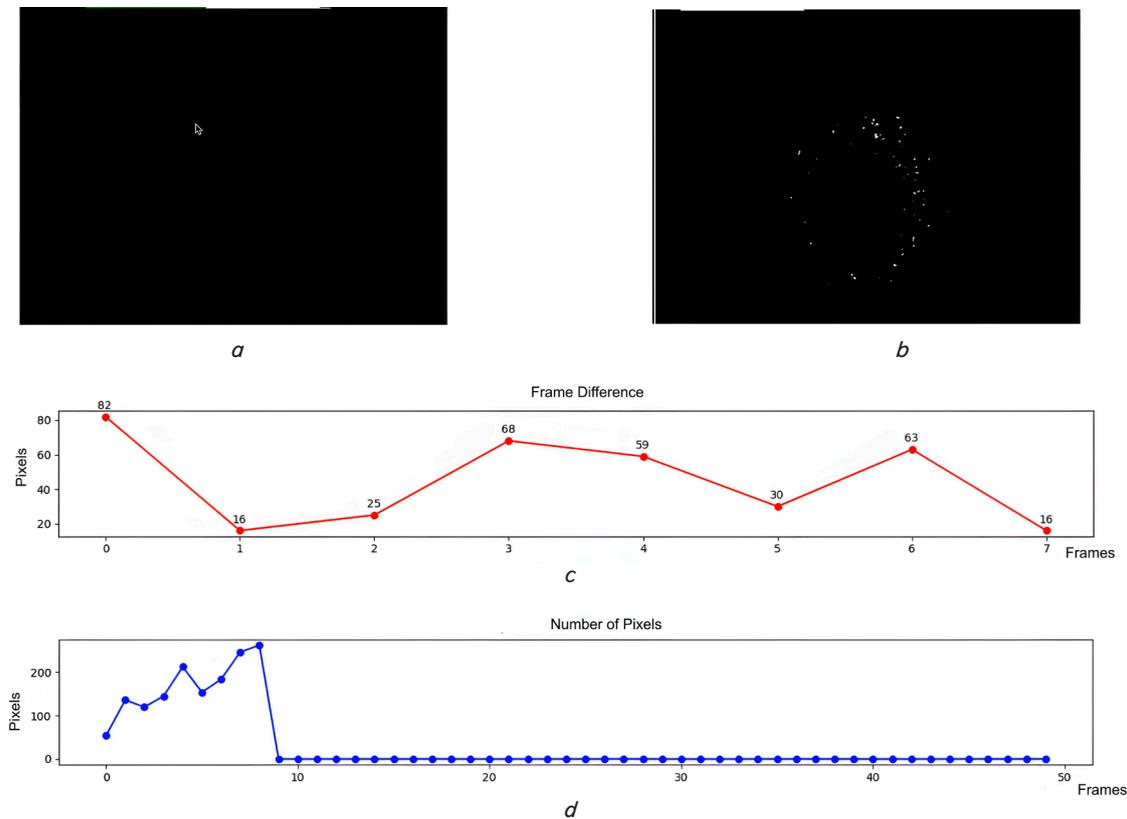
Fig. 21. Plots that record impacts on a fiber-optic cable during an attempt to achieve unauthorized access: *a* – change in the structure of the light spot with weak mechanical impact on the fiber-optic cable; *b* – binarized image of pixels registered after threshold processing; *c* – plot of the instantaneous rate of change in the number of white pixels; *d* – plot of the total number of white pixels during the impact
