Modern risk assessment of the influences of natural and military man-made factors on the state of the historical buildings of the Kyiv-Pechersk Lavra

T.V. Kril¹, I.A. Cherevko², S.V. Shcherbyna³, O.O. Chalyi³, 2024

The article presents the results of the analysis of the operation of devices for various purposes — from the recording of seismic-acoustic waves, which have a high frequency of natural oscillations, to low-frequency ones, which are recorded by a laser inclinometer.

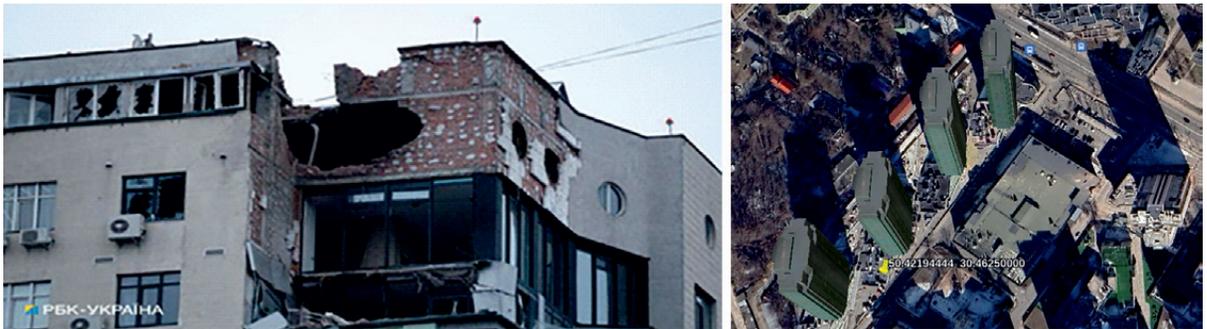
Fig. 1. A 26-story building in the Solomyanskyi district of Kyiv, damaged by debris from a downed Russian drone on the night of December 21—22, 2023. On the left is a damaged part of the house.

An infrasound event of the «technical explosion» type was also recorded on the night of December 21—22, 2023 at Solomyansky district, V. Lobanovskiy avenue, 4-B, 50°25'19" N 30°27'45" E, type of weapon: kamikaze drone Shahed (Fig. 1). The distance from the explosion to the observation point in building No. 3 of the KPL is 6738.52 meters. Records of three components of the infrasound waves from the explosion are presented in Fig. 2.

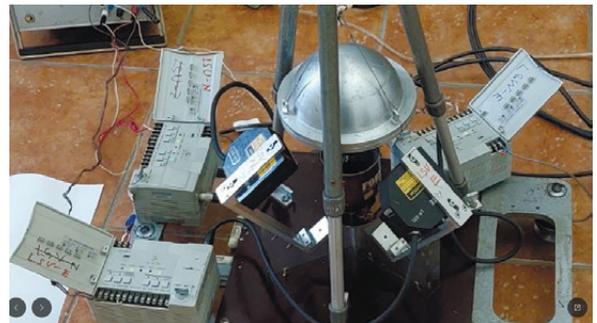
Fig. 8. General scheme of the 3D laser inclinometer, which was located in the 3rd building of the KPL.

Statistical analysis of laser inclinometer data. The next major stage of scientific research into the condition of the KPL introduced a new approach to long-term measurements of ground tilts in various areas of this historic site. This was necessary due to the significant tilting of the KPL Bell Tower, caused by the many underground cavities. For this purpose, a functional working 3D model of a laser inclinometer with a Foucault pendulum was used. (Fig. 8, 9).

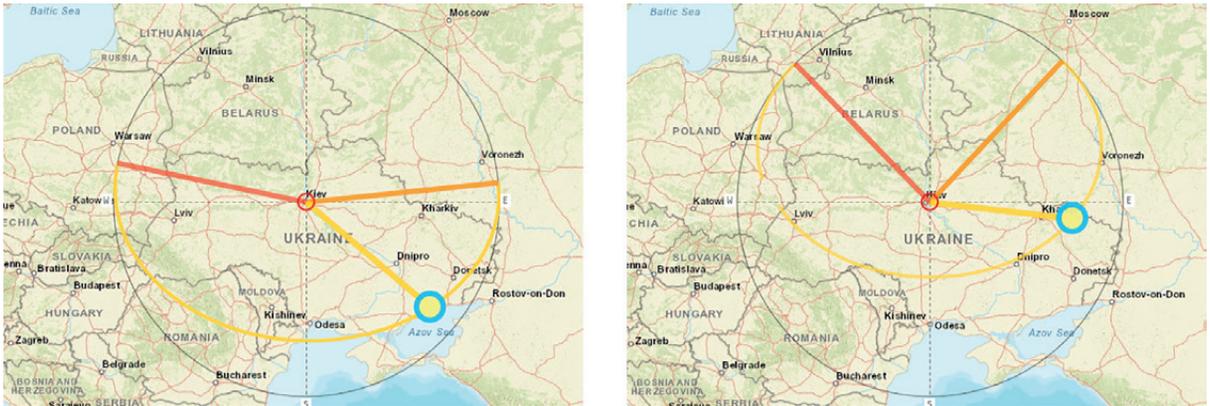
Fig. 16. Trajectories of the Moon's movement for the period from 2024-02-10 00:05:02 to 2024-02-24 23:05:14 relative to the location point of the laser 3D inclinometer on the full-scale map of the country to track its relative position relative to North and South of Ukraine <https://www.mooncalc.org/#/50.5187,30.38,5/2024.02.06/23:58/1/3>. The Moon trajectory: *a* — 13 February 2024 12:35 UTC+2 (see Fig. 14, *b*); *b* — 18 February 2024 12:35 UTC+2 (see Fig. 7).

In Fig. 16, you can see that the direction and angle of the relative movement of the Moon relative to the observation points in buildings No. 3 and No. 4 does not change and does not depend on the time of the Moon's movement relative to these observation points for any time interval. Unfortunately, such almost constant values of the angles and directions of the Moon's movement relative to these

– anomalous sharp displacement is associated with the trajectory of the Moon (see Fig. 15, 16) relative to these voids on the territory of the KPL, because such significant and sharp shifts do not occur in other regions of homogeneously filled regions of the upper part of the KPL environment.
