This paper introduces a methodology devised for thermographic inspection of concrete technical condition inside concrete dams. Water infiltration into a dam accelerates the processes of concrete degradation, so temperature fields provide important information about the dynamics of these processes. As a result of the thermal imaging survey of the observation gallery at a historic hydraulic structure, a formalized pattern of the temperature field inside the dam was acquired and the locations of temperature anomalies associated with infiltration were identified. At the leakage points, the water temperature differed from the concrete temperature by 1.0–2.9 °C, indicating different rates of water flow through the water wall and the gallery ceiling. The temperature of the gallery areas with increased infiltration was 1–2 °C higher than the 12.7 °C selected as the reference temperature. When recording the temperature fields, the optical axis of the thermal imager was directed along the gallery, and not perpendicular to the surfaces under study, as in construction thermography. To this end, a methodological approach was devised to eliminate distortions of the resulting thermograms caused b

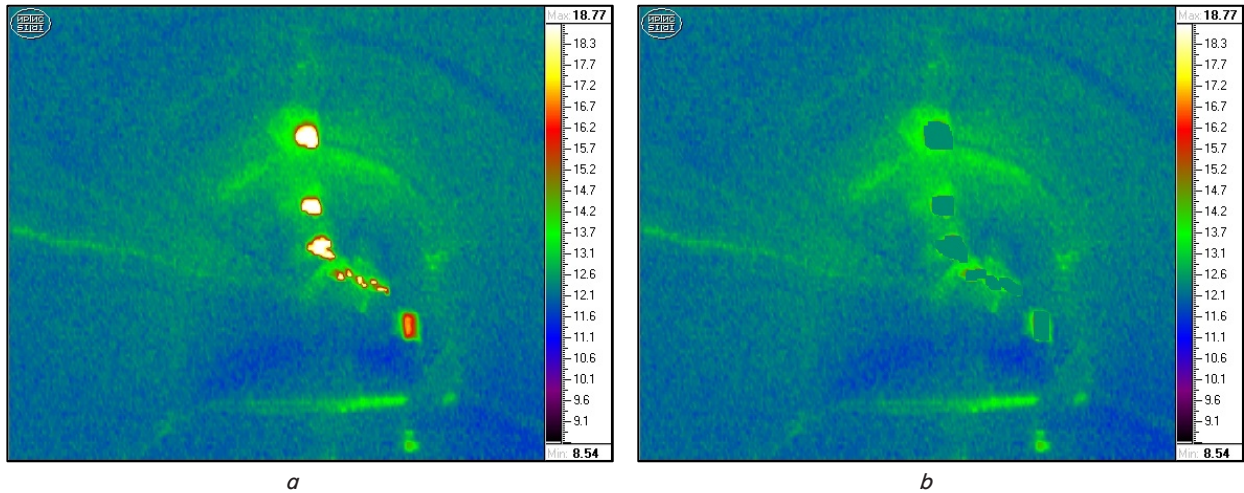
After filtering the acquired image using the dependences shown in Fig. 6, we get the final view of the thermogram after processing (Fig. 7, b). Comparison of the acquired thermogram with the original one (Fig. 7, a) confirms the fact that the influence of external heat-emitting sources has significantly decreased after processing. Quantitative assessment shows a decrease in the interference signal by more than 2.5 times [12, 13].

Fig. 7. Eliminating the influence of external sources of radiation: *a* – initial thermogram; *b* – processed thermogram

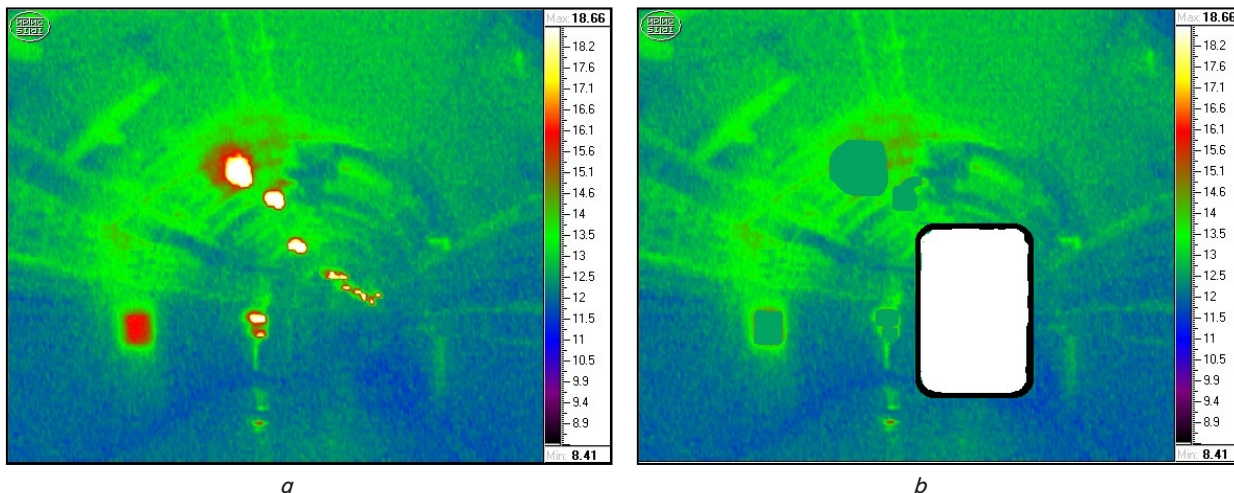
Fig. 9. Thermogram of the section of the upper gallery with angular displacement: *a* – untreated, $T_{av}=13.6\text{ }^{\circ}\text{C}$; *b* – after processing, $T_{av}=12.7\text{ }^{\circ}\text{C}$

Fig. 9 demonstrates that as a result of thermogram processing, the integrated temperature criterion T_{av} turned out to be less than that on the unprocessed one because of the exclusion of influence of lighting lamps and electrical distribution equipment, as well as taking into account the mask. After processing the entire sequence of thermograms, the difference between the average temperatures of treated and untreated ones was 0.7–2.8 °C.
