The object of this study is high-strength steel of API 5DP Gr 105 that has been used during well completion in a corrosive environment. This work emphasizes key factors affecting material damage caused by slip marks, tensile load, and hydrogen content in contaminated brine and completion fluid, which were not addressed in previous studies. Several tests, including chemical, mechanical, and surface characterization, were conducted. The chemical composition test of the fluid shows that the brine has been contaminated by H₂S gas and sulfur, with inevitable traces of chloride, bicarbonate, carbonate, bisulfide, and sulfide, providing active sites for hydrogen atom diffusion at the slip marks. The material composition test confirms that the failed material is API 5DP Gr 105. A noticeable amount of phosphorus increases grain boundary segregation and weakens the cohesive metallic bond. A hardness at 28 Rockwell C is inevitable and increases the material's vulnerability to embrittlement, despite the Charpy energy test showing a manageable level, confirming local brittleness. The high tensile strength of 914 MPa is evidence of embrittlement, even though the material remains ductile, with a

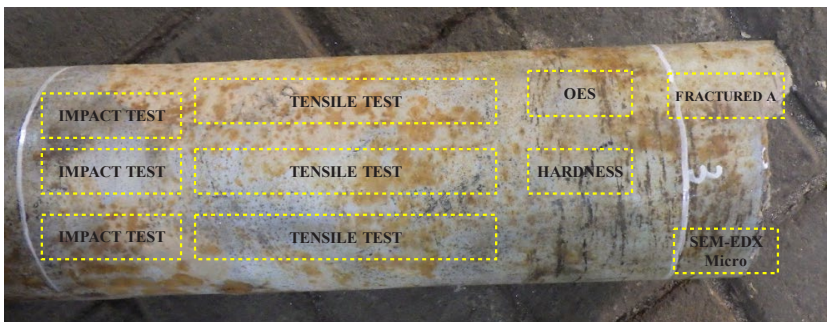
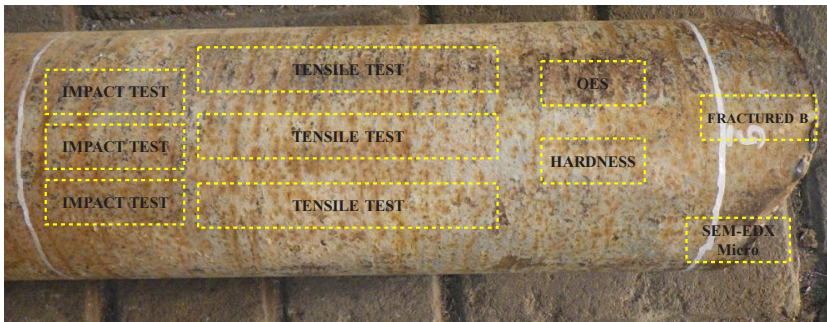
Fig. 3. The proposed location for the test and examination:
a – fractured sample A; *b* – fractured sample B

Fig. 3, *a*, *b* show various locations of types of tests according to the damage of failed material and the possible location of hydrogen impact that lowers the mechanical properties of the drill pipe.

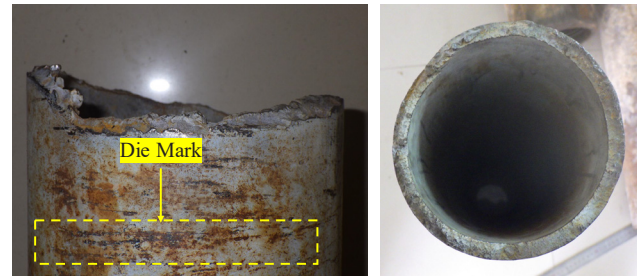
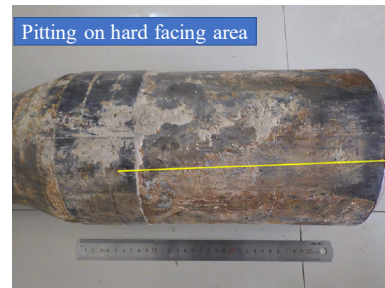
Fig. 4. The testing specimen:
a – drill pipe A (fracture A); *b* – drill pipe B (fracture B);
c – drill pipe C (fracture C)

Fig. 4 presents a designated test specimen for each drill pipe. In this study, the drill pipe specimen exhibits notable material degradation, including die marks, pitting, and localized rust. The specimen was subjected to mechanical property assessments and surface characterization.

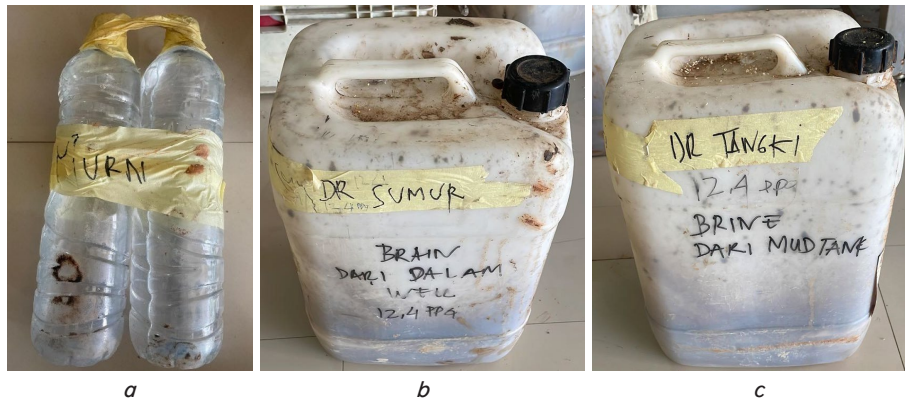
Fig. 5. High-density completion fluid sample at various locations: *a* – fresh; *b* – Spent fluid from the well; *c* – brine mud fluid

The HDCF fluid from various locations is retrieved to compare the effects of impurities on the mechanical properties of drill pipe. The presence of impurities such as chloride, bicarbonate, and carbonate from fluid sample was analyze to delve into susceptibility of API 5DP material against embrittlement (Fig. 5).

Overall, the pH of the three samples indicates an alkaline system, with the spent HDCF notably exhibiting a lower pH of 8.91 compared to the other solutions. The presence of chloride at 900 ppm signifies a moderate concentration that may promote pitting corrosion. Furthermore, the detection of bicarbonate and carbonate ions at 129.33 ppm and 127.21 ppm suggests a moderate level of alkalinity, which can potentially lead to the formation of scale, such as calcium carbonate. Additionally, in the brine mud HDCF fluid system, a chloride content of 800 ppm indicates moderate salinity. The elevated bicarbonate and carbonate levels at 140 ppm and 138 ppm imply a more alkaline, buffered system. It is hypothesized that ions such as chloride, bicarbonate, and carbonate influence hydrogen generation and absorption into steel.

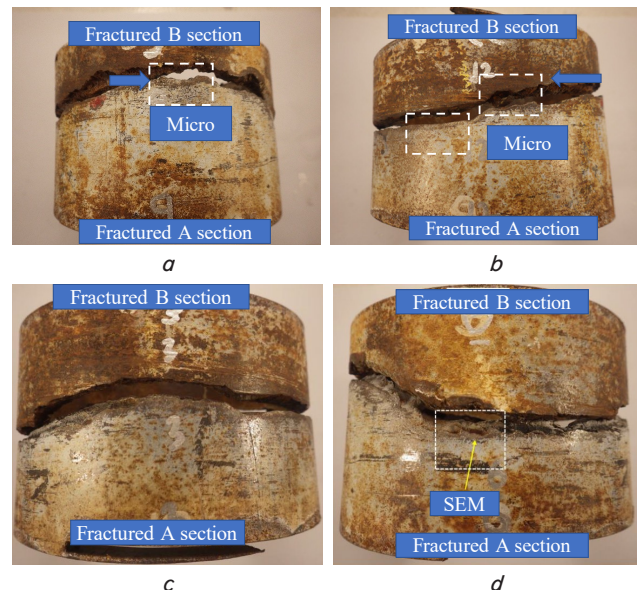
Fig. 7. The micro and macro test location: *a* – 9 o'clock; *b* – 12-o'clock; *c* – 3-o'clock; *d* – 6 o'clock

The macro test was made on the specimen according to ASTM E340 while the micro test was subject to ASTM E407 to delve into the thinning susceptibility and the crack propagation on the cross-section (Fig. 7).
