DOI: 10.15587/1729-4061.2023.273788

DAMAGE FORMATIONS OF RAMIE FIBER COMPOSITES MULTILAYER ARMOUR SYSTEM UNDER HIGH-VELOCITY IMPACTS

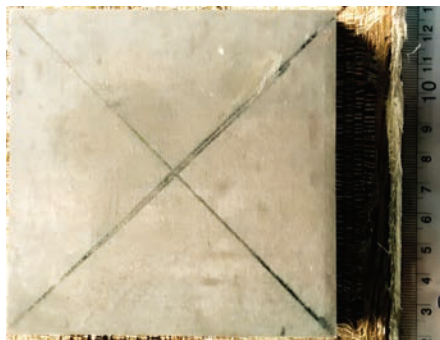
Fig. 3. Wolfram carbide material

The type of ceramic used was WC with dimensions of 100×100×4 mm and placed on the front, in Fig. 3. The number of WC starts from 1–3, and so on until it can hold bullets.

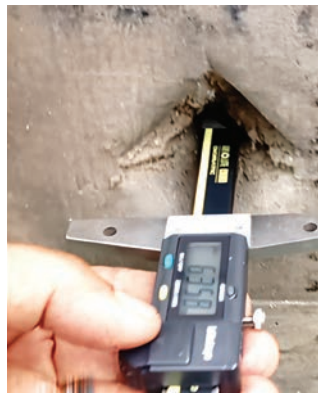
Fig. 7. Back face signature measurement illustration

All materials were subjected to shooting testing using a long-barreled rifle. If the projectile failed to penetrate the panel, it will form a gunshot indentation on the clay. This gunshot indentation with a certain depth is called Back Face Signature (BFS). Fig. 7 shows how to measure BFS. The BFS depth level shows the total projectile energy distributed towards the back of the panel [29].

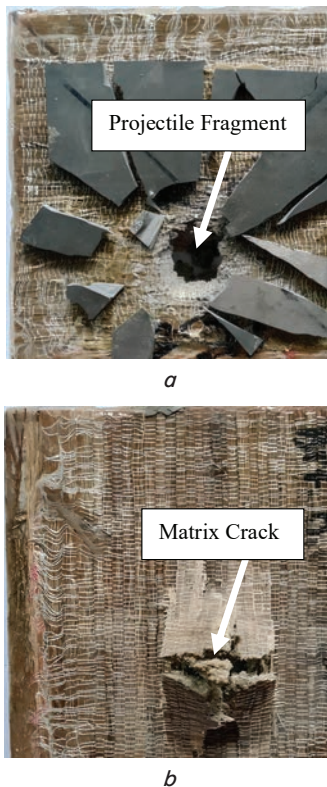
Fig. 10. Macrostructure of 1WC+10R: *a* – front side; *b* – rear side hard steel core

The macroscopic phenomenon of composite panel breakdown mode and failure are presented in Fig. 10–12. The figures show damage to the front and rear surfaces of the MAS. Various modes of damage occurred in the MAS such as projectile fragment, matrix crack, radial crack, impact point, ceramic fragment. Ceramic is the material of the first layer on the MAS mode and as a barrier material, most of the kinetic energy absorption is done by ceramic fragmentation.

The compression stress that occurs at the inlet side and the tensile stress that occurs at the exit cause minor damage to the inlet side, while the damage to the exit side is more intensive. From this phenomenon, it is seen that there is an increase in damage for 1WC+10R, as shown in Fig. 10, *a*. The macrostructure of ceramic rupture for 1WC+10R. Damage to the panel on the outside caused by the impact of the projectile resulted in a matrix crack, in Fig. 10, *b*. The tensile and compressive forces from the impact of the projectile are intensive enough to make the ramie fibers deform and even break.

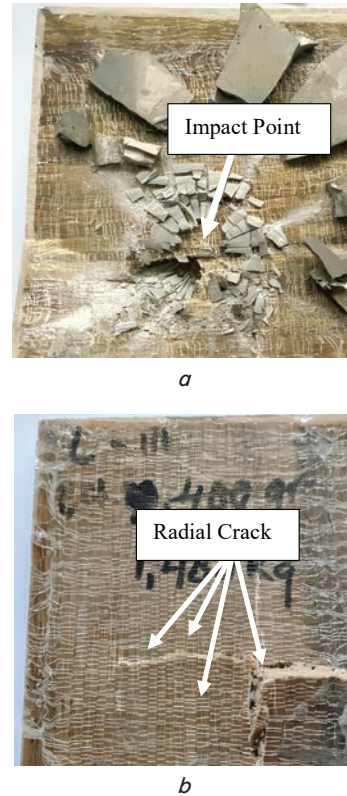
Fig. 11. Macrostructure of 2WC+10R: *a* – front side; *b* – rear side hard steel core

The phenomenon, it is seen that there is a damage for 2WC+10R, as shown in Fig. 11, *a*. Projectile pressure partially into the MAS lamination could plastically deform the composite, forming a mountain-like shape and causing plastic deformation and radial cracking *s*, as seen in Fig. 11, *b*.

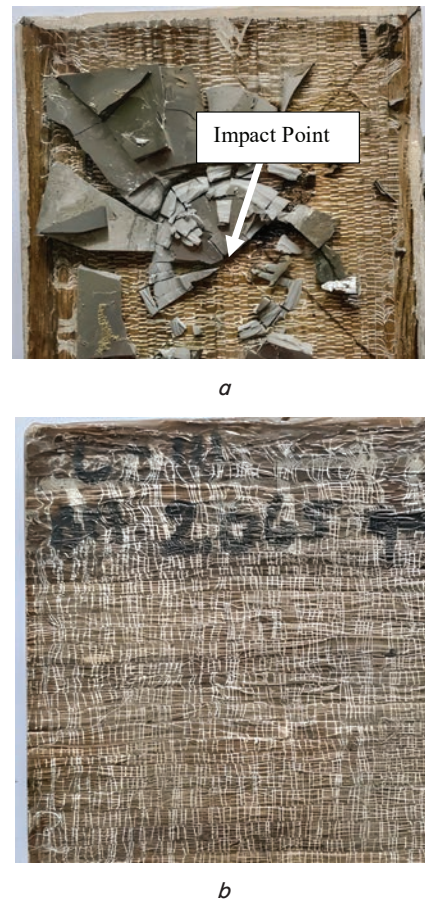
Fig. 12. Macrostructure of 3WC+10R: *a* – front side; *b* – rear side hard steel core

The phenomenon, it is seen that there is a damage for 3WC+10R, as shown in Fig. 12, *a*. But projectile couldn't penetrate the MAS lamination, as seen in Fig. 11, *b*.

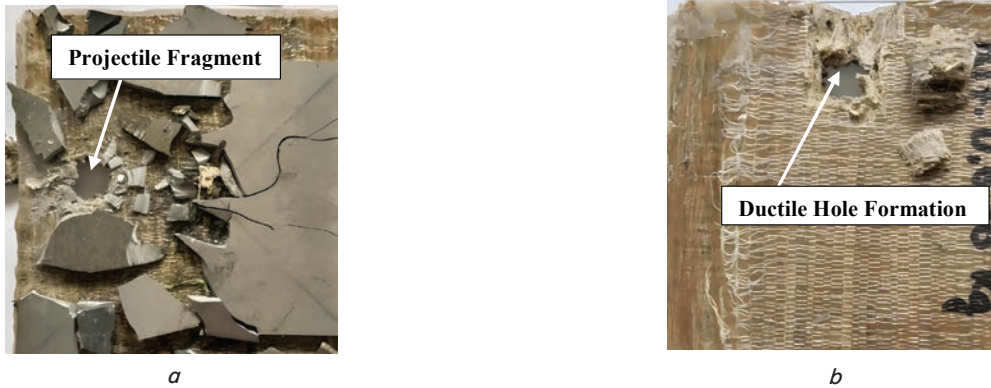
Fig. 13. Macrostructure of 1WC+10R: *a* – front side; *b* – rear side

Fig. 13, *a* show the damage rupture of ceramic 1WC+10R. Damages occurred in Fig. 13, *a* are because the projectile

compressive force is smaller, and the tensile force is greater. Fig. 13, *b* shows a ramie damage and causing ductile hole formation because of failed to withstand the projectile.

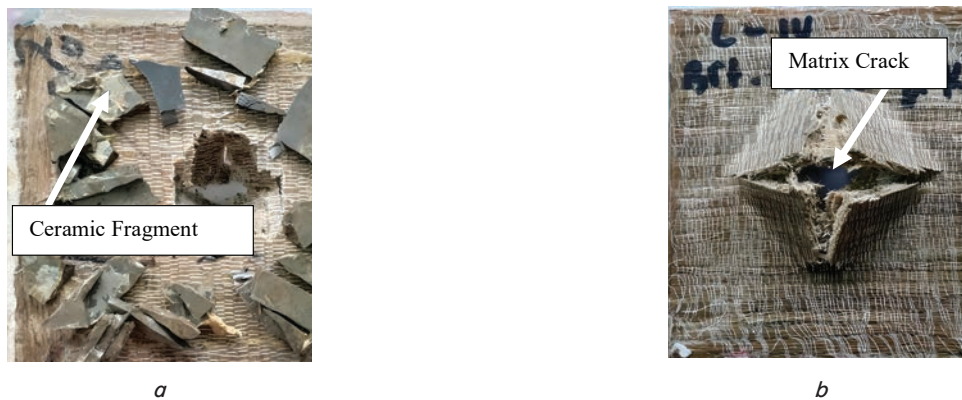
Fig. 14. Macrostructure 2WC+10R: *a* – front side; *b* – rear side

Fig. 14, *a* show the rupture of ceramic 2WC+10R. The damage to the rear side is greater and matrix crack damage is formed, as seen in Fig. 14, *b*.
